**FINAL DRAFT PRELIMINARY
ASSESSMENT**

**SITE ASSESSMENT REPORT
FLAMINGO BAY ARMY TEST
AREAS, WATER ISLAND, VI**

Prepared for
U.S. Department of the Interior
Bureau of Reclamation
Denver Federal Center
Denver, Colorado

July 17, 2001

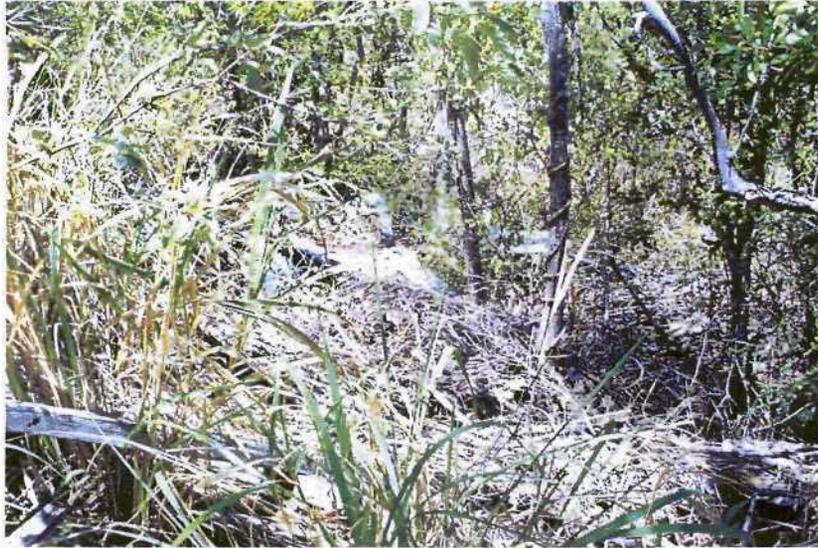
Photo 1 – Debris in the southern portion of the landfill.

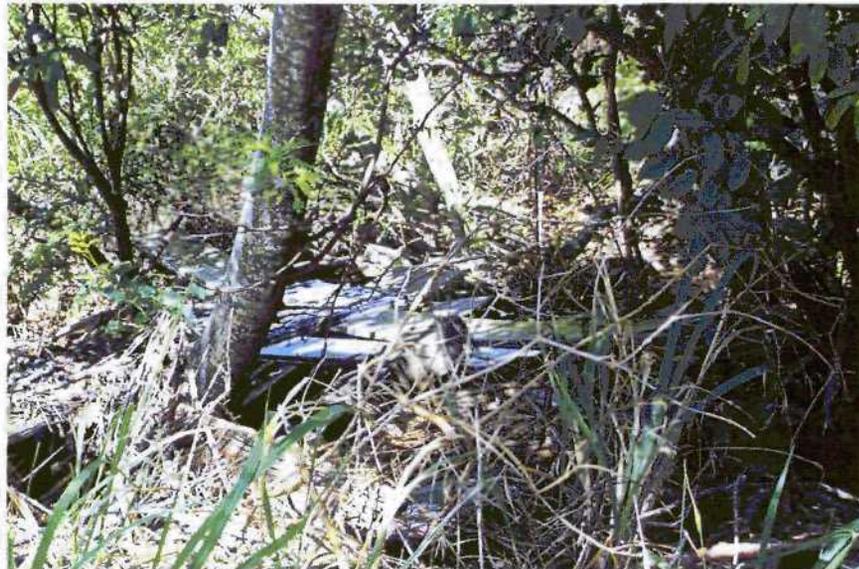
Photo 2 – Debris in the southern portion of the landfill.

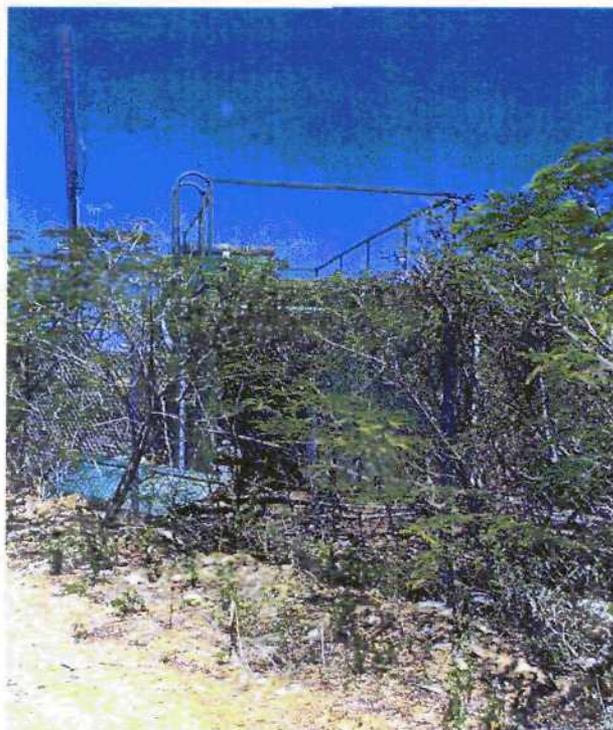
Photo 3 – Abandoned equipment in the eastern area of the landfill

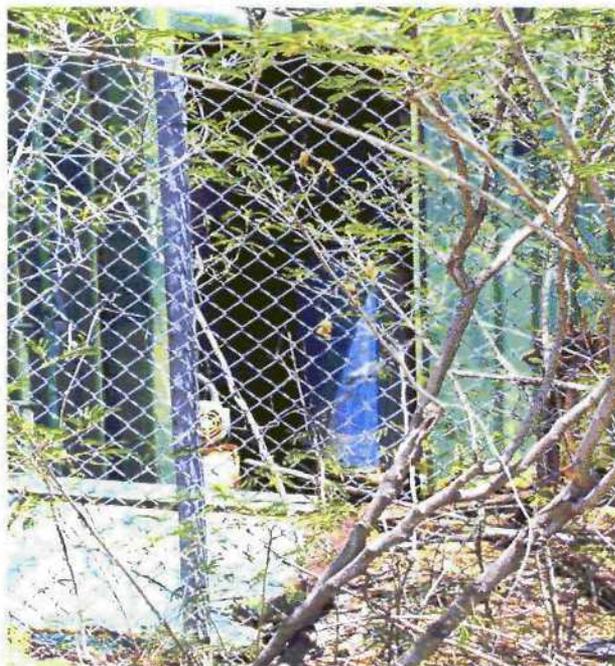
Photo 4 – Abandoned Equipment on eastern portion of landfill.

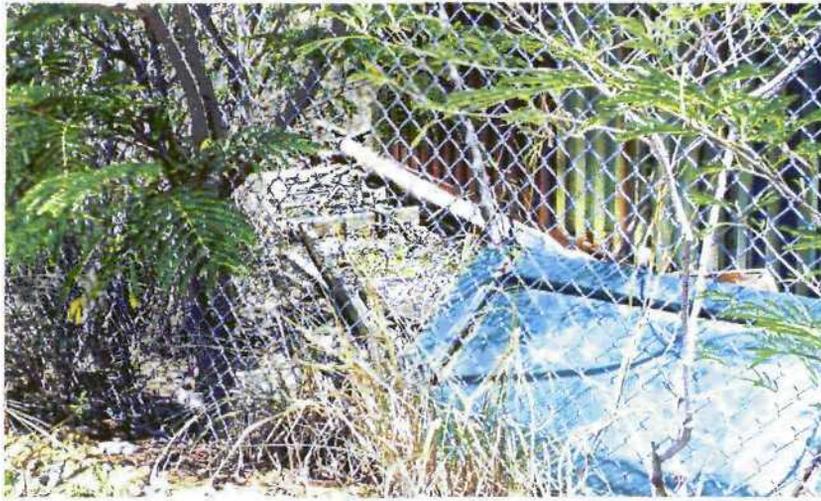
Photo 5 – Debris on Northern edge of landfill.

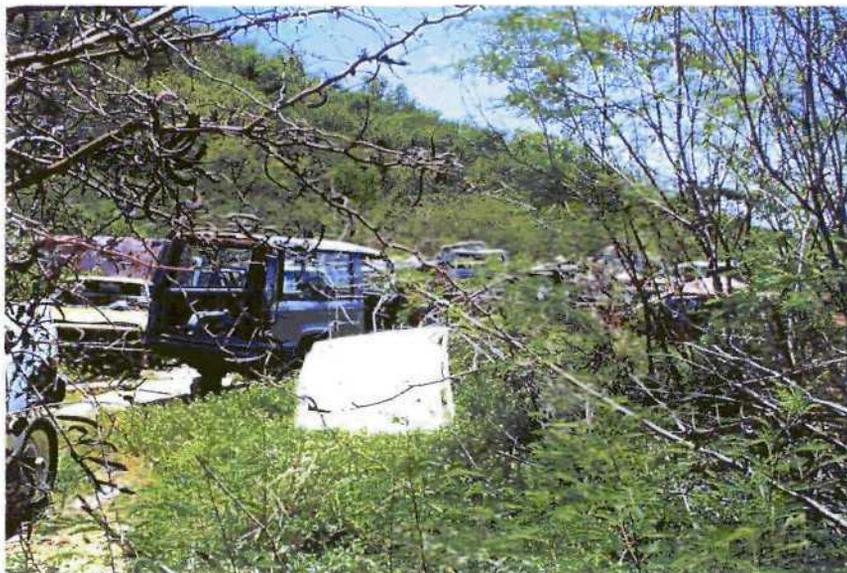
There were no containers observed in Test Area 4. The cars were simply parked on the ground surface.

Photo 6 – View of Cars in Test Area 4.

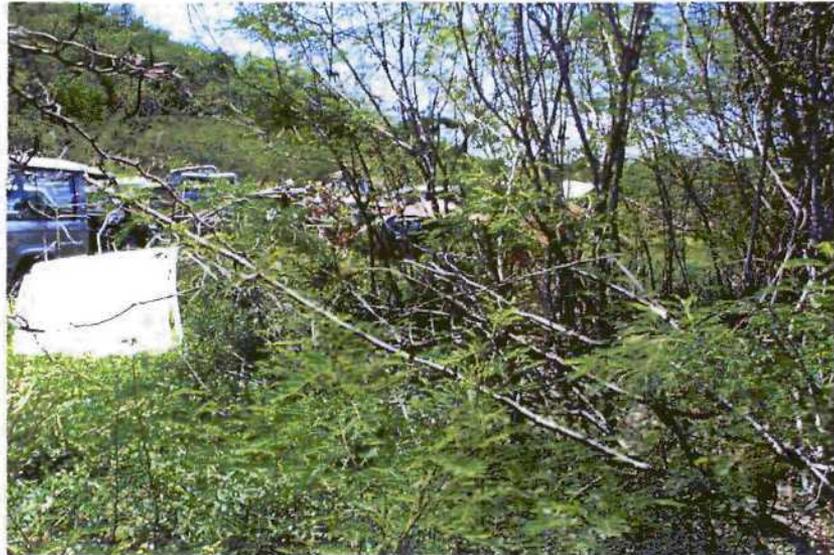
Photo 7 – Abandoned Cars in Test Area 4.

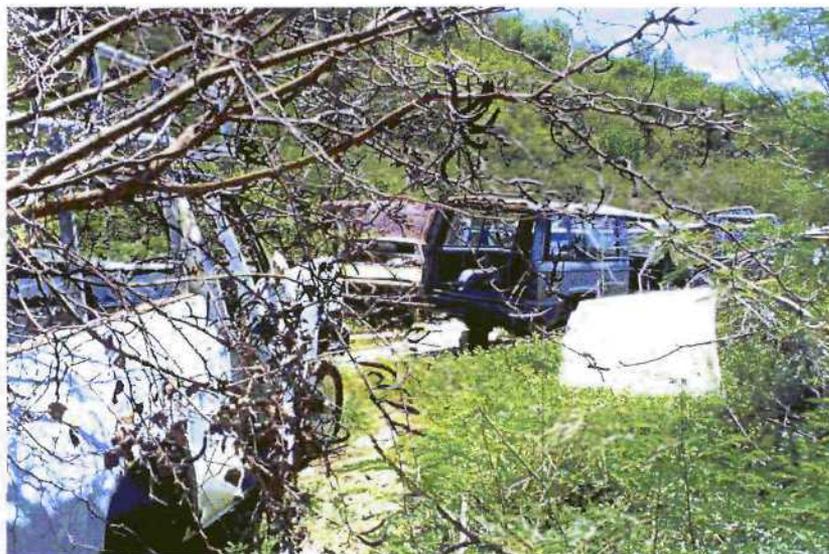
Photo 8 - .Abandoned Cars in Test Area 4.

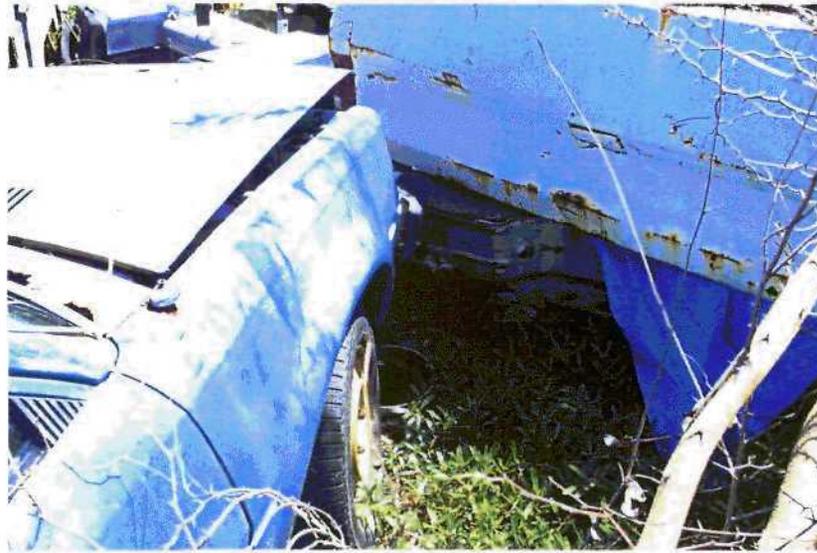
Photo 9 – Abandoned Cars in Test Area 4.

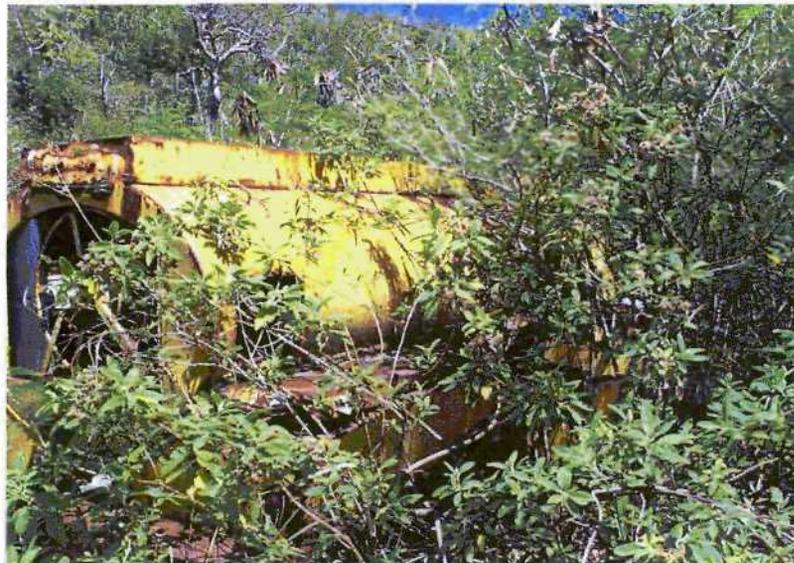
Photo 10 – Abandoned Tanker Truck in Test Area 4.

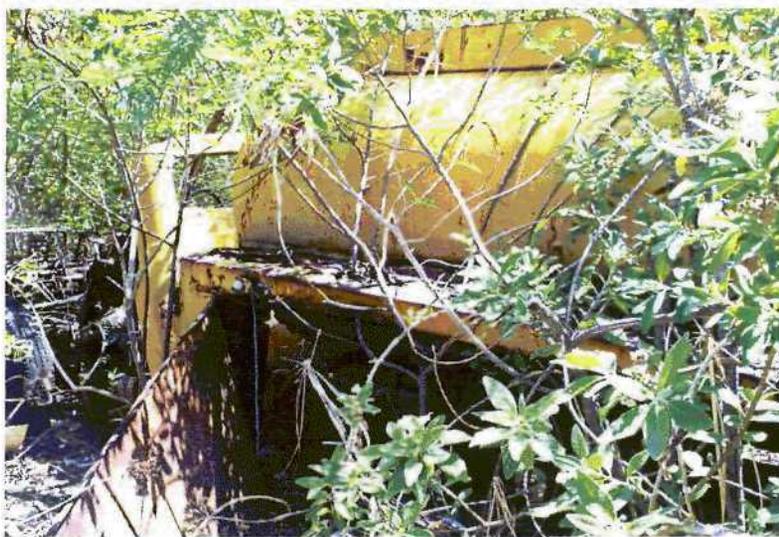
Photo 11 – Abandoned Tanker in Test Area 4.

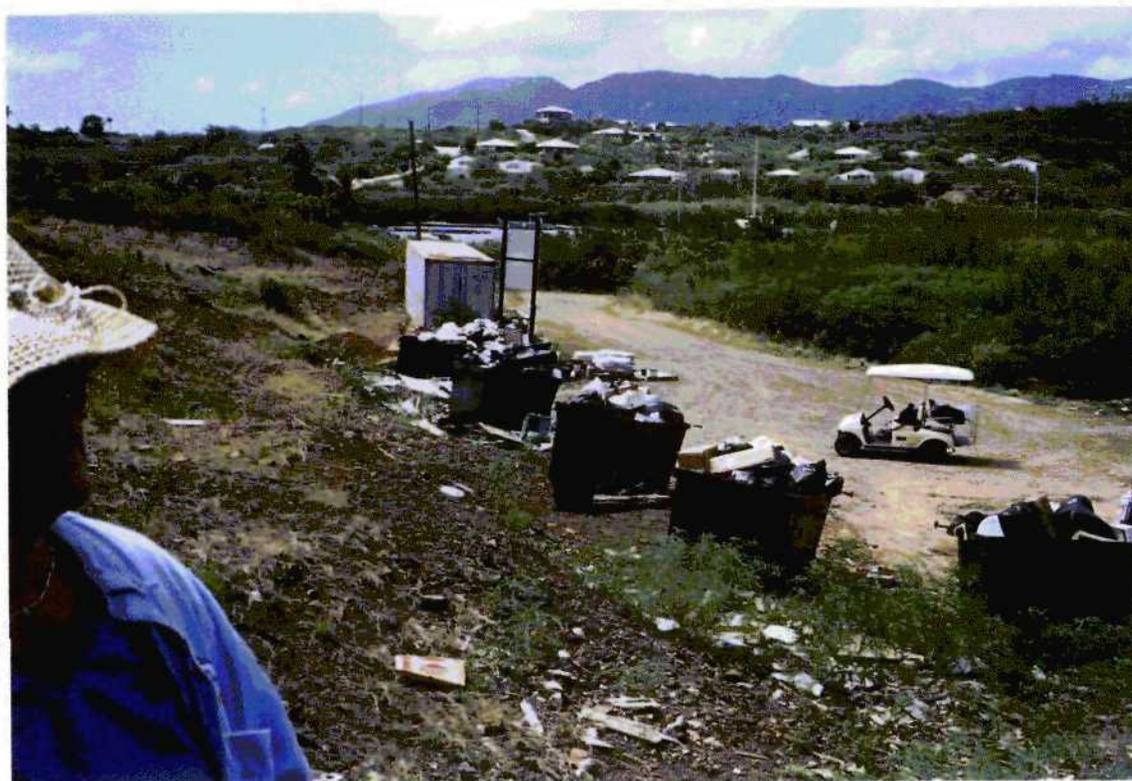
The roll-off containers used to collect household trash are in good condition. The containers holding used oil were also free from rust, bulges, or dents. No leaks were observed from the car batteries and the used oil containers.

Photo 12 – Roll-off Bins for Collection of Household Trash in Test Area 5.

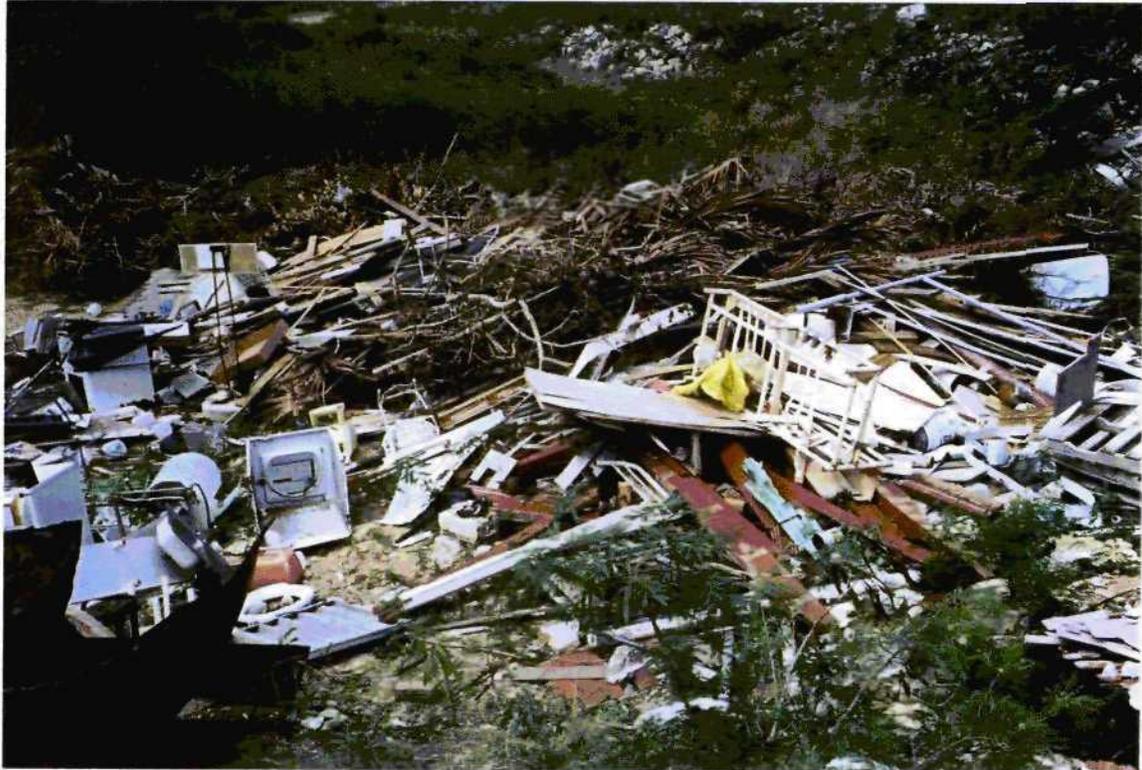
Photo 13 – View of Construction Debris in Test Area 5.

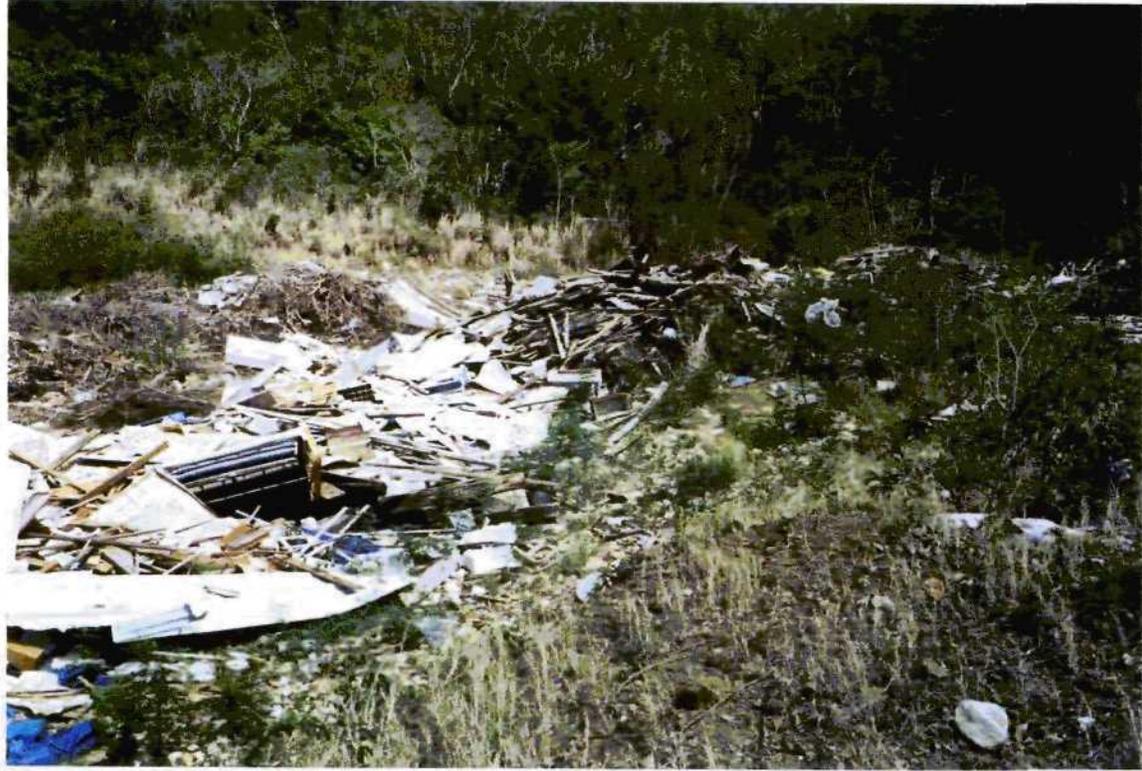
Photo 14 – View of Construction Debris in Test Area 5.

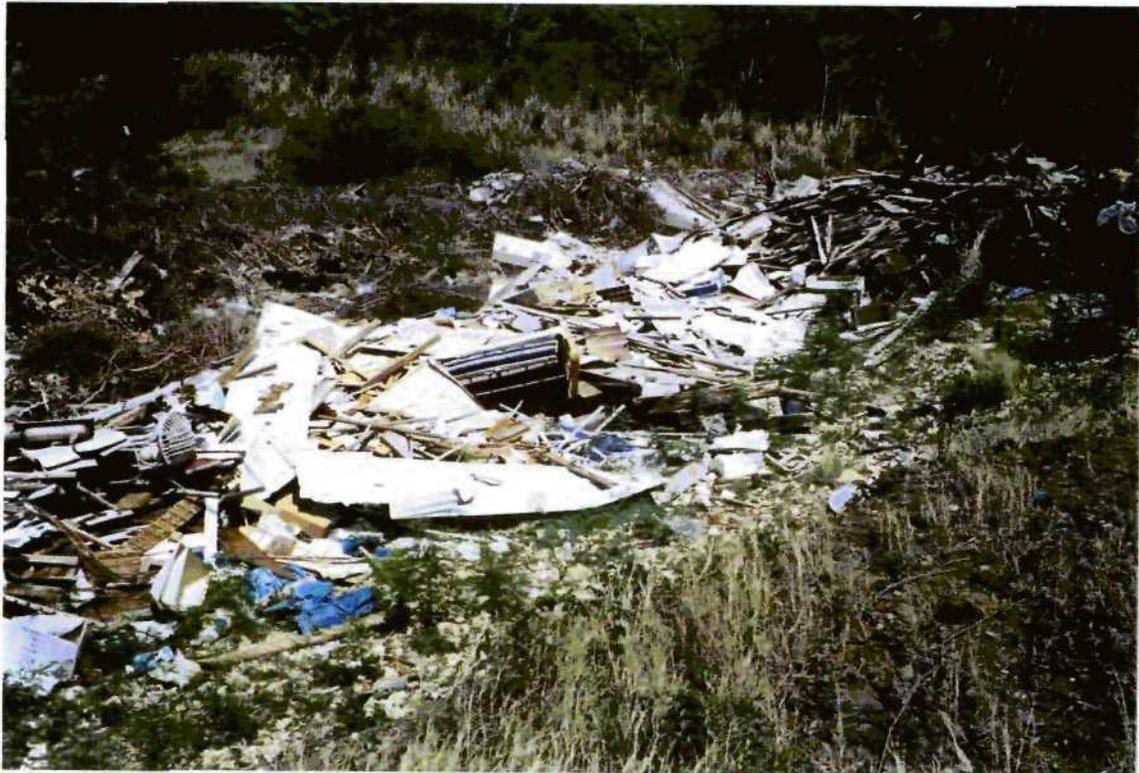
Photo 15 – View of Construction Debris in Test Area 5.

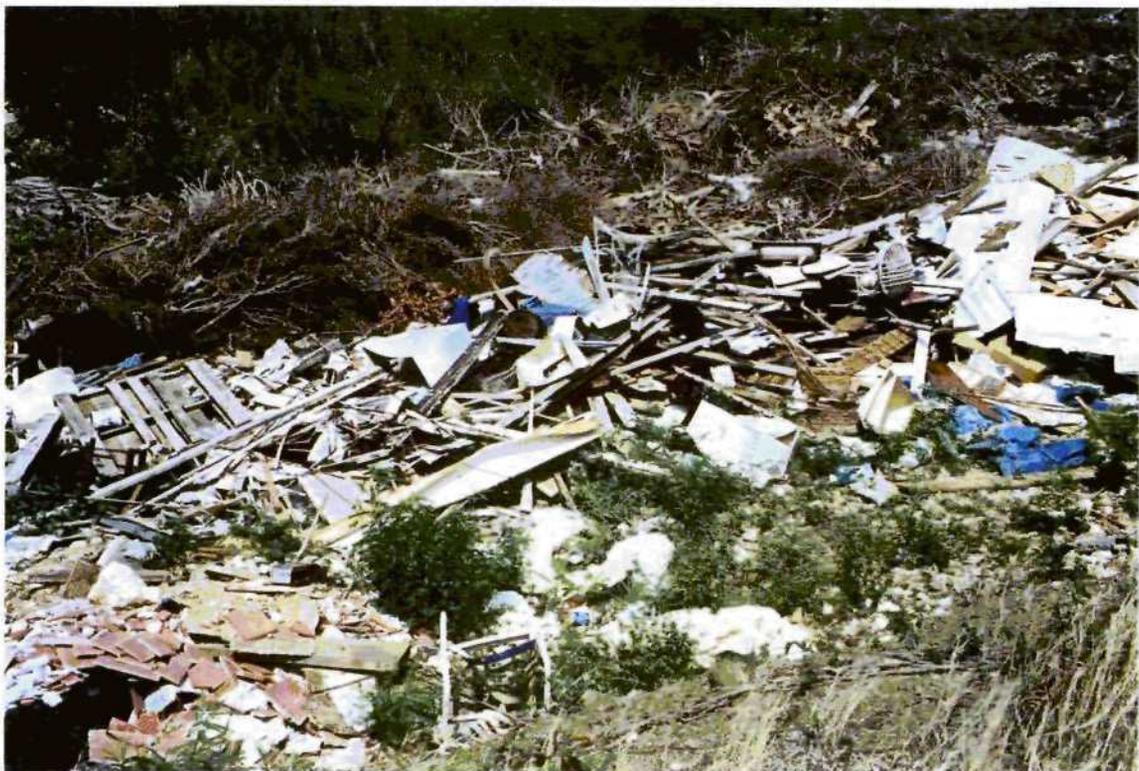
Photo 16 – View of Construction Debris in Test Area 5.
