SEAGRASS SURVEYS

Post-Construction Benthic Resources Surveys for Maintenance Dredging of the Intracoastal Waterway in the Vicinity of Bakers Haulover Inlet

Submitted by Miami-Dade County Department of Economic and Regulatory Resources –
Environmental Resources Management,
in accordance with Scope of work for FIND Agreement #ICW-DA-13-02 with Miami-Dade
County

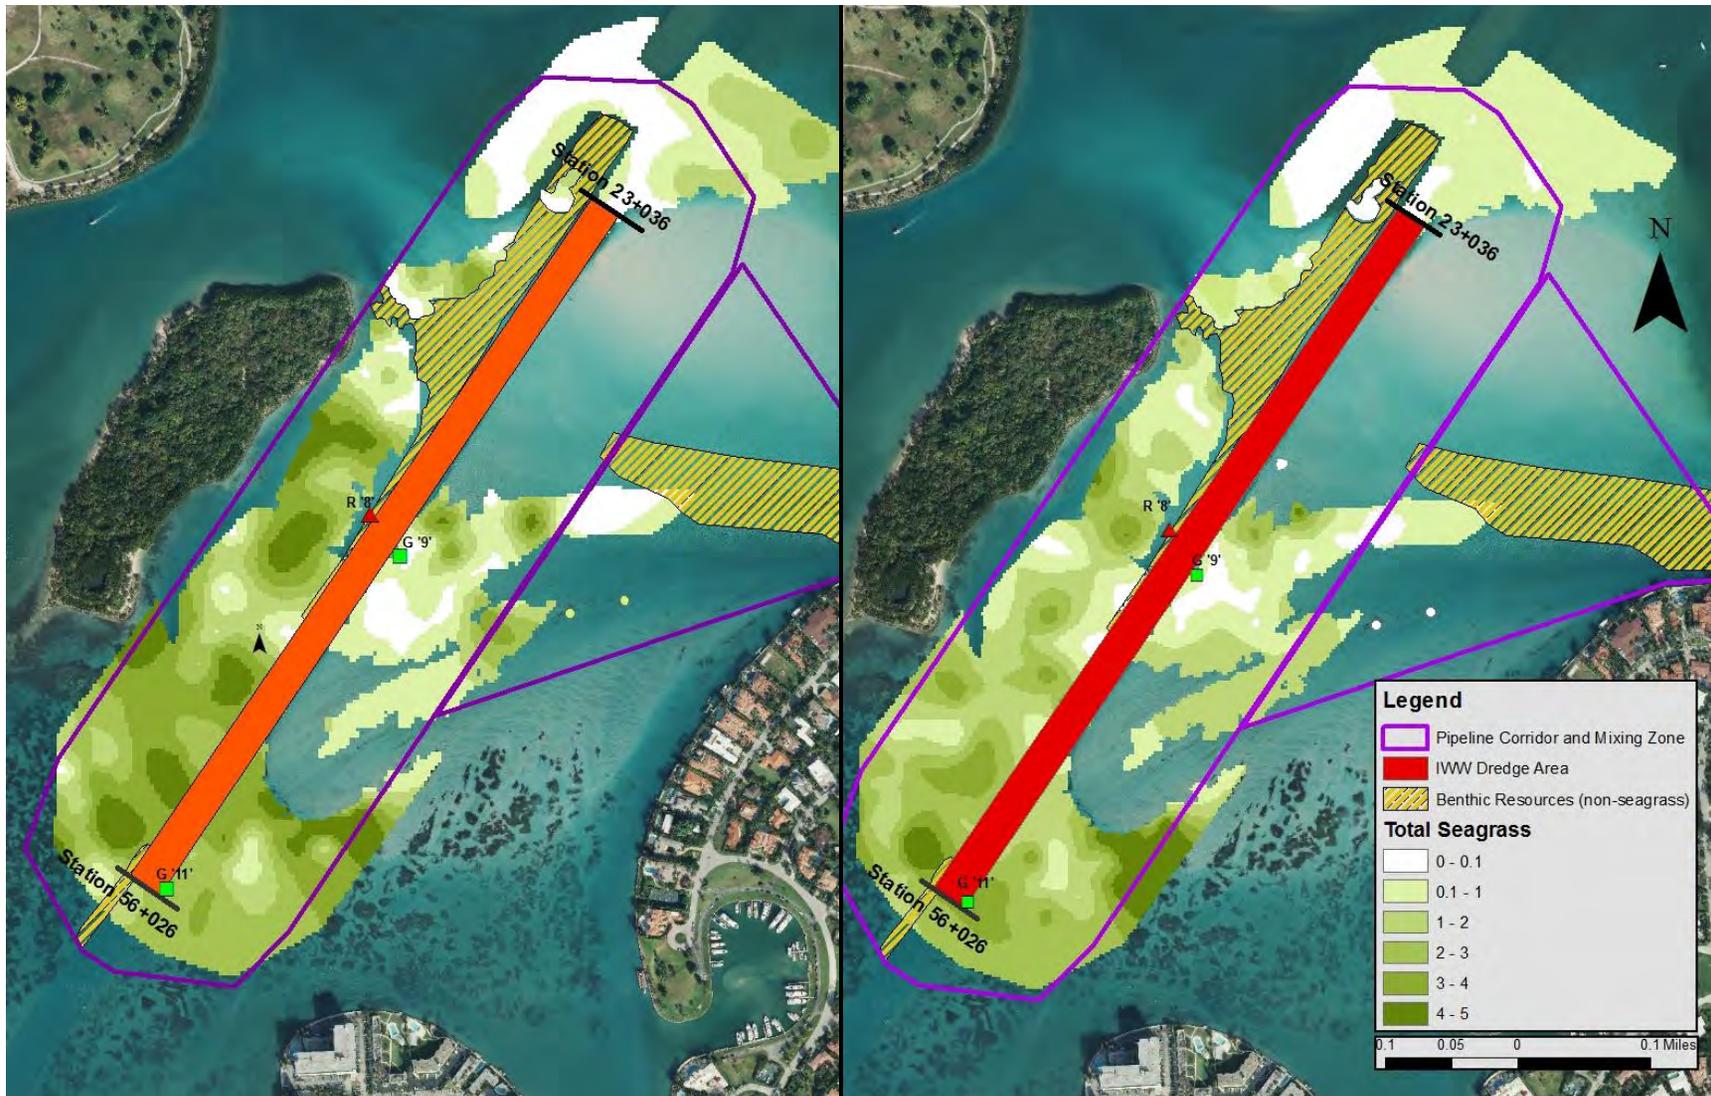
Figure 1. Bakers Haulover Intracoastal Waterway Channels maintenance dredging and benthic resource locations. Stations sampled during Post-Construction surveys.

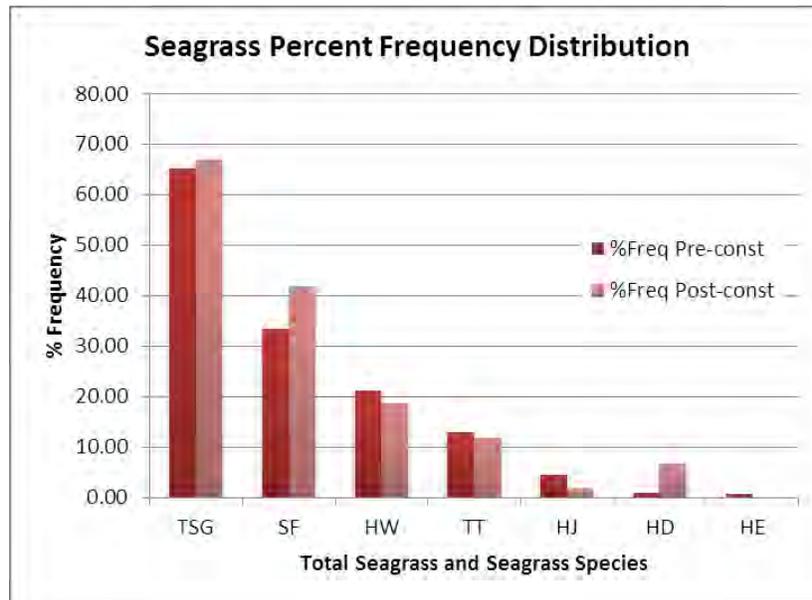
Seagrasses remain abundant and diverse, with the same five species as the pre-construction surveys distributed through the Mixing Zone. The frequency of seagrass observations was similar to the pre-construction sampling for the all seagrasses (Figure 3), with *Syringodium* being 8.4% higher. Using the Total Seagrass metric (TSG) for all seagrass species combined (McDonald, et. al 2008), cover/abundance showed a similar pattern to pre-construction with some lower BBCA values in the central-eastern area (Figure 2). TSG indicated there was a shift to lower percent cover compared to pre-construction, with 15.3% fewer observations having coverage greater than 25% (BBCA ≥ 3) (Figure 4). While, a similar percent increase was obtained for the lower BBCA class values less than 25% coverage (BBCA 2 - 0.1). Patchiness, as indicated by no seagrass (BBCA 0), was present at a similar percent of stations during the pre-construction and post construction, 28.7% versus 26%, respectively (Figure 4).

Figure 3. Seagrass frequency distribution for the combined seagrass species (TSG) and individual species.

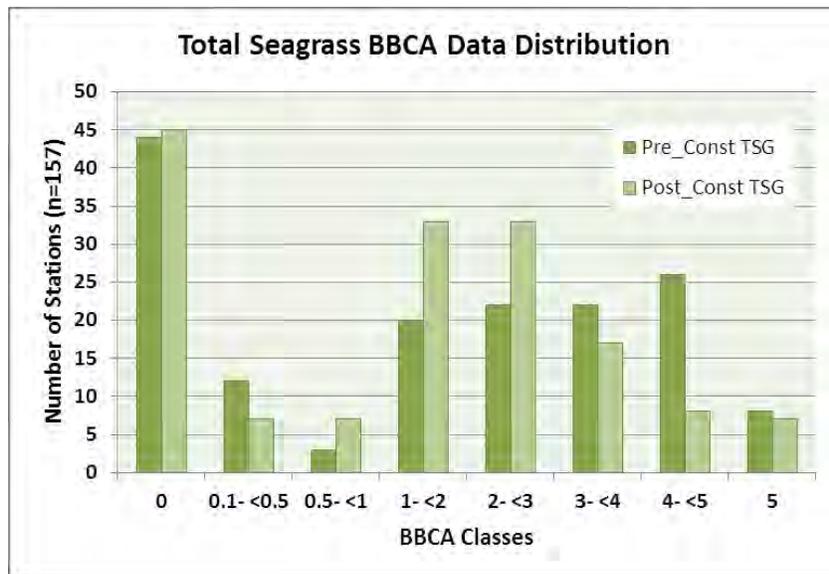
Figure 4. Total Seagrass abundance distribution for the area based on BBCA class data frequency.

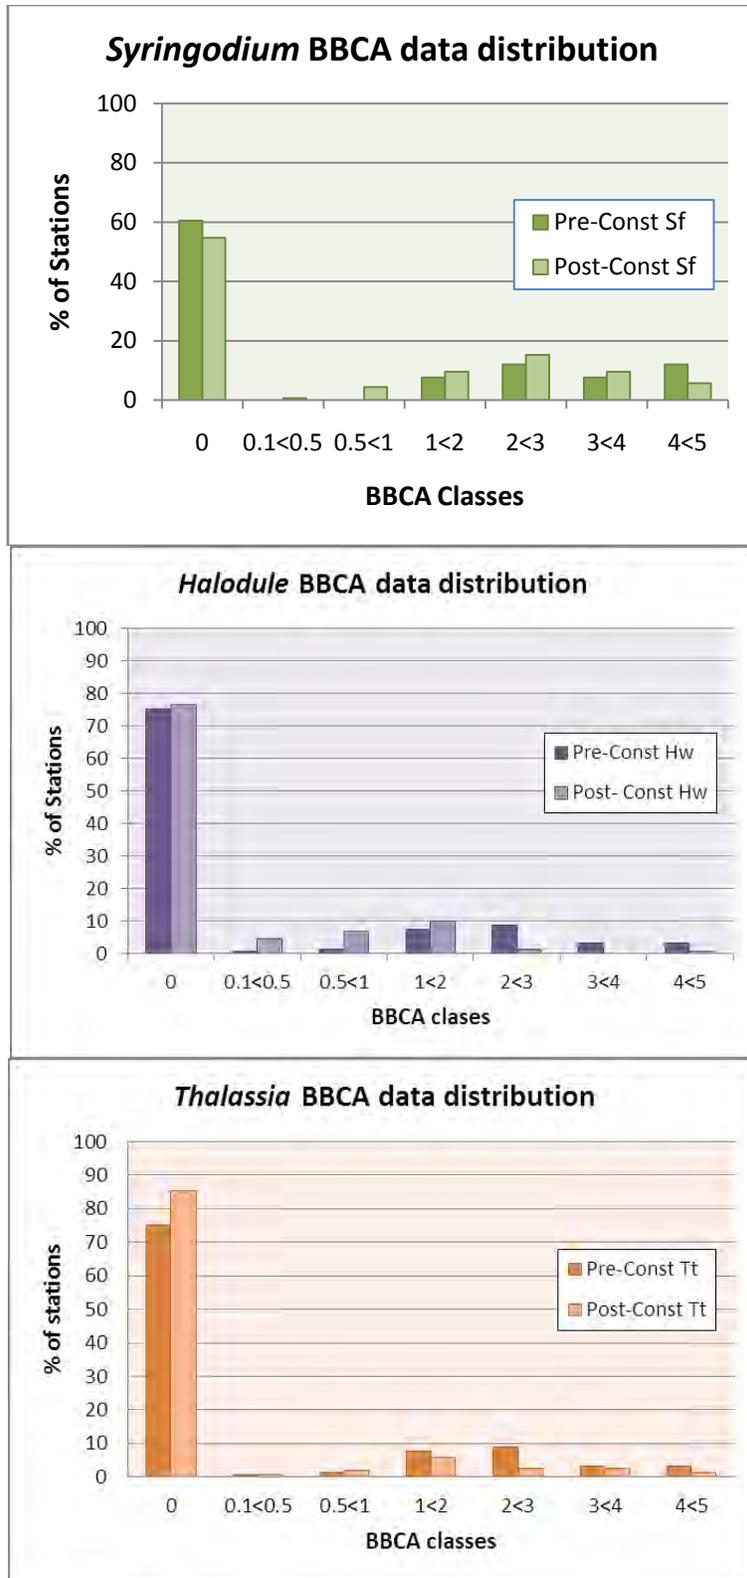
The overall frequency of the species was consistent in the pre and post construction assessments. The differences in the pre/post Total Seagrass metric, is associated with the variations noted in the three most abundant seagrasses *Syringodium*, *Halodule* and *Thalassia*. Each had fewer observations in the higher BBCA classes during the post –construction sampling (Figure 5). For *Syringodium*, there was reduction primarily in the percentage of stations with coverage >75%, while for *Halodule* and *Thalassia* there were fewer stations observed in each of the coverage classes above 5% (BBCA >2). The increase in the amount of samples showing a lower BBCA group, can be attributed to two factors:

Figure 5. BBCA class frequency percentages during pre and post construction surveys for *Syringodium*, *Halodule*, and *Thalassia*.

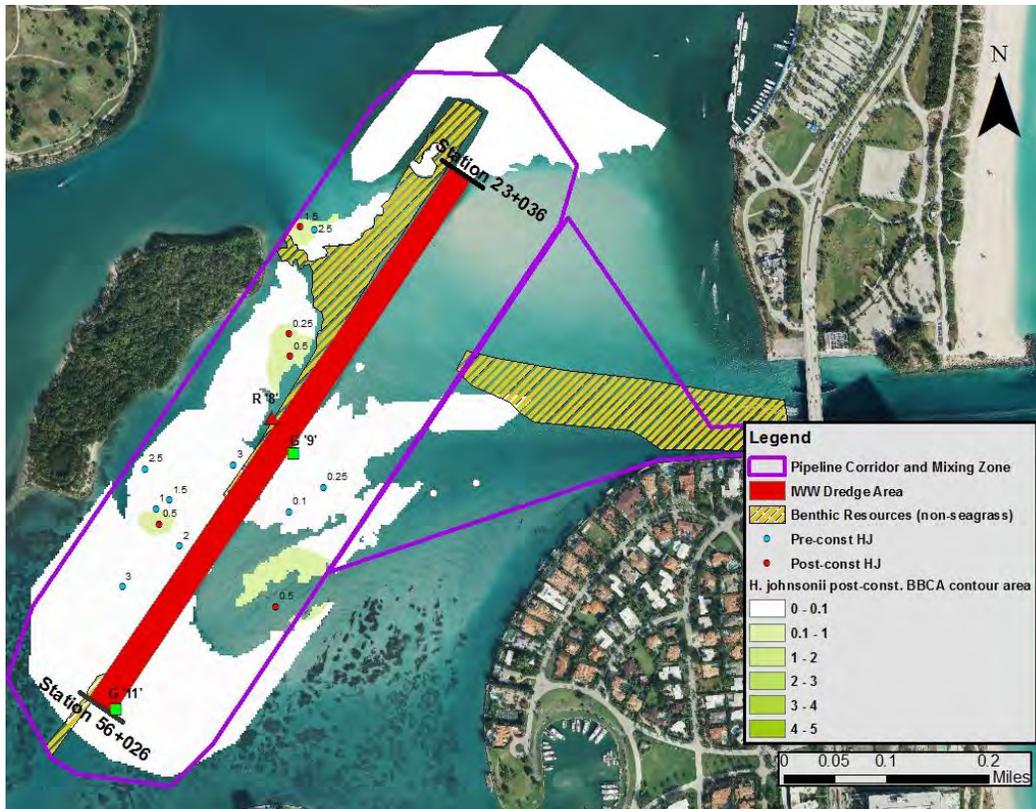
Specifically in regards to the threatened seagrass *H. johnsonii*, the west region of the Mixing Zone showed the highest concentration of *H. johnsonii* during pre and post construction sampling surveys. During post-construction, *H. johnsonii* was observed at a new set of stations and was absent from all stations where it had been recorded during pre-construction (Figure 6). This seagrass has shown itself to be variable at this location; in 2010 it seagrass was observed more on the east side of the IWW (Figure 6). Monitoring in other areas indicates that there is high spatial and temporal variation in the abundance of *H. johnsonii* (Virnstein *et. al.*, 1997) and can explain this pattern of alternated absence-presence observed in the Haulover IWW area.

Figure 6. Pre and post BCCA scores, can post construction contour plots of for *H. johnsonii* within the project area.

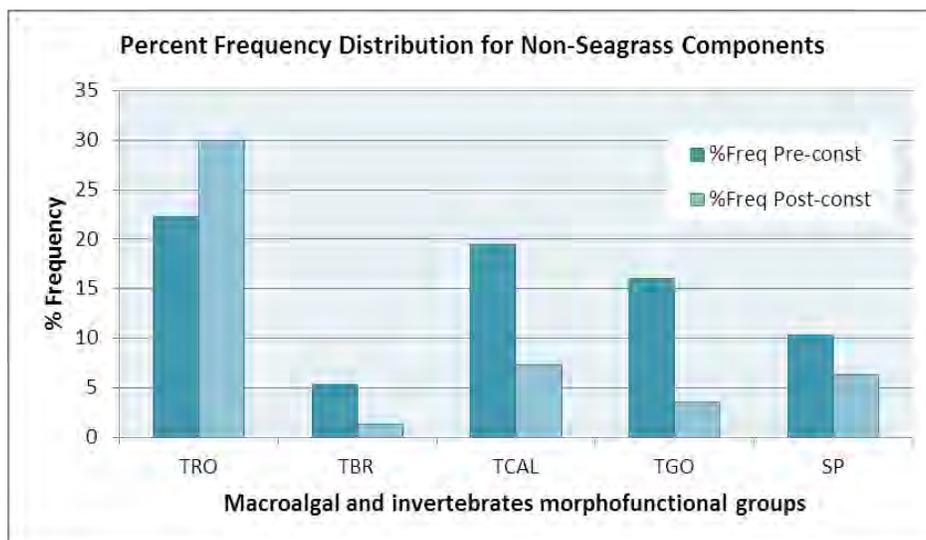
Among the individual macroalgal components and sponges of the benthic community sampled during the post-construction surveys in the seagrass areas, red algae (TRO), sponges (SP), calcareous green algae (TCAL) and green algae other (TGO) were the most frequent (Figure 7). A general decrease in the frequency of observation in all of these non-seagrass benthic groups during the post-construction was observed in the area, with the exception of the red algae group.

Figure 7. Macroalgae and sponge component frequency pre and post construction.

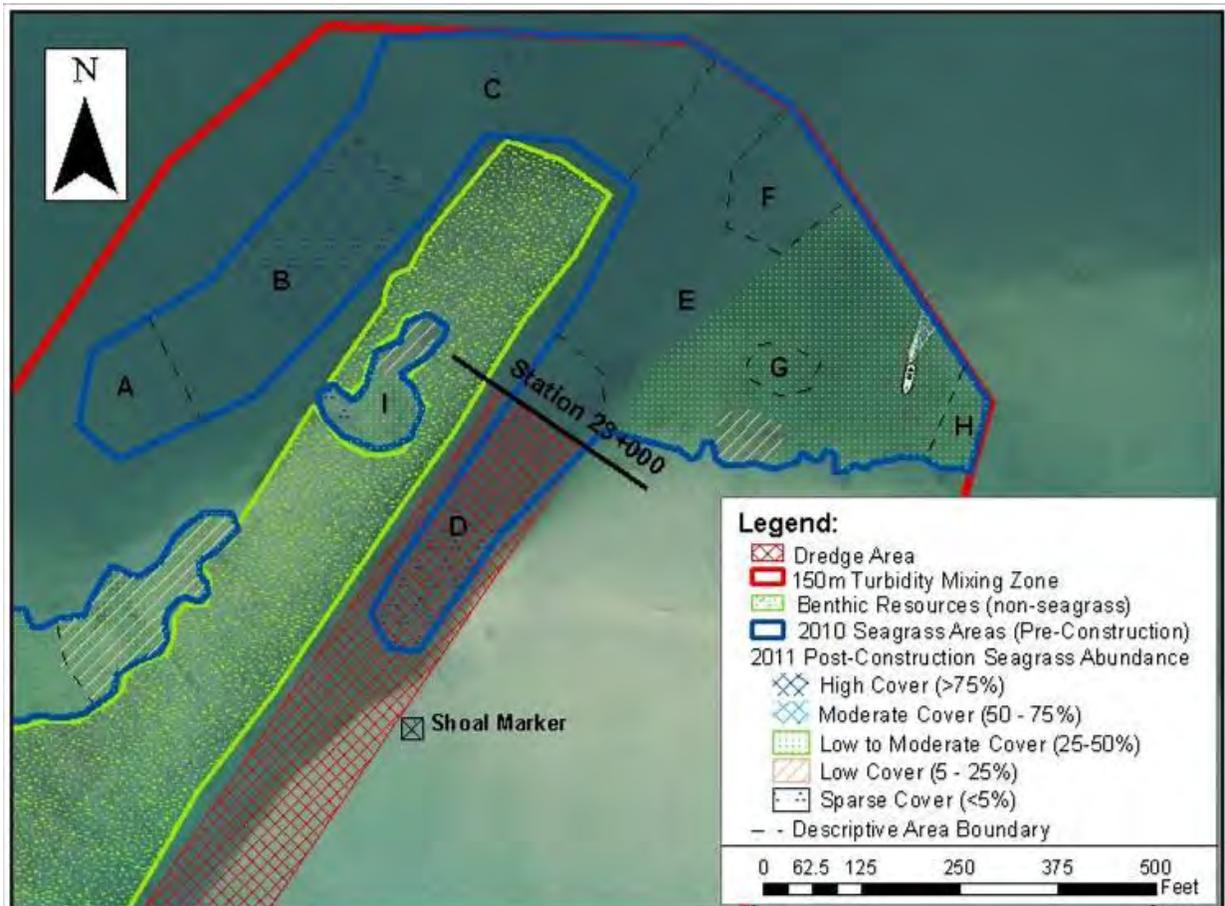
Figure 2. Seagrass areas in the north region of the mixing zone (2009 aerials) based on post construction surveys. Lettered areas are described further in text.

The large seagrass area was divided into similar areas based on species composition and abundance, A through H as shown in Figure 2. The seagrass areas west of the channel, Areas A, B, and C, were comprised of sparse (<5%) to low (5 - 25%) seagrass cover of *Halophila decipiens* prior to construction. In the post construction assessment, these areas were void of seagrass or only contained sparse *H. decipiens*.

Moderate (50 - 75%) seagrass cover consisting again of *H. decipiens* only was observed in Area D in the channel prior to construction. However, after construction, Area D only contained a small area of sparse *H. decipiens*.

Area F was a high (>75%) seagrass cover areas dominated by *H. decipiens* with sparse *H. wrightii* before construction. No seagrass was observed in this area during the post construction assessment.

In the pre-construction surveys, Area G was a low seagrass cover area comprised of a mix of *Syringodium filiforme*, *H. wrightii*, and *H. decipiens*. The post construction assessment documented a slightly higher abundance, low to moderate cover, but only of *S. filiforme* and *H. wrightii*—*H. decipiens* was not observed.

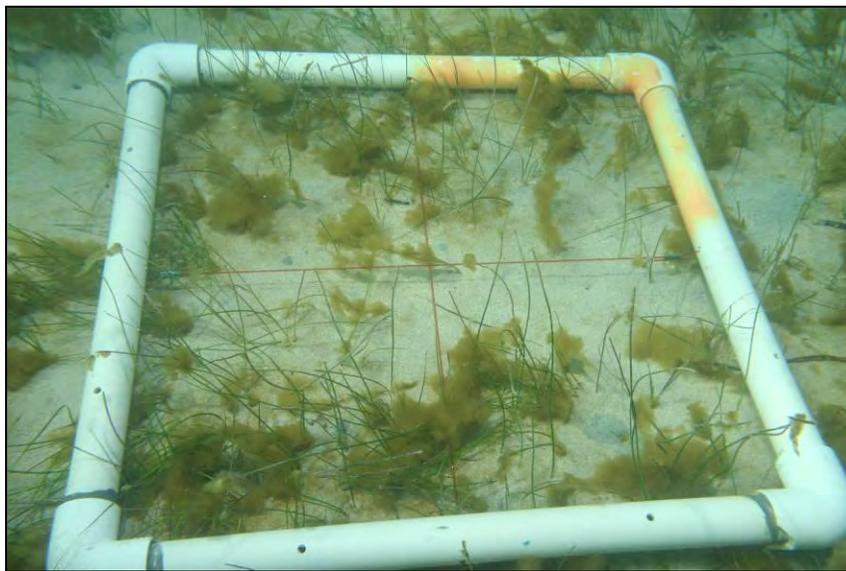
In the extreme eastern portion, Area H, *H. wrightii*, *S. filiforme*, and *Thalassia testudinum* were all observed in mixed species seagrass beds with a combined moderate percent cover. The abundance of *T. testudinum* was lower in the post construction assessment resulting in a low to moderate overall seagrass cover for this area (Figure 3).

Figure 3. Post construction survey quadrat with *Syringodium filiforme* and *Halodule wrightii* in the North Region—Area H.

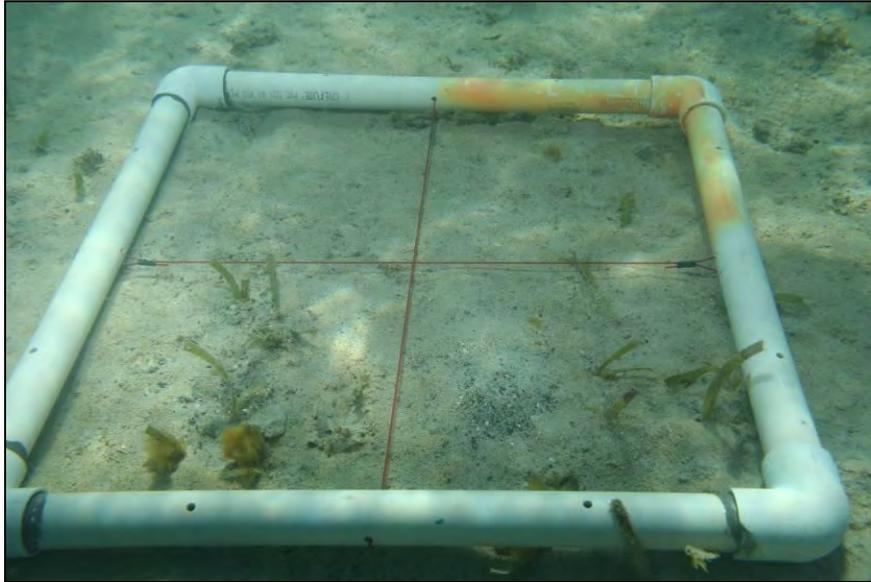
Just west of the channel, a smaller seagrass area (Area I) was observed surrounded by an area with non-seagrass benthic resources. In both the pre and post construction surveys, sparse *T.*

testudinum with low percent cover was observed in the western portion of this seagrass area (Figure 4) while low to moderate percent cover of *H. wrightii* was observed in the east.

Figure 4. Post construction survey quadrat with sparse *Thalassia testudinum* cover (North Region—Area I_.

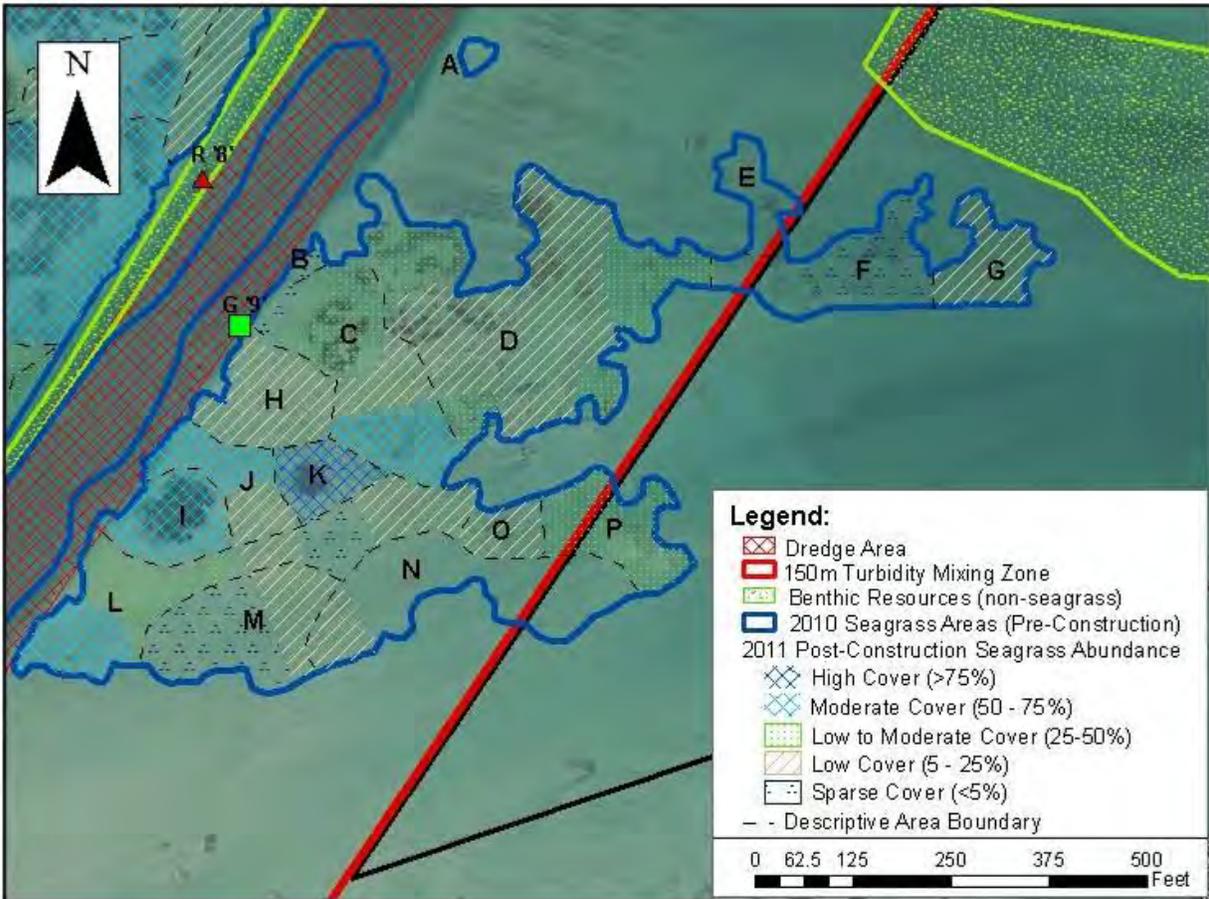
Two different seagrass areas were found within the eastern region of the mixing zone during the pre-construction surveys (Figure 5). Drift red algal species and macro-algae species (*Halimeda* spp., *Penicillus* spp., *Udotea* spp., and *Caulerpa* spp.) were common throughout the seagrass areas. To the north of the seagrass areas, a sand and rubble area was noted with drift red algae, blue-green algal turf, and hydroids before and after construction.

Figure 5. Seagrass areas in the eastern region of the mixing zone (2009 Aerials) based on post construction surveys. Lettered areas are described further in text.

The large seagrass area was comprised of several seagrass and algal species with a wide range of abundance (Areas B through P; Figure 5). In the late summer/early fall pre-construction surveys, the threatened species, *H. johnsonii*, was observed throughout the area along the ICW channel east toward the edge of the survey area (except Areas G, I, K, O, and P). The observed range of *H. johnsonii* in the east region is shown in Figure 1. During the winter post construction surveys, *H. johnsonii* was not observed.

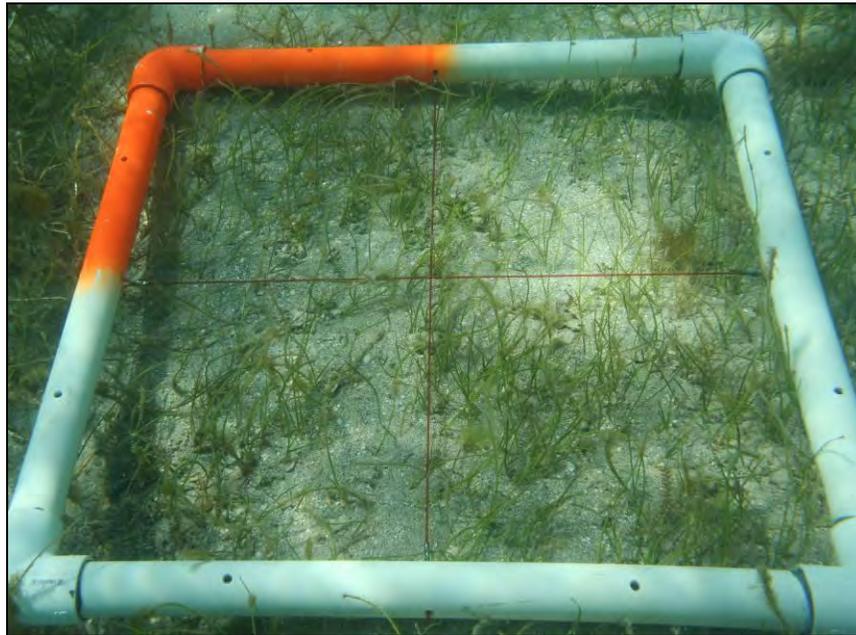
Area D was a low to moderate percent cover seagrass area in the pre-construction surveys with *T. testudinum* dominating the cover followed by *S. filiforme*, *H. wrightii*, and *H. johnsonii* in the northwest portion, *H. wrightii* dominating followed by *S. filiforme* and *H. johnsonii* in the center, and *S. filiforme* dominating followed by *H. wrightii* in the east (Figure 6). The northwest and eastern portion of Area D maintained low to moderate seagrass cover in the post construction assessment while the cover decreased in the central region due to the absence of *H. johnsonii* and lower cover of *S. filiforme*.

Figure 6. Post construction survey quadrat with *Syringodium filiforme* (East Region—east portion of Area D).

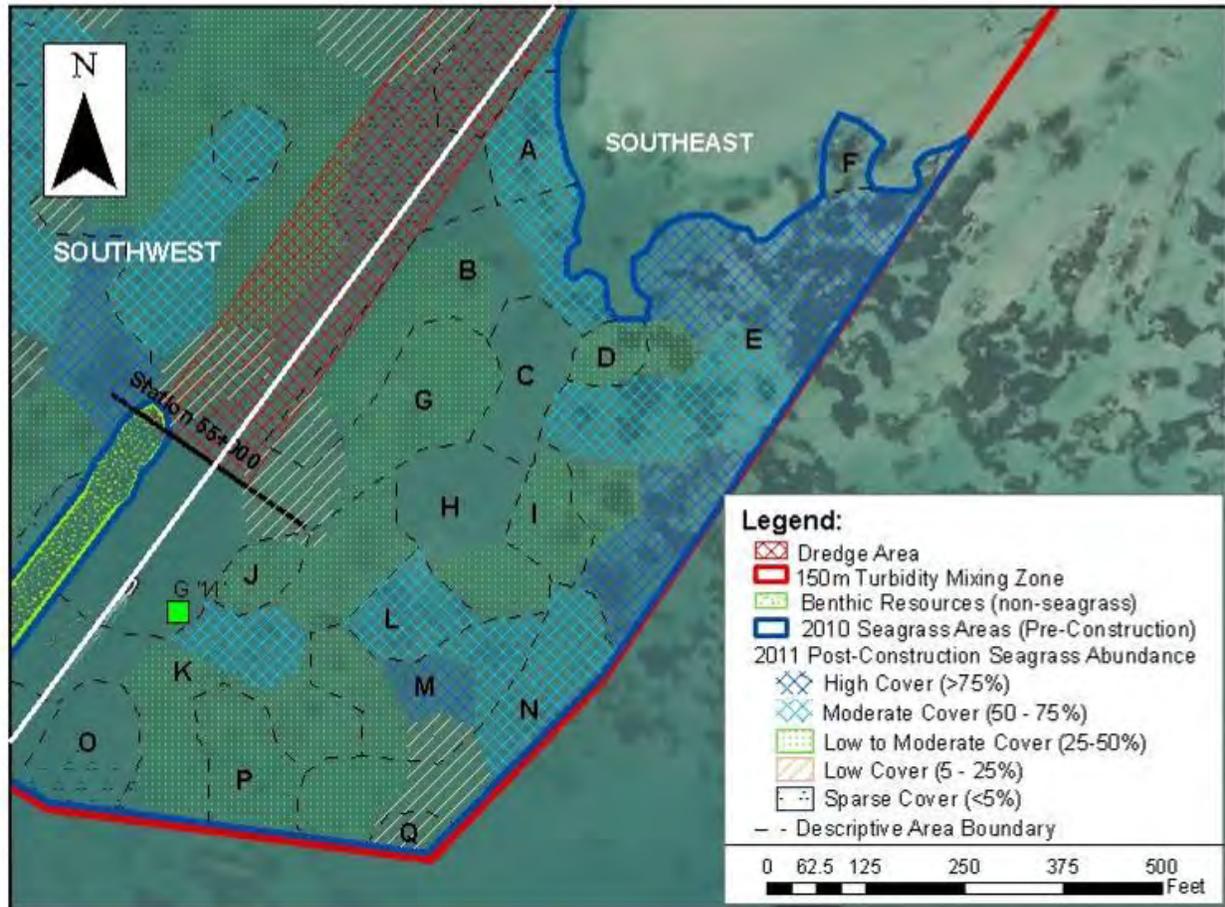
The southeast region is comprised of one large seagrass area that continues to the west into the southwest and western regions (Figure 7). Several seagrass species were observed with a wide range of abundance in both the pre and post construction surveys. Drift red algae and macro green algae were also found through the seagrass areas in the southeast region. North of the seagrass area barren sand now covers what appears to be seagrass in the 2009 Aerials.

Figure 7. Seagrass areas in the southeastern region of the mixing zone (2009 Aerials) based on post construction surveys. Lettered areas are described further in text. Note that the southwestern region includes the areas in the channel and to the west (see Figure 7).

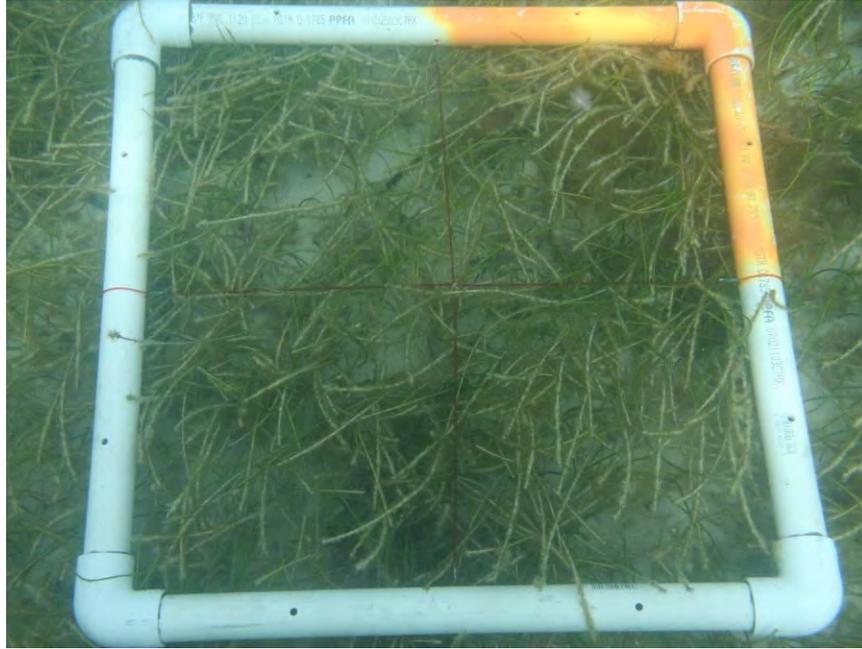
In the pre-construction surveys, Areas A, E, and L had high (>75%) percent seagrass cover dominated by dense *S. filiforme* beds (visible on aerials, Figure 6). The threatened species *H. johnsonii* was also observed in the pre-construction surveys in the north portion of Area E adjacent to the dense *S. filiforme* beds. In the eastern portion of Area E, the *S. filiforme* beds also had a low cover of *T. testudinum* around the edges in the pre-construction surveys. A lower abundance of *S. filiforme* was observed in Area A, the central portion of Area E, and Area L during the post construction surveys. However, the majority of Area E maintained high seagrass cover (Figure 8). *Halophila johnsonii* was not observed in the north portions of Area E during the winter post construction surveys. During the post construction surveys, the northeastern portion of Area E was found void of seagrass due to the shoal migrating farther south.

Figure 8. Post construction survey quadrat with high *Syringodium filiforme* cover Southeast Region—Area E.

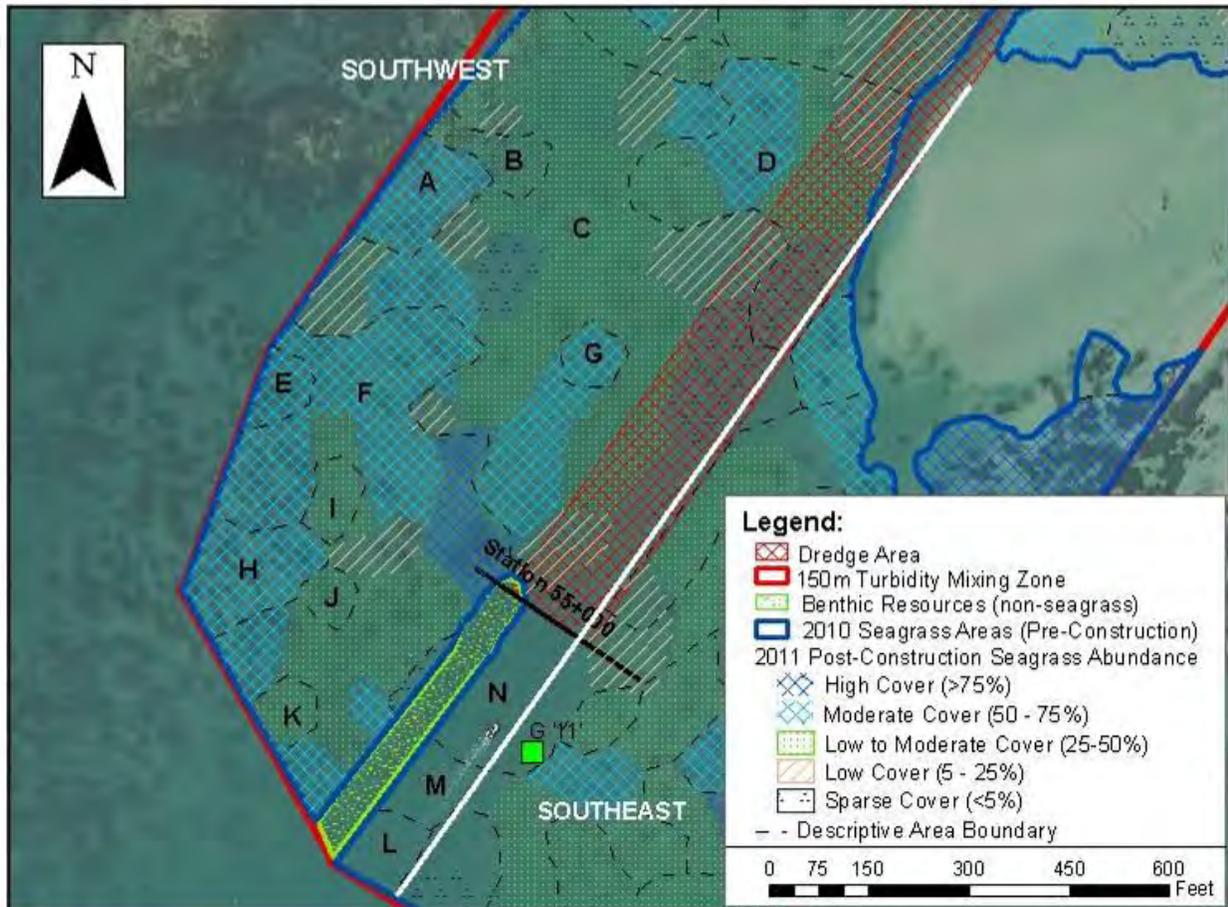
During the pre and post construction surveys, one large seagrass area was found within the southwest region of the 150m mixing zone (Areas A through N; Figure 9). This seagrass area extended through the ICW channel and into the previously described southeastern region as well as north into the western region. Throughout the seagrass area, drift red algae and macro green algae including *Halimeda* spp., *Udotea* spp., and *Caulerpa* spp. were observed.

Figure 9. Seagrass areas in the southwestern region of the mixing zone (2009 Aerials) based on post construction surveys. Lettered areas are described further in text. Note that the southeastern region includes the areas east of the channel (see Figure 6).

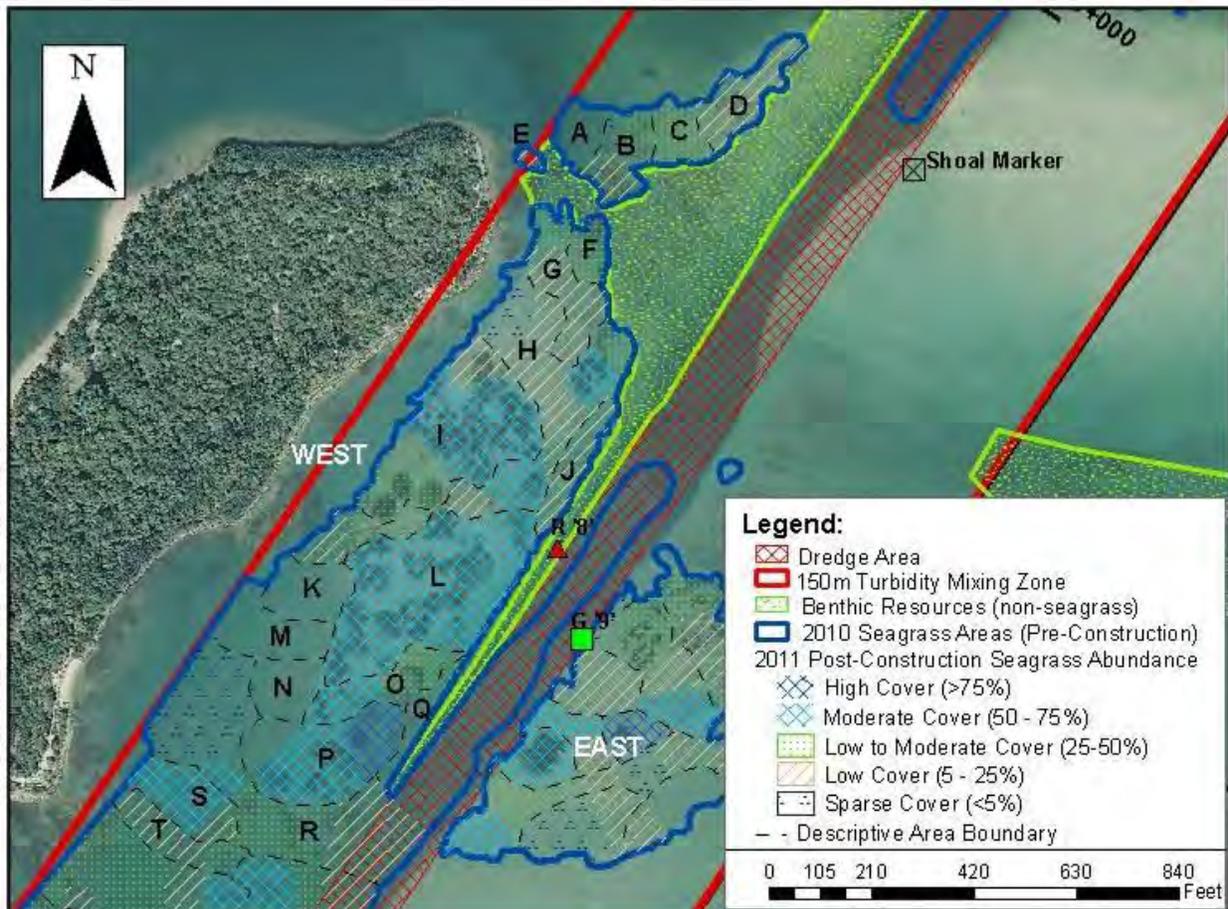
Two large and one small seagrass areas were found within the west region of the 150m mixing zone (Figure 10). The largest area extends north from the southwestern region and two more areas are to the north. In both the pre and post construction surveys, drift red algae and macro green algae including *Halimeda* spp., *Udotea* spp., *Penicillus* sp., and *Caulerpa* spp. were observed throughout the seagrass areas. Outside of the largest seagrass area to the west is sand with sparse green algal coverage. To the north and east is an area with non-seagrass benthic resources including sponges, soft coral, algae, and sparse hard coral colonies. The benthic resources were also found on the west wall of the channel, but not on the floor of the channel considered part of the dredging footprint.

Figure 10. Seagrass areas in the west region of the mixing zone (2009 Aerials) based on post construction surveys.

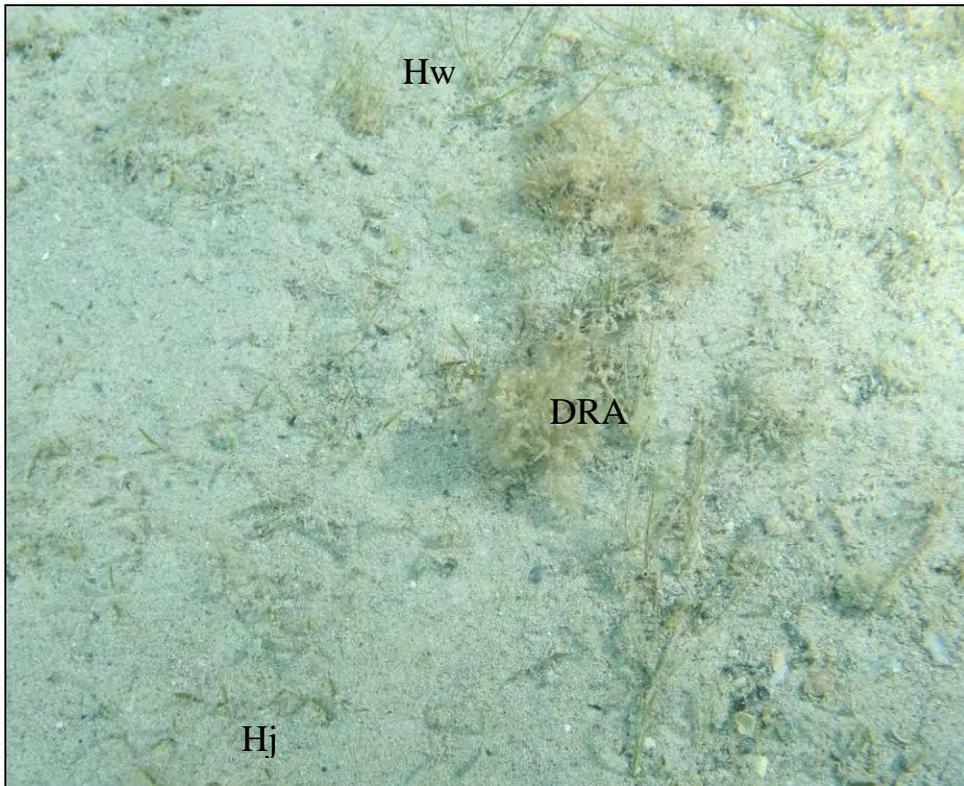
Figure 3. *Halodule wrightii* (Hw), *Halophila johnsonii* (Hj), and drift red algae (DRA) in seagrass area north of shoal.

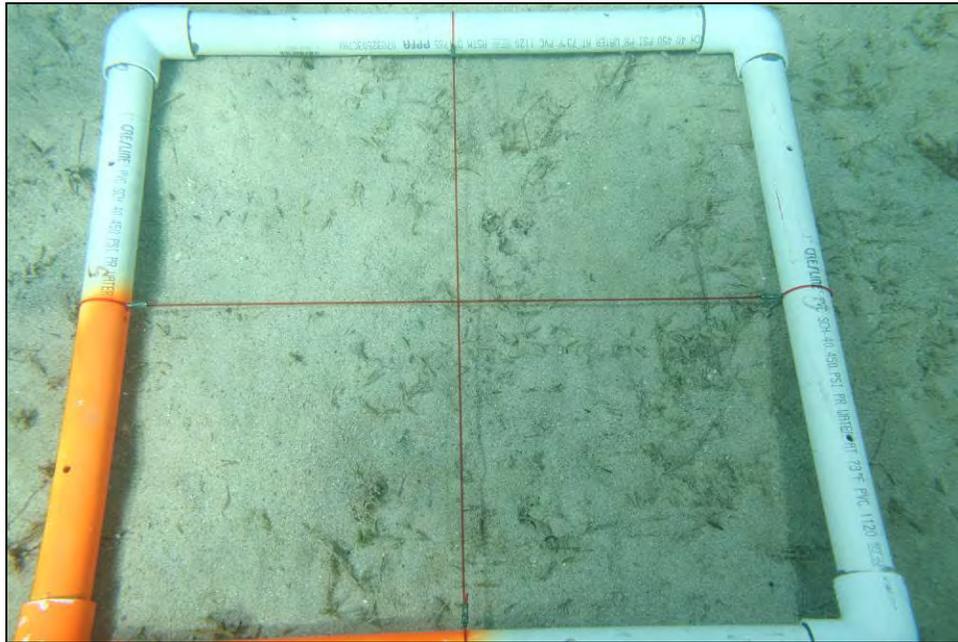
The largest seagrass area, **E-1**, was comprised of several seagrass and algal species with a wide range of abundance. The areas with high (>75%) and moderate (50-75%) percent seagrass cover were dominated by dense *Syringodium filiforme* beds. The north moderate cover area in the center of E-1 also had *Thalassia testudinum* around the edges of the *S. filiforme* beds. *Halodule wrightii* and *H. decipiens* were also observed in the moderate percent cover area in the northeast. The low to moderate seagrass cover areas (25-50% cover) were comprised of *H. wrightii* in the south, *S. filiforme*, *T. testudinum* and *H. wrightii* in the northwest, *S. filiforme* and *H. wrightii* in the center, and *S. filiforme* in the Northeast. The sparse (<5%) and low (5-25%) cover areas throughout E-1 were comprised of *H. wrightii* and *H. johnsonii*. The threatened seagrass *H. johnsonii* was observed throughout the western area of E-1 along the ICW channel and in a

smaller area on the west and north edge. The observed range of *H. johnsonii* in the east region is shown in Figure 1.

Figure 5. *Halophila johnsonii* in the western portion of E1.

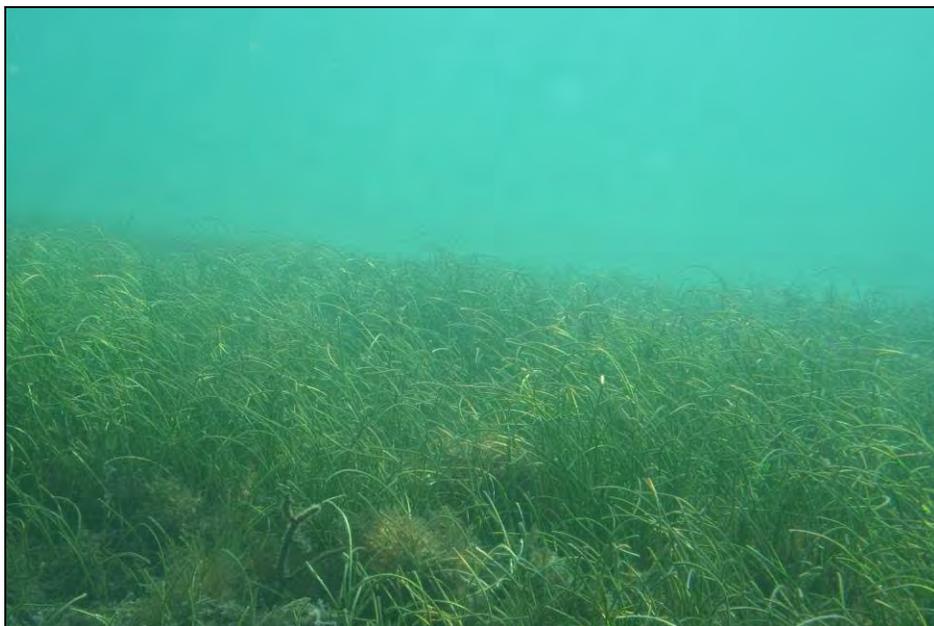
Seagrass Area E2 and E3 were comprised of two seagrass species—*Halodule wrightii* and *Syringodium filiforme* (Fig. 4). Both areas were dominated by *S. filiforme* with a lower percent cover of *H. wrightii*.

Figure 6. *Syringodium filiforme* bed in E-2.

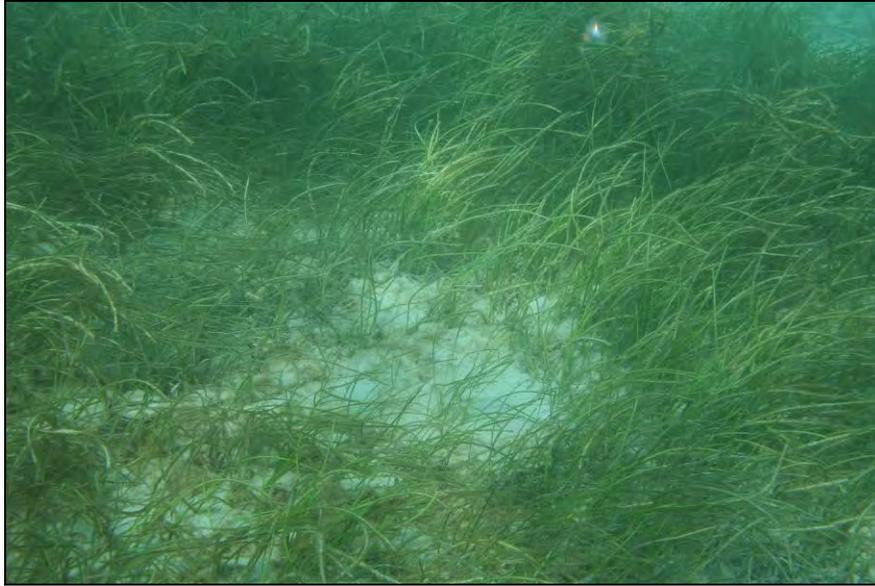
The high percent cover areas (>75%) within the west region were all dense *Syringodium filiforme* beds. *Syringodium filiforme* was also the dominant seagrass species in the moderate coverage (50-75%) areas through out this region except the northern most area (Figure 12). In this area, both *S. filiforme* and *Halodule wrightii* were abundant. The low to moderate (25-50%) cover areas were comprised of *S. filiforme* in the south and *S. filiforme*, *H. wrightii*, and *Halophila decipiens* in the central and north. *Halophila johnsonii* was also present in the northern most low to moderate coverage areas.

Figure 12. Moderate (50-75% cover) seagrass area with *Syringodium filiforme* and *Halodule wrightii* in the northern part of the west region.

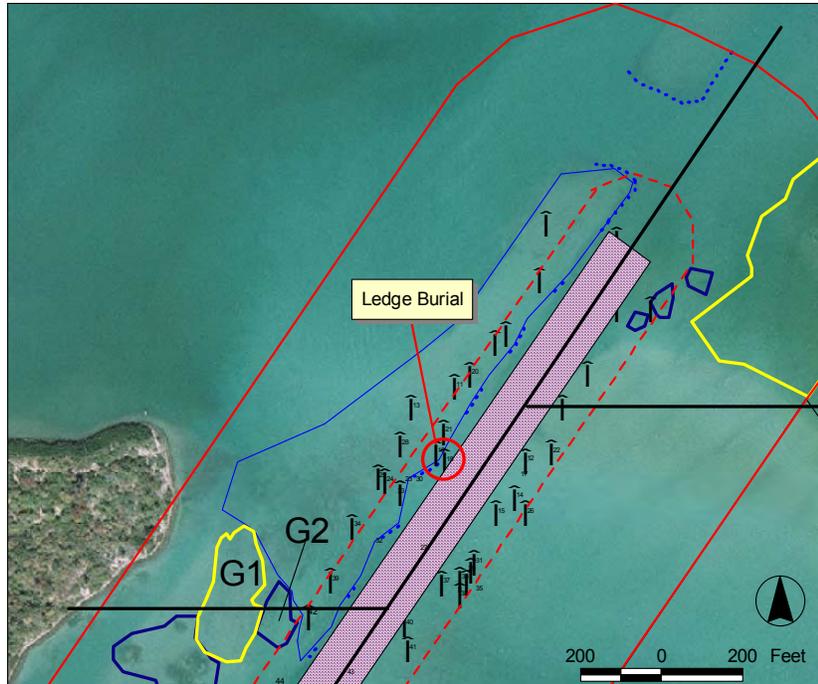
Figure 6: Region G of the Mixing Zone, showing location of sand burial impact.

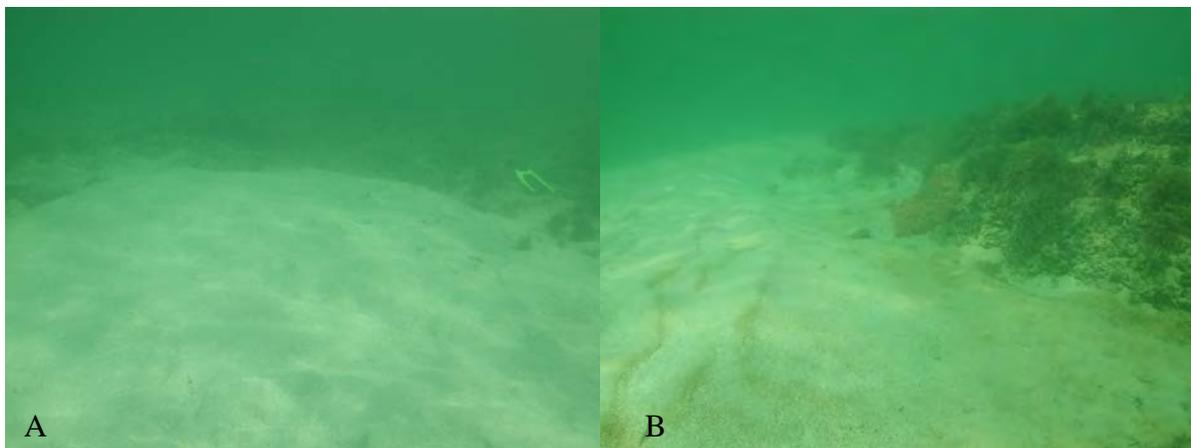
Figure 7: A) Aerial view of sand burial; B) Side view of sand burial from north side.

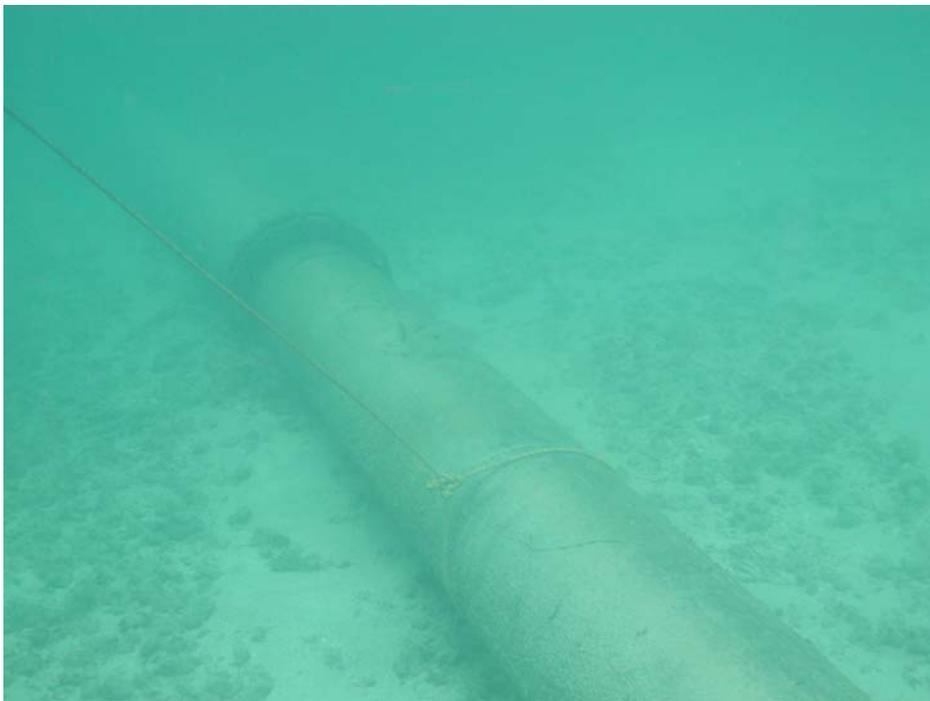
Figure 10: Pipeline placed on sand and algae.

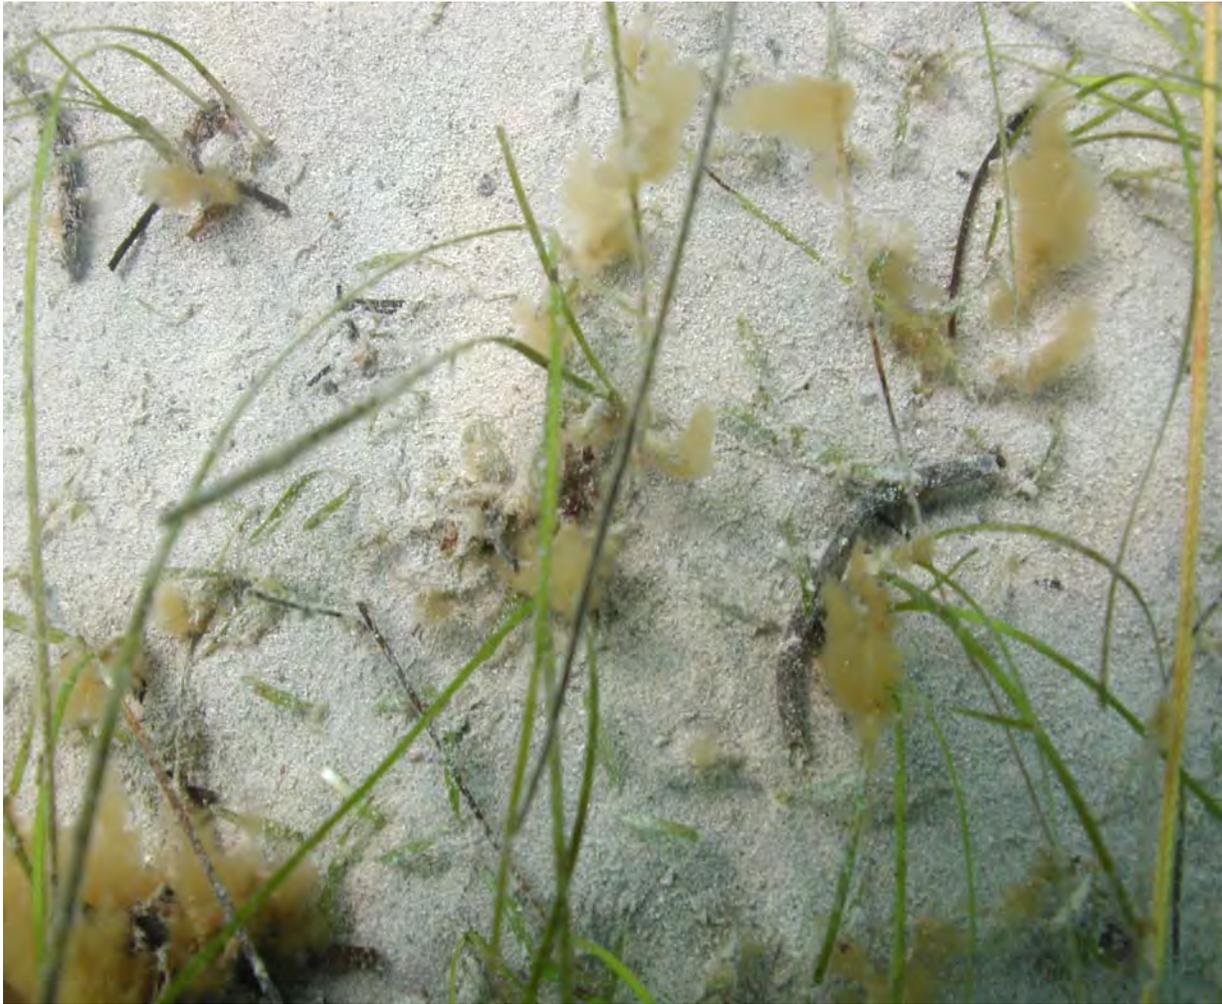
Figure 3: Close up of *Halodule wrightii* and *Halophila johnsonii* in Seagrass Area A4.
