SEAGRASS SURVEYS

Post-Construction Benthic Resources Surveys for Maintenance Dredging of the Intracoastal Waterway in the Vicinity of Bakers Haulover Inlet

Submitted by Miami-Dade County Department of Economic and Regulatory Resources –
Environmental Resources Management,
in accordance with Scope of work for FIND Agreement #ICW-DA-13-02 with Miami-Dade
County

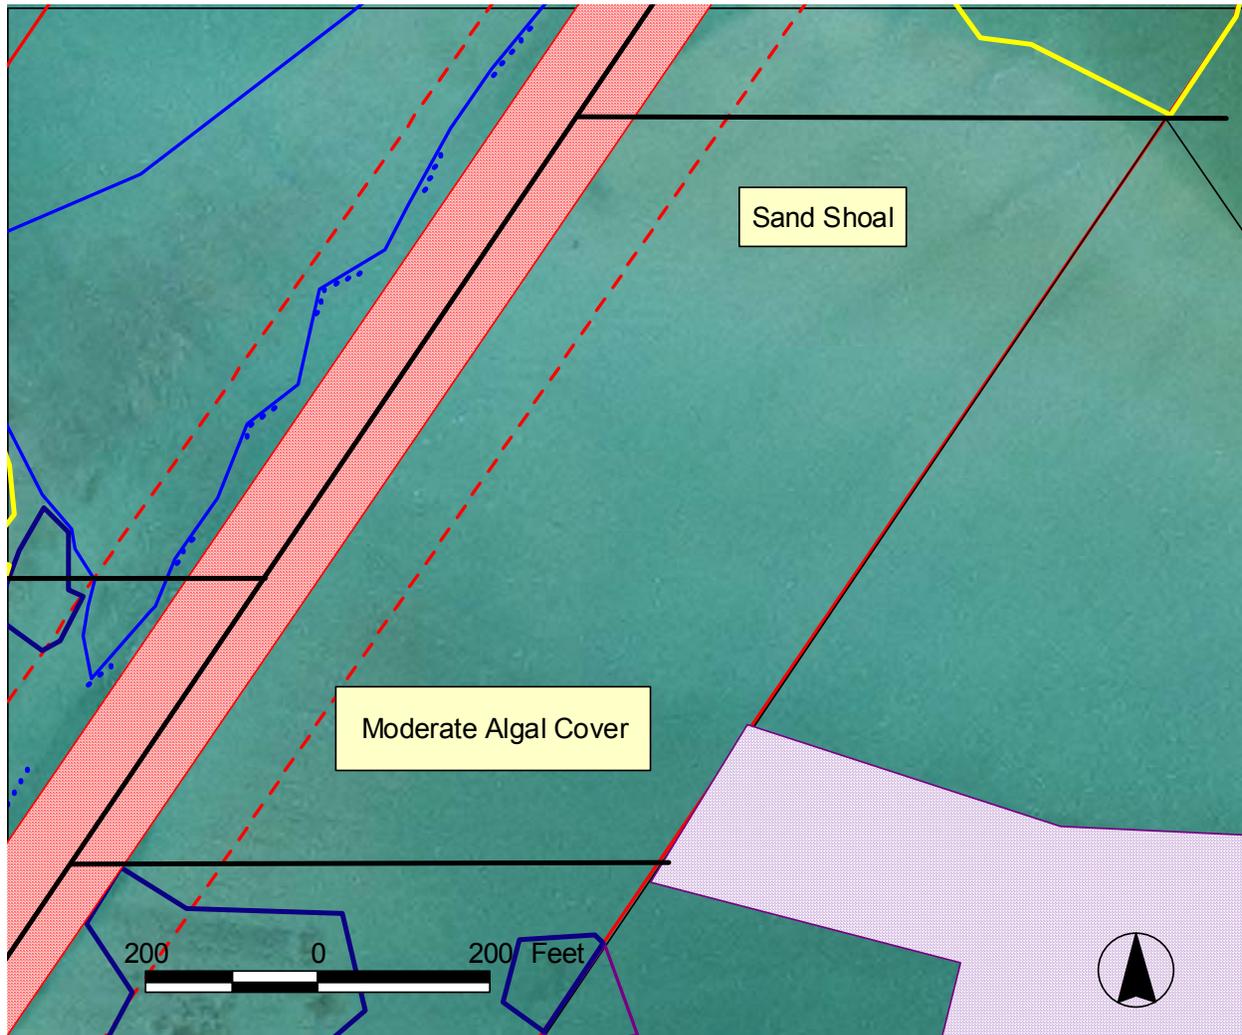
Seagrass was not observed in Region B of the mixing zone (Fig. 4). The northern portion of this area is a sand shoal void of any vegetation. In the southern end, moderate coverage of turf, blue green, and red algae was noted. Cushion sea stars, *Oreaster reticulatus*, were also observed in this area.

Figure 4: Region B of the Mixing Zone

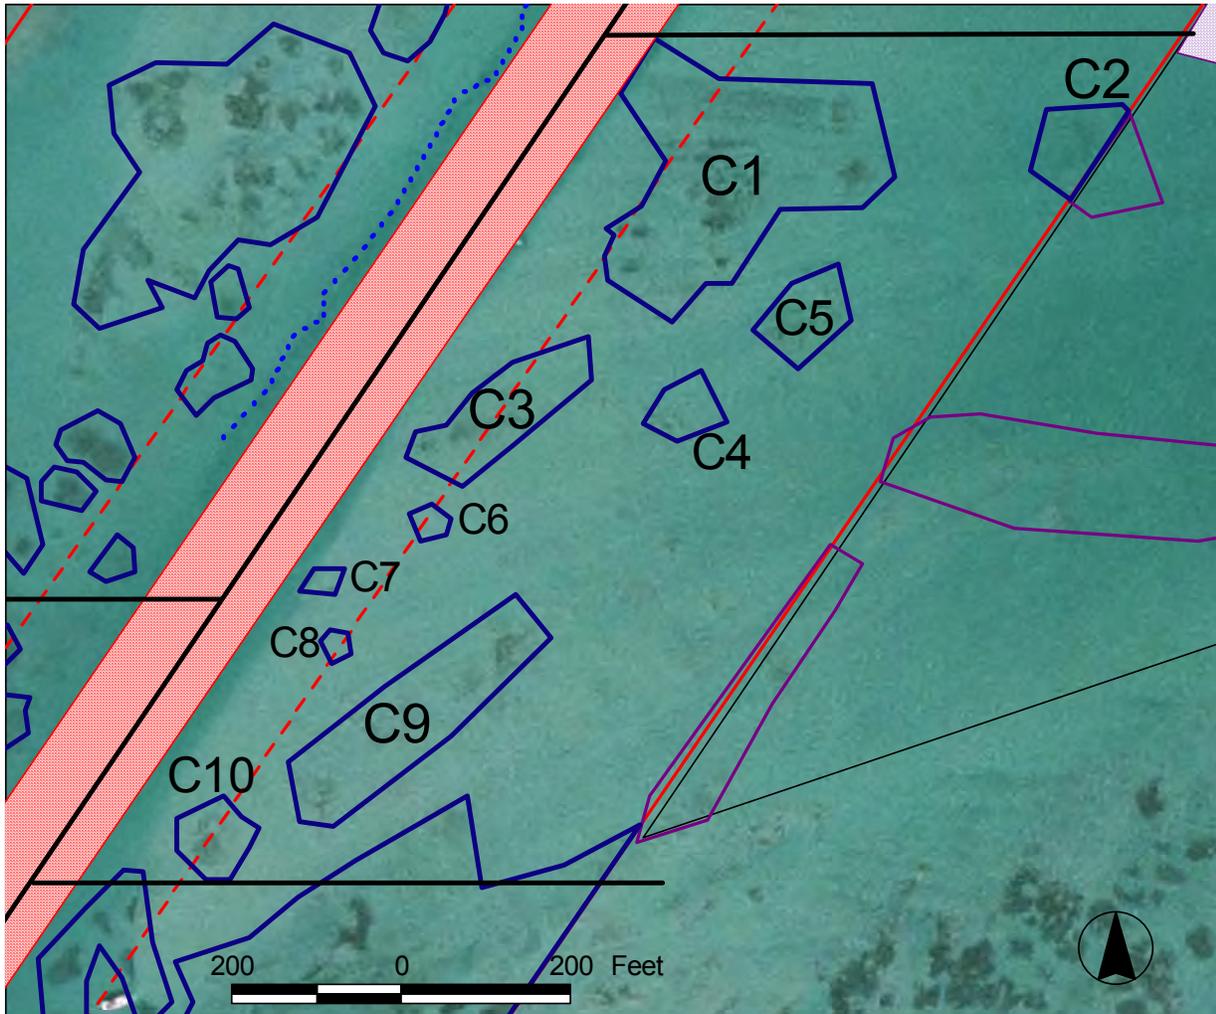
Ten different seagrass areas were found within Region C (Fig. 5). All or portions of Area C1, C3, C6, C7, C8, and C10 are within 100' of the channel and are subject to an increase chance of damage due to anchoring.

Figure 5: Seagrass Areas in Region C of the Mixing Zone

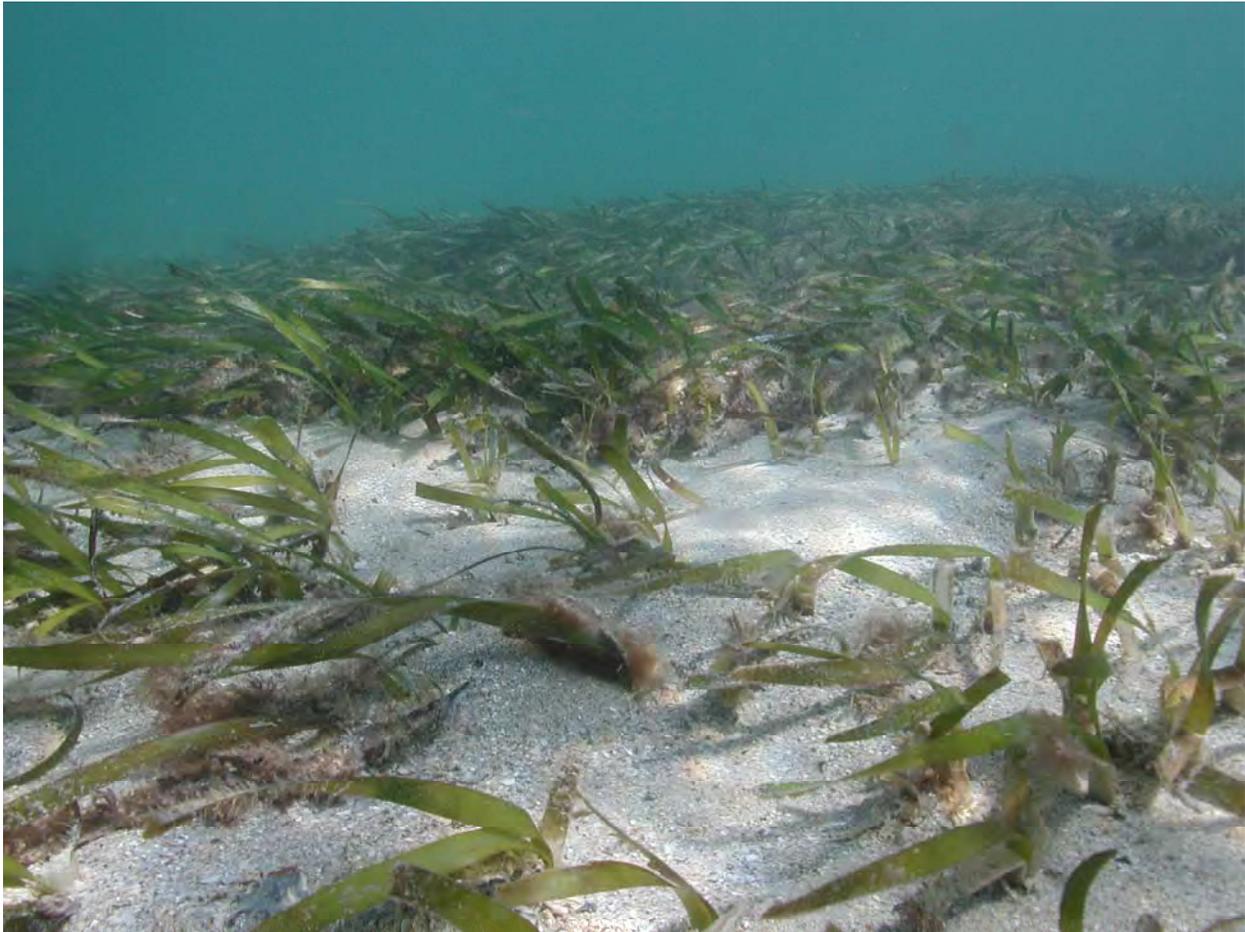
Figure 6: Dense *Thalassia testudinum* bed in Seagrass Area C1.

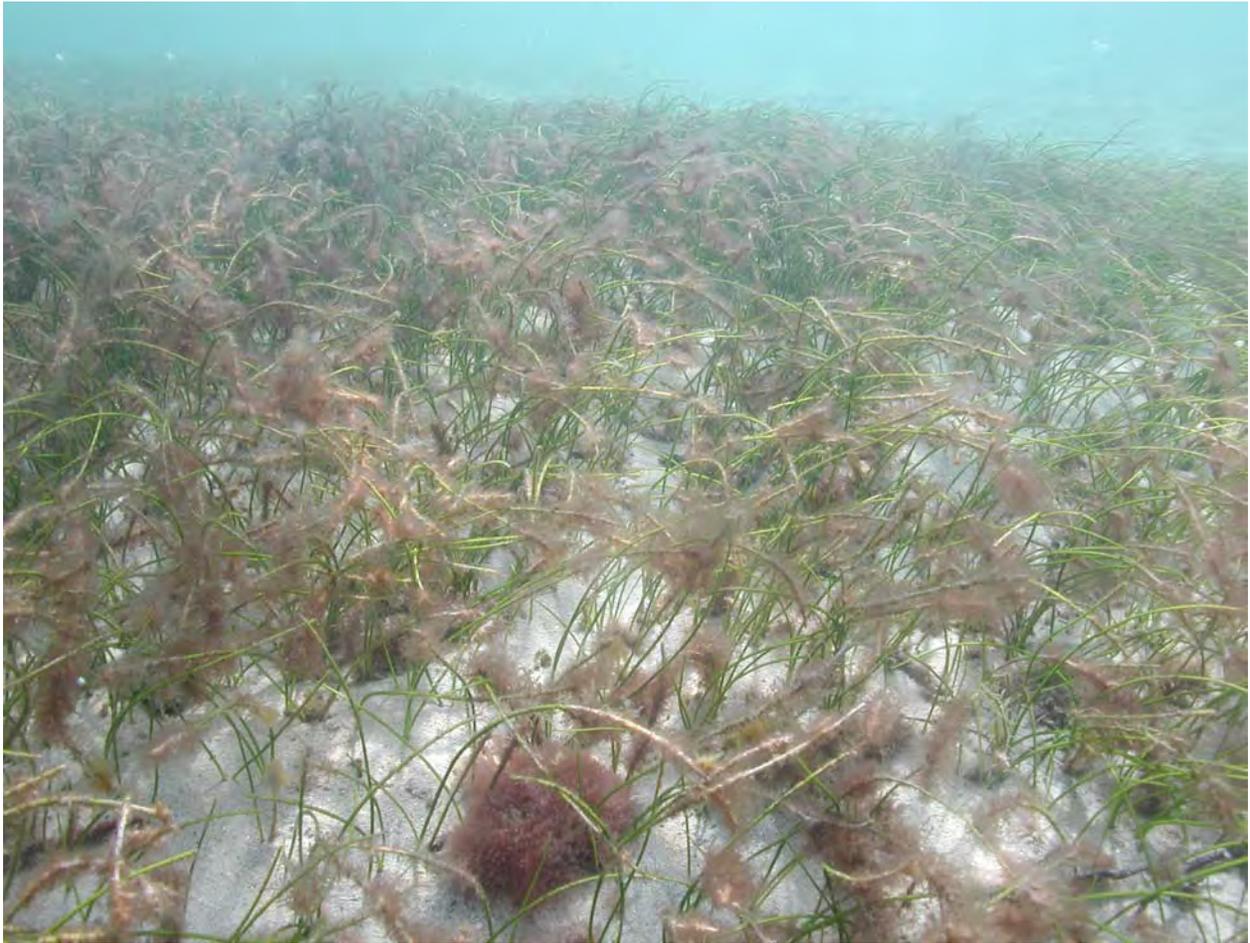
Figure 8: *Syringodium filiforme* bed in Region D.

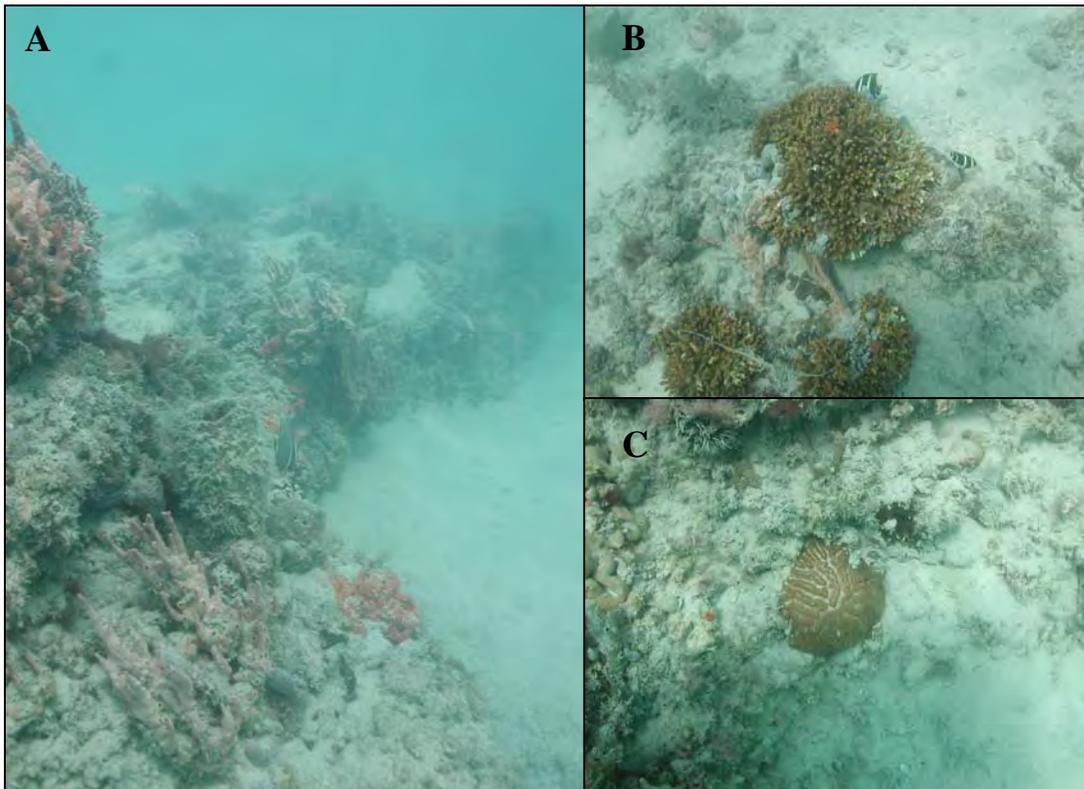
Figure 11: A) West wall of channel; B) *Oculina diffusa* on west wall; C) *Meandrina meandrites* on west wall of channel.

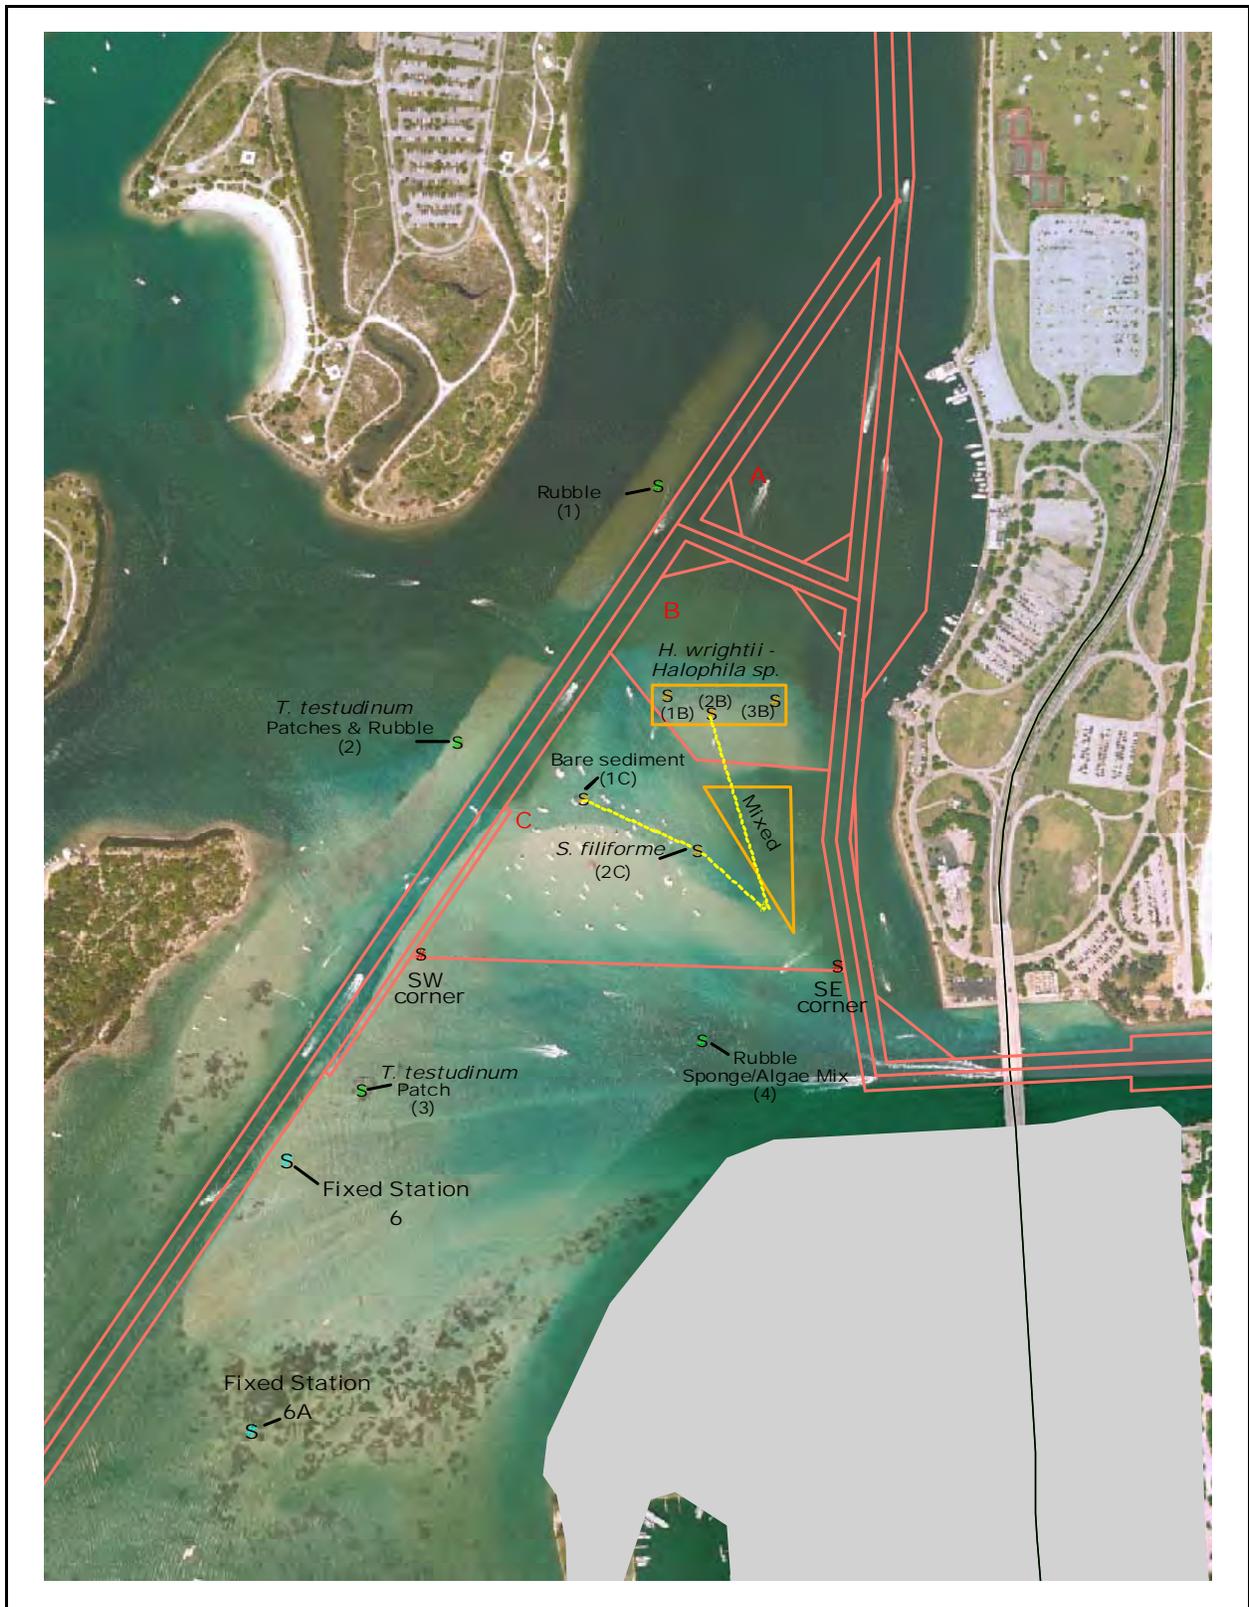
The previously dredged flood shoal area (Polygon C) is presently mostly sand with no epibenthic organisms, however scattered seagrasses are found in the eastern, and northern deeper regions of that area. Sparse soft coral and seagrass have been identified in the northeastern portion of Polygon C. The southern region of Polygon B (just north of Polygon C) supports a sparse mixture of seagrass, including Johnson's Seagrass (*Halophila johnsonii*). The regions surrounding the designated dredging areas support sparse seagrasses and/or algal assemblages on sand and rubble. The presence and density of these assemblages is seasonally dependant.

Figure 1. 2003 Aerial photograph of the 'Flood Shoal' with the USACE project drawings overlaid, and survey site references.

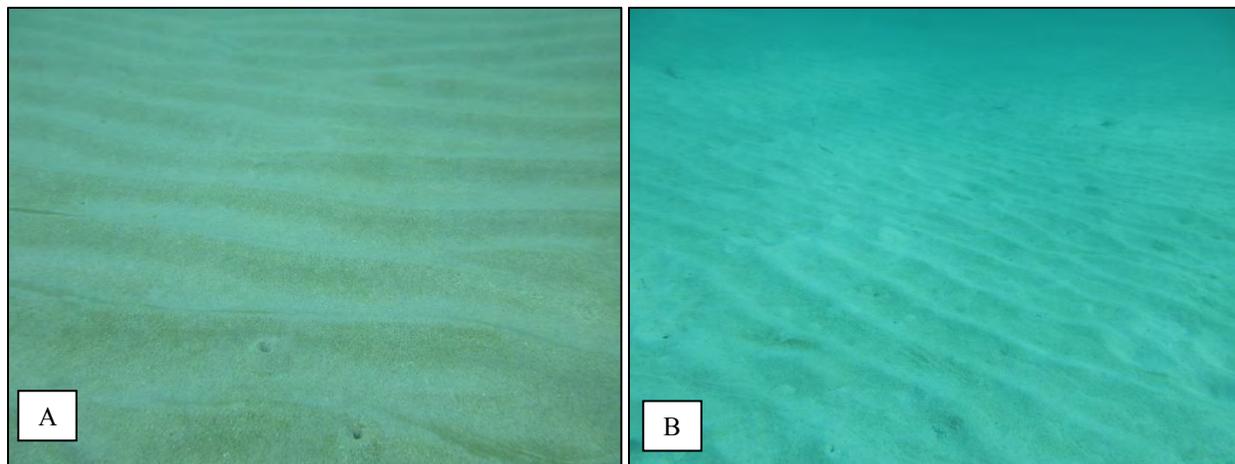
Figure 2. Barren sand observed along the survey transects. A). Transect 4 (~R-16). B). Transect 8 (~R18).

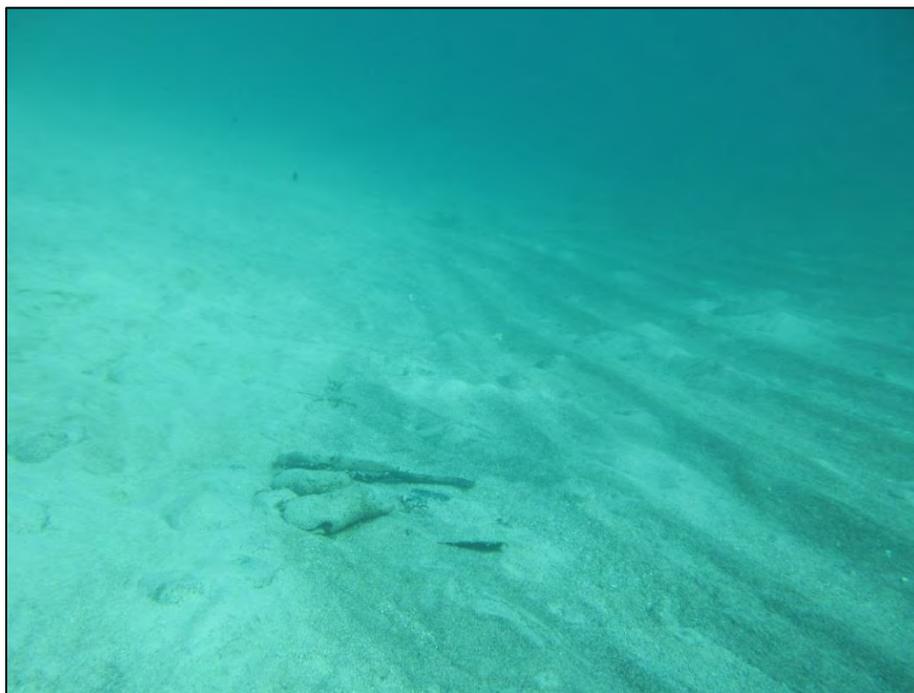
Figure 3. Sand transition area from finer, lighter sand in the west to darker, coarser sand toward the east along Transect 7 (~R17.5).

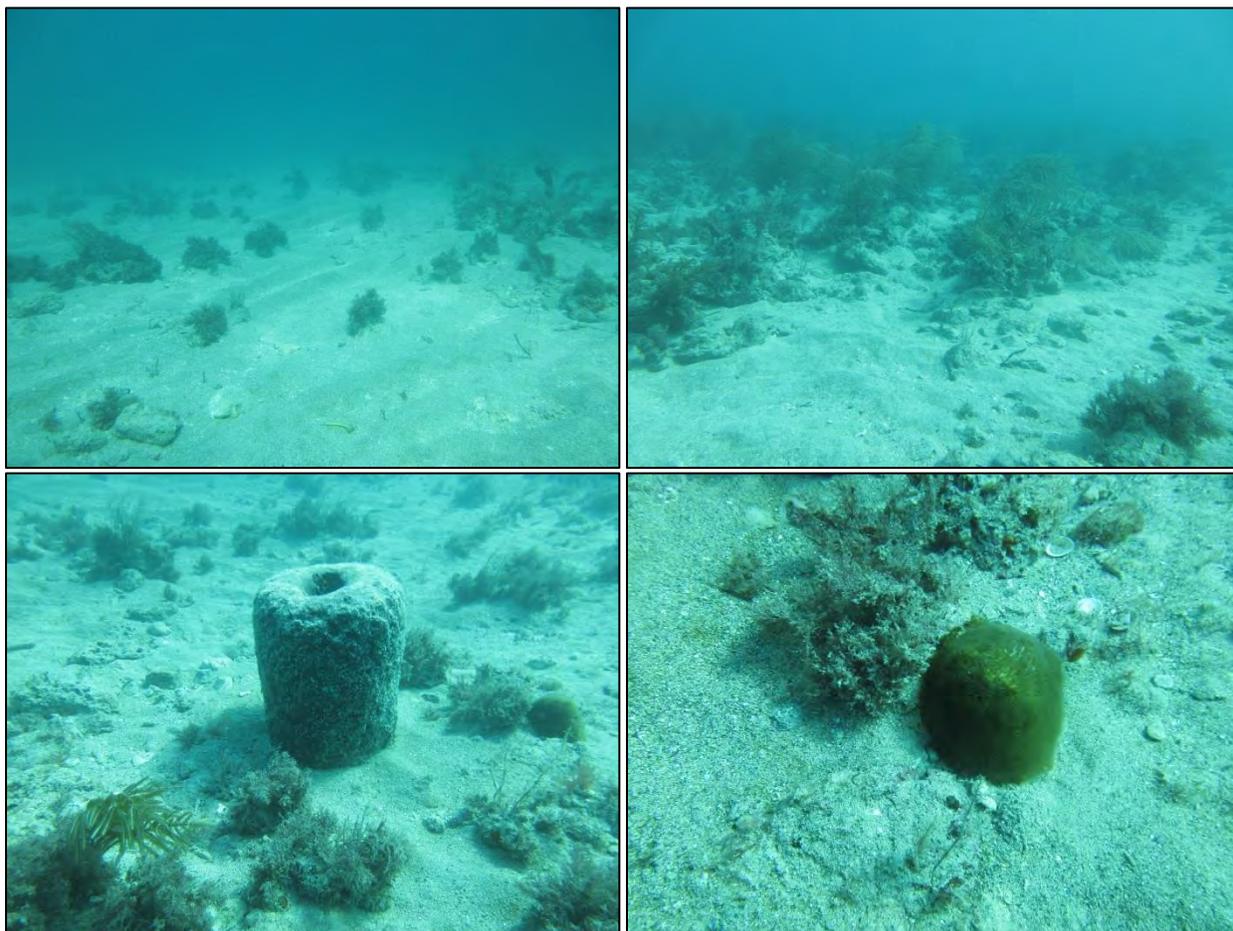
The rubble and emergent biota areas toward the end of Transect 4 and between Transects 11 and 12 are associated with dredged sewer outfall pipeline corridors (Appendices 1-3). The rubble around the northern corridor had up to 2ft of relief and began approximately 900ft from shore (Figure 4). The southern corridor had up to 4ft of relief with larger boulders in some areas and began approximately 500ft from shore (Figure 5). Biota in both areas included porifera, octocorals, and scleractinians (Table 1).

Figure 4. Rubble and emergent biota toward the east end of Transect 4.

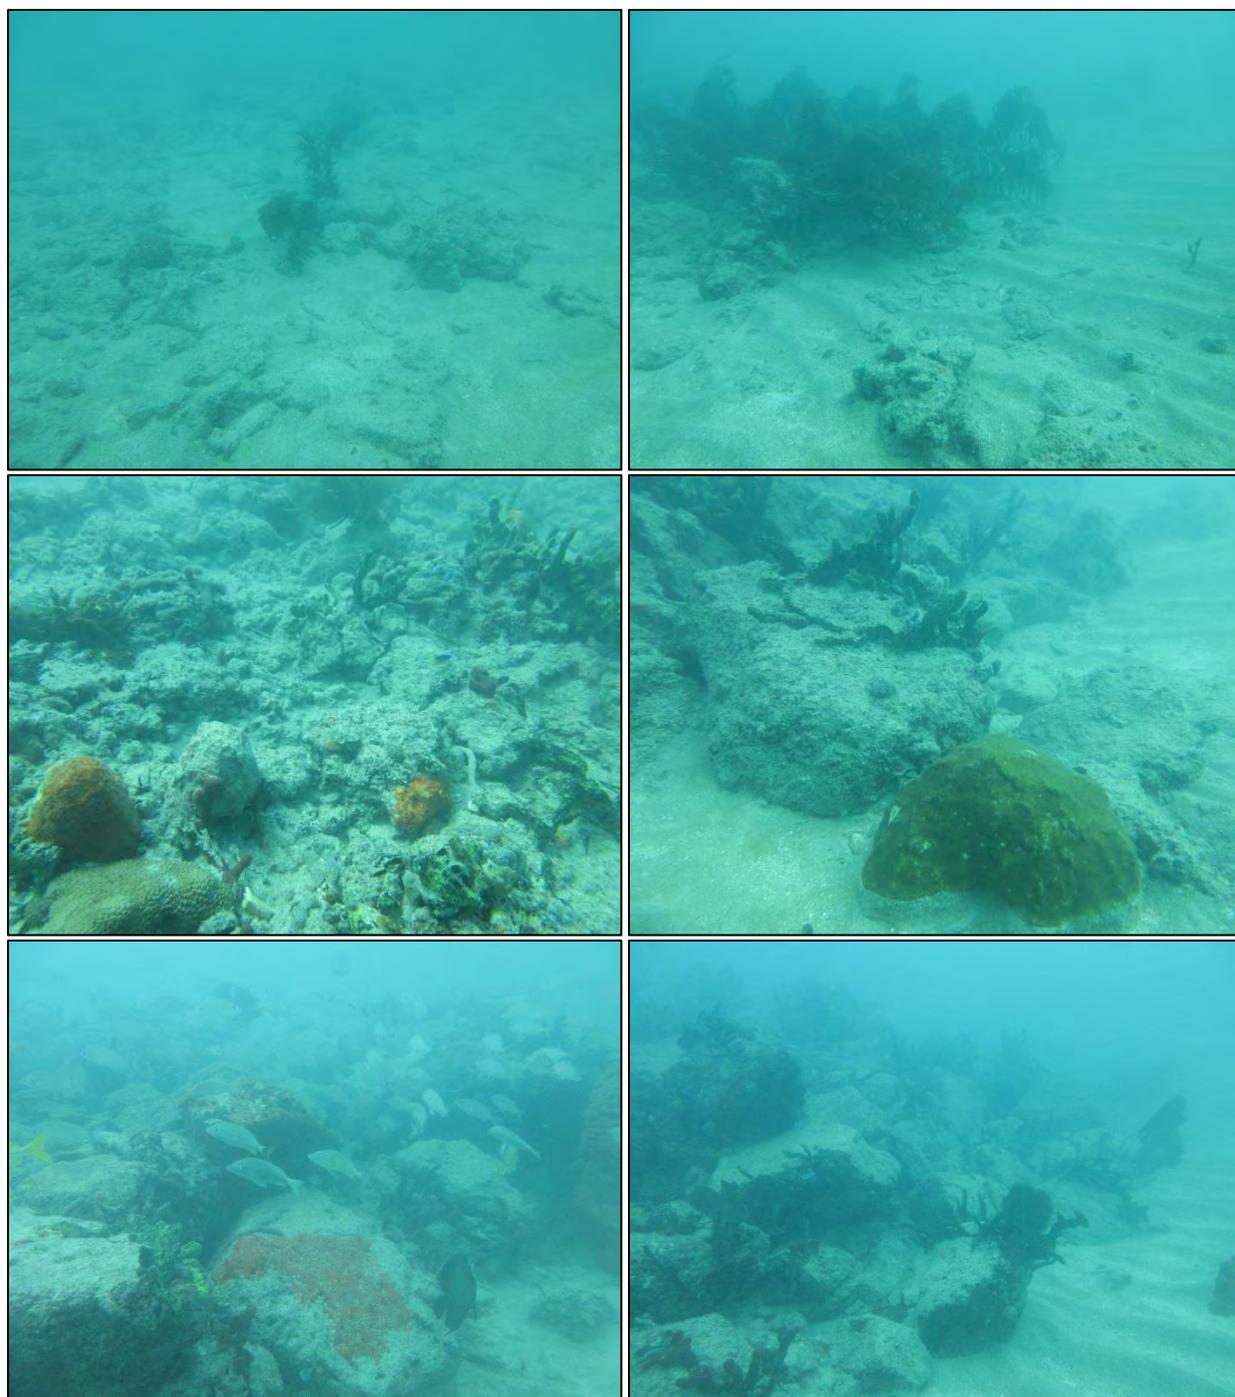
Figure 5. Rubble and emergent biota between the east end of Transect 11 and 12.

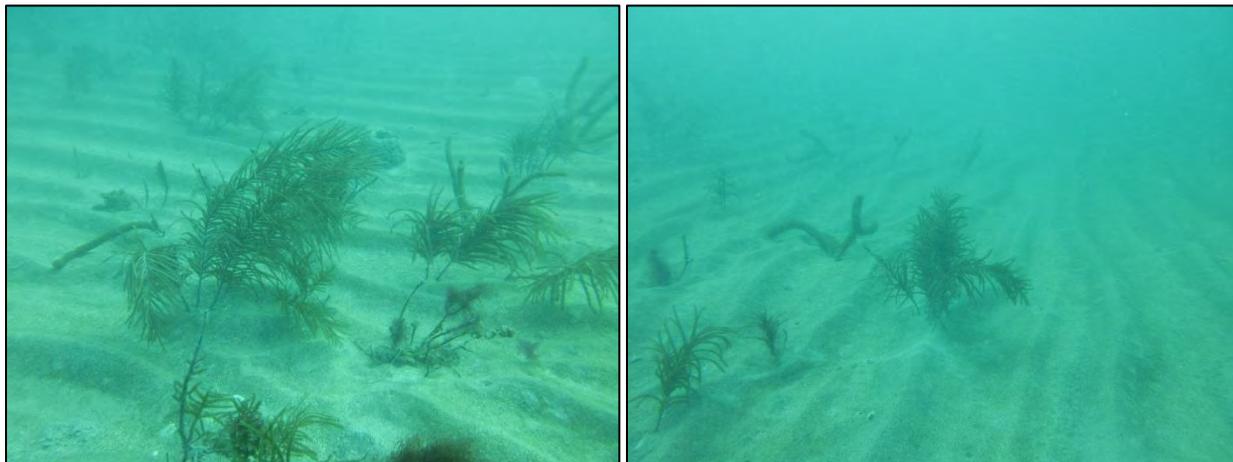
mainly emergent octocorals and algae (Figure 6) with sparse exposed hardbottom with porifera and small scleractinians (Figure 7). Observed species are listed in Table 1.

Figure 6. Emergent biota observed along the resource trace at the eastern end of Transects 1-3.

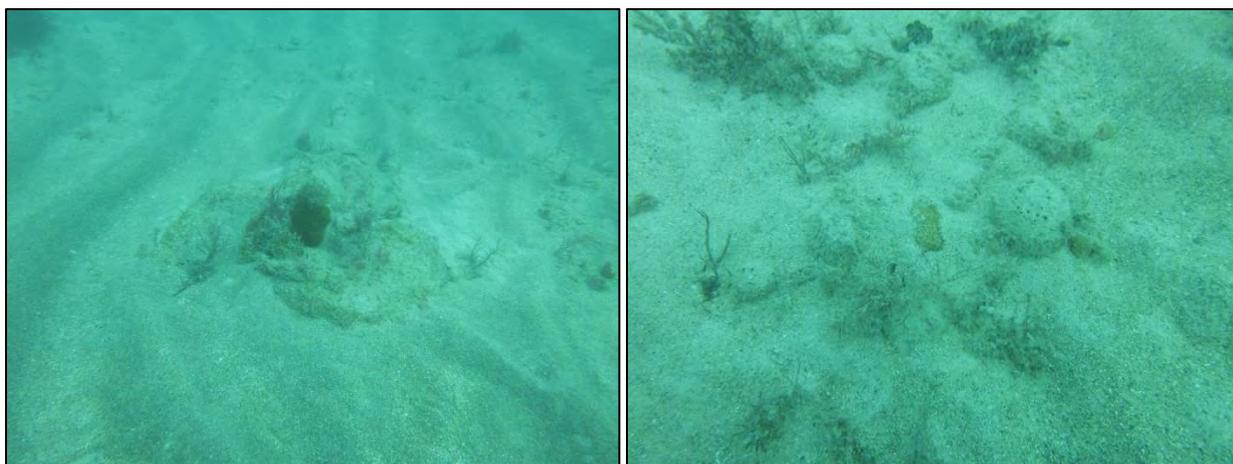
Figure 7. Occasional exposed hardbottom along the emergent biota trace at the eastern end of Transects 1-3.

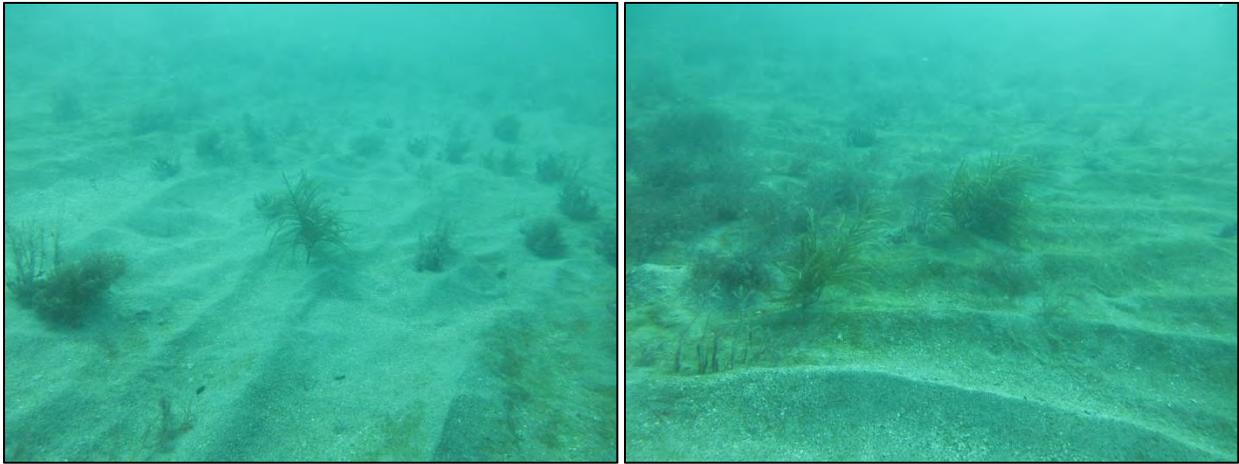
Figure 11. Emergent biota beyond the east end of Transects 8 and 9.

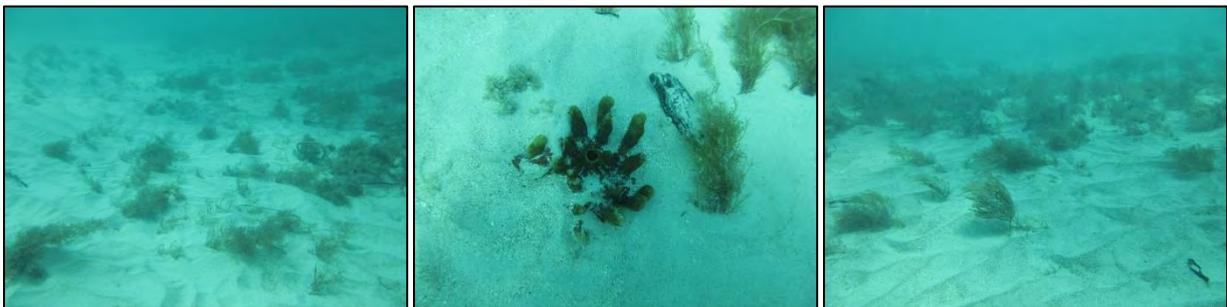
Figure 12. Emergent biota in small patch between Transects 9 and 10.

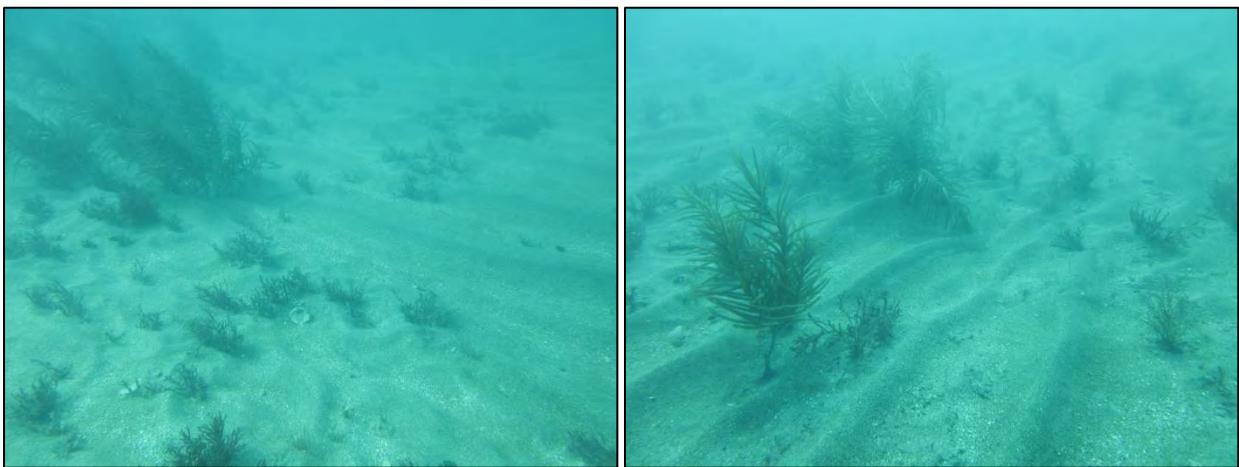
Figure 13. Northern emergent biota edge beyond the eastern end of Transects 10 and 11.

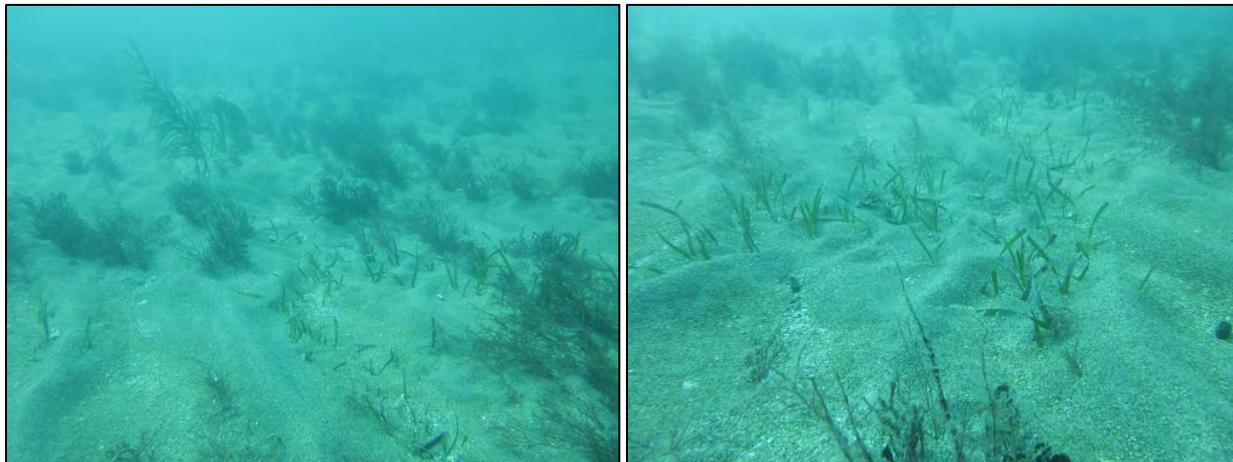
Figure 14. Southern emergent biota edge beyond the eastern end of Transect 10 and 11.

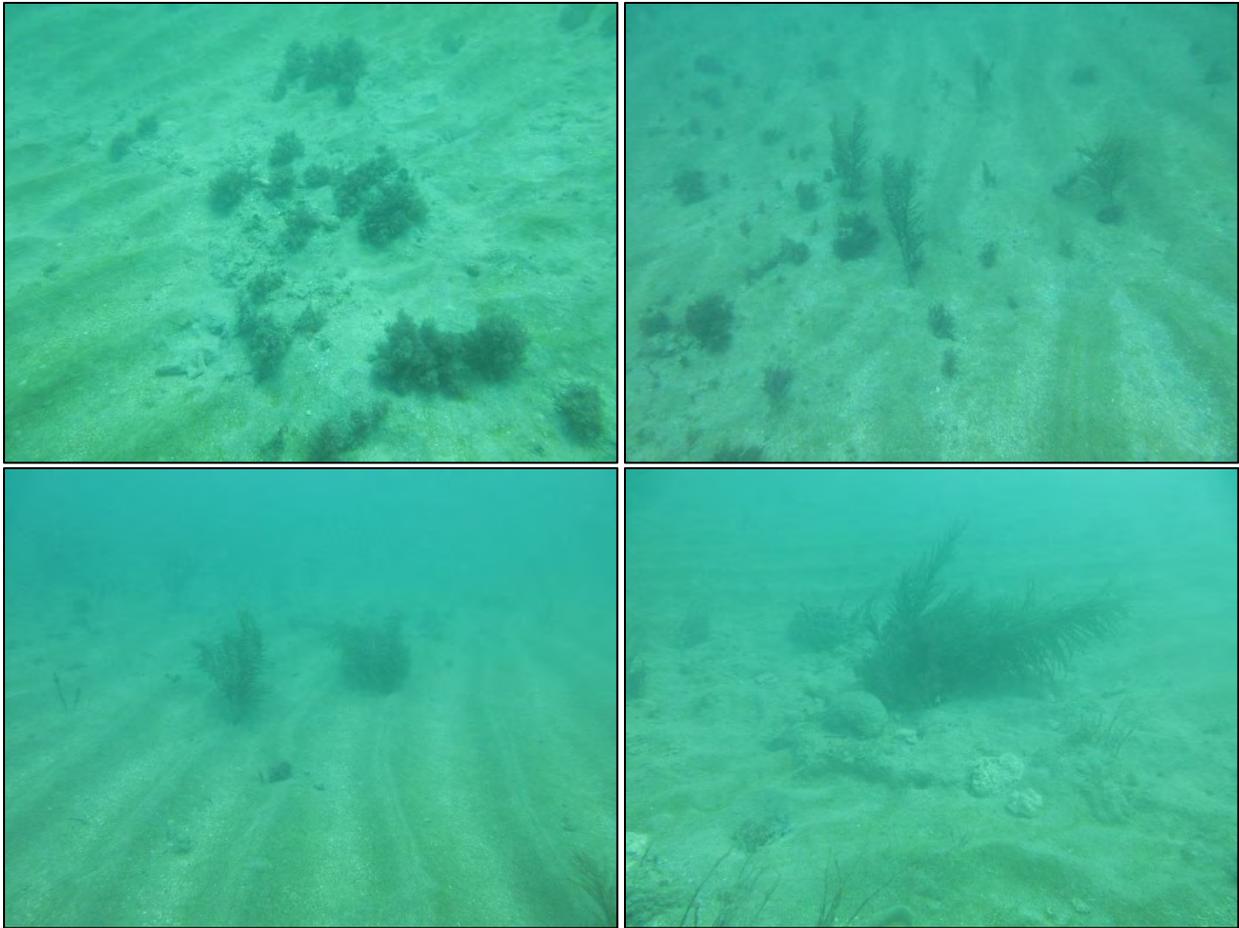
South of the rubble corridor, from Transects 12 through 16, the western edge of emergent biota was traced. The emergent biota edge was approximately from 1,000ft to 1,300ft (305m to 396m) from shore. This far southern emergent biota area was comprised predominantly of emergent octocorals, algae, and sparse exposed hardbottom with porifera and generally small (<4cm) scleractinians (Figure 15). Occasionally, areas with denser biota patches with more exposed hardbottom and larger scleractinians (~20cm diameter) were observed (Figure 16). Along this trace, a few areas were also observed with clusters of metal tire rims (Figure 17). Observed species are listed in Table 1.

Figure 15. Emergent biota and exposed hardbottom between and beyond the eastern ends of Transects 12 through 16.

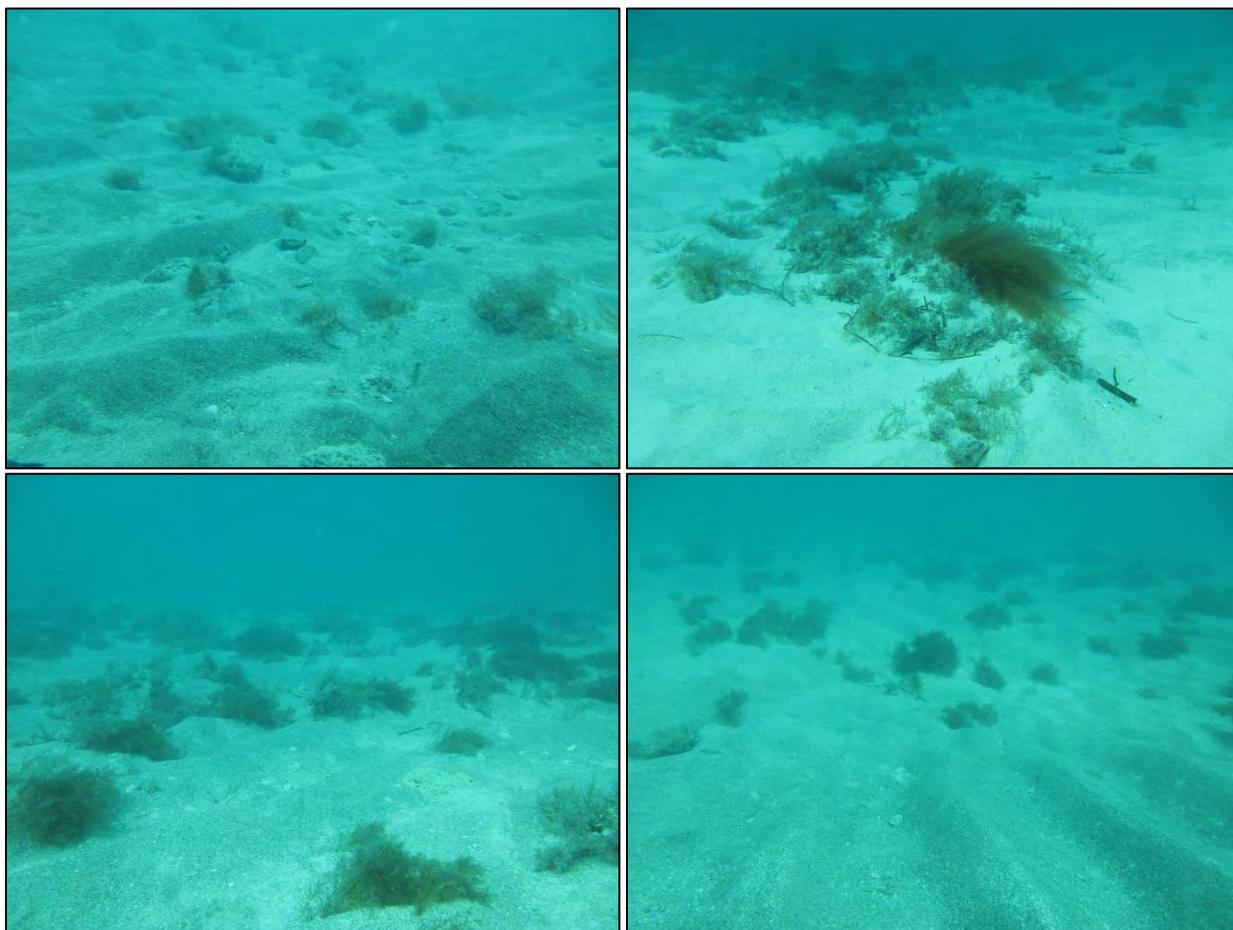
One area of unconsolidated rubble with algae and hydroids was observed between Transects 7 and 8 just east of the sand transition area (Figure 18; Appendix 1 and 2). This area is approximately 750' (229m) from shore. Scleractinians and attached octocorals were not observed in this area. Only a single boring sponge was observed on a large piece of rubble. Dislodged octocorals and sponges were observed mixed in with rubble, hydroids, and algae. Observed species are listed in Table 1.

Figure 18 Rubble and algae area between Transects 7 and 8.

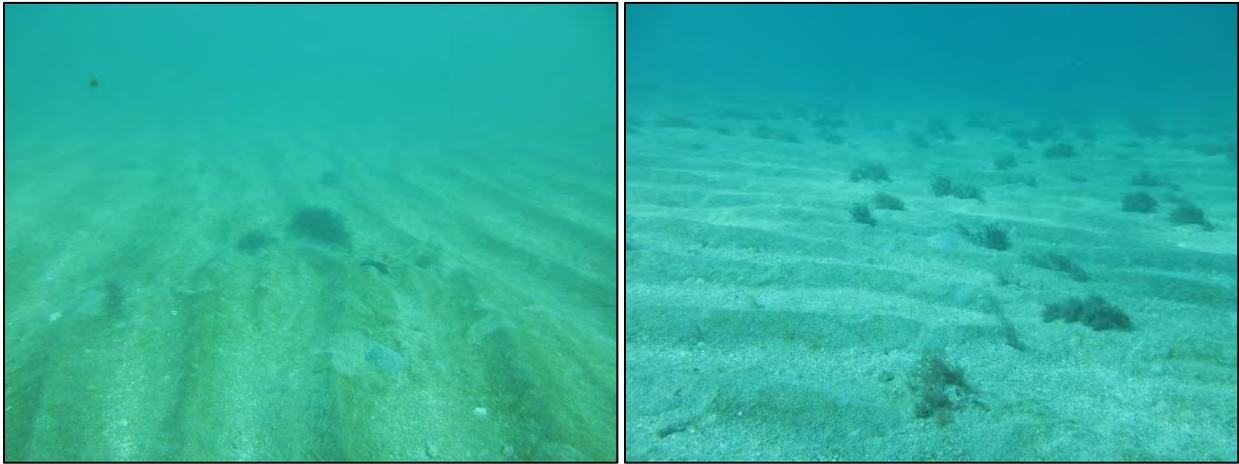
South of the eastern end of Transect 3, the definable edge of emergent biota faded out to an area with algae only (Appendices 1-3). The algae area extends south toward the eastern end of Transect 6 (Figure 19), flanking both north and south sides of an area with rubble and emergent biota. An additional smaller algae (Figure 20) area was observed between the eastern end of Transect 7 and 8 to the east of a patch of emergent biota and between two definable areas of emergent biota and occasional exposed hardbottom to the north and south. A third algae area (Figure 21) was observed from just north of Transect 10 to Transect 13 flanking both the north and south sides of an area of rubble and emergent biota. DERM biologist attempted to trace the western extent of this algae area but the varying densities and visibility only provided an approximate trace. *Chondria* species, *Bryothamnion* species, and hydroids were the most abundant species. All observed species are listed in Table 1.

Figure 19. Algae area toward the eastern extent of Transects 4-6.

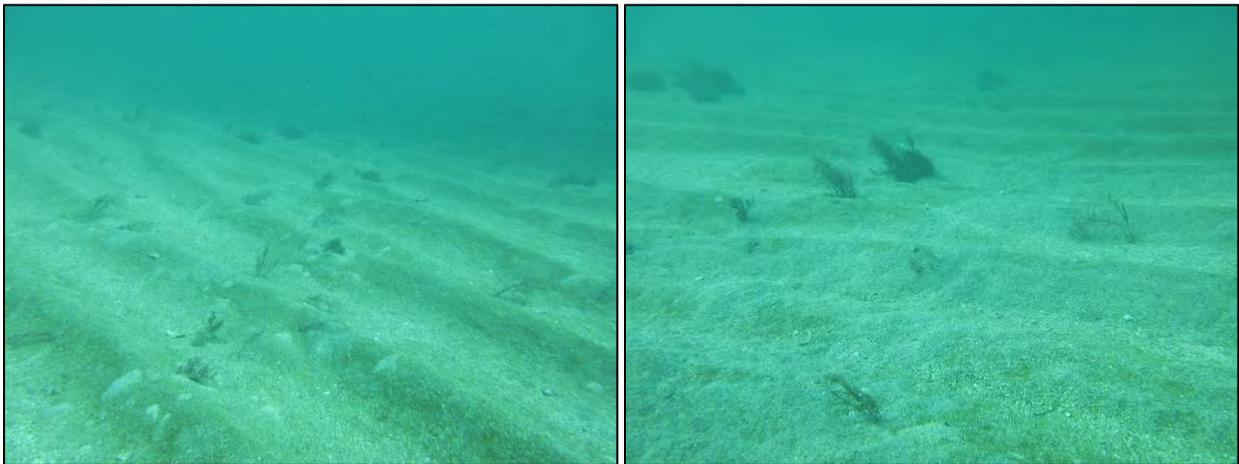
Figure 20. Algae area between Transects 7-8.

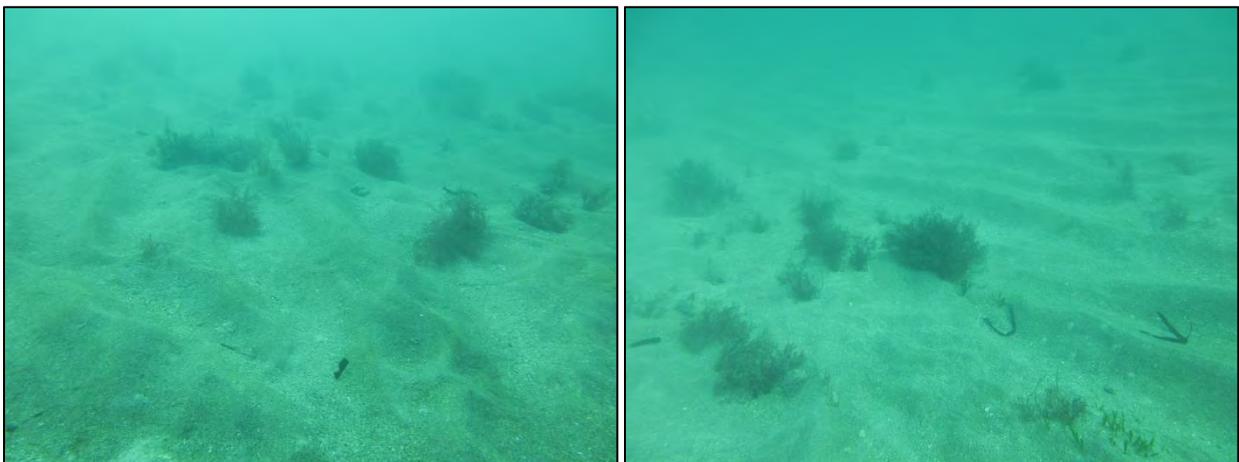
Figure 21. Algae area along Transect 10.

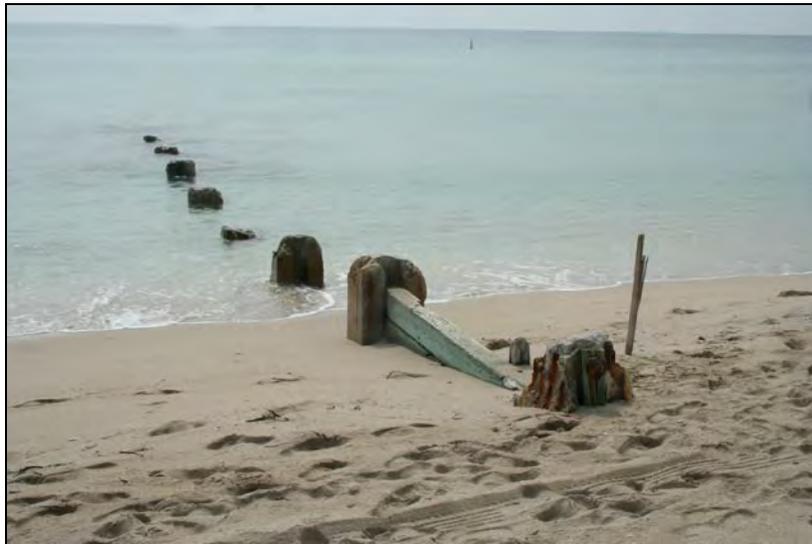
The northern portion of the survey area (Bal Harbour Beach) has five exposed shore-perpendicular groins extending offshore from the beach between R28 and R32 (Figure 1 and Appendix 1-2). These groins have been buried and unburied through nourishment/erosion process. Portions of the groins are tidally exposed. The groins are composed of concrete pilings, wood, and limerock boulders. At this time, the groins support benthic species including sponges (*Cliona* spp.), bryozoans, hydroids, tunicates, and algae. Numerous fish species and other motile invertebrates are also observed along the groin structures. The northernmost groin (Groin A) was only evaluated in the 2008 Survey and the results are included in the groin description as part of the RAI response in Appendix 5. The remaining four groins (Groins B- E) were evaluated during these surveys. The species of benthic and motile species observed on these four southern groins are listed in Table 1. Figures 2 -5 illustrate the resources found on groins B through E respectively. The area the groins and associated biota cover are listed in Table 2.

Figure 1. Beach view of exposed groin (E) on Bal Harbour Beach.

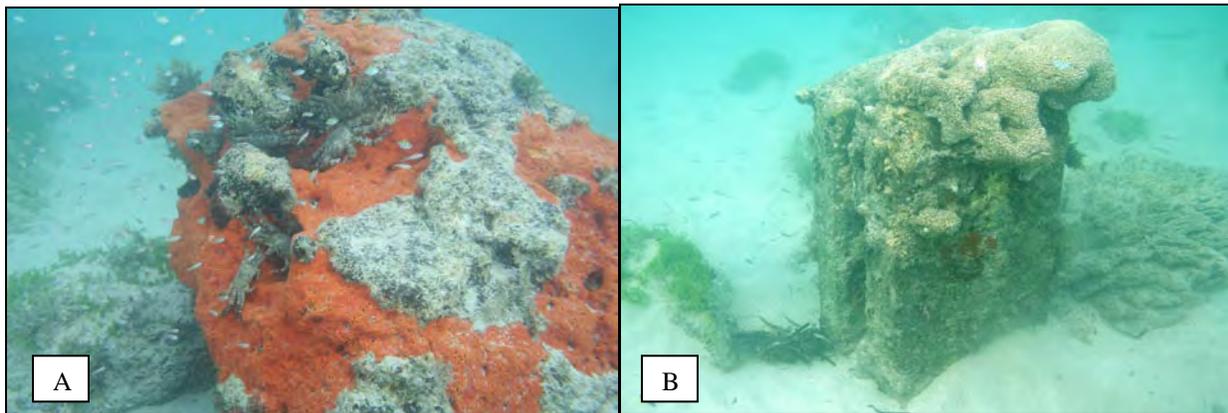
Figure 2. Biota on Groin B. A.) Cliona species, true crabs (Brachyura), and numerous juvenile fish. B.) Worm reef (*Phragmatopoma caudata*) on and adjacent to groin structure.

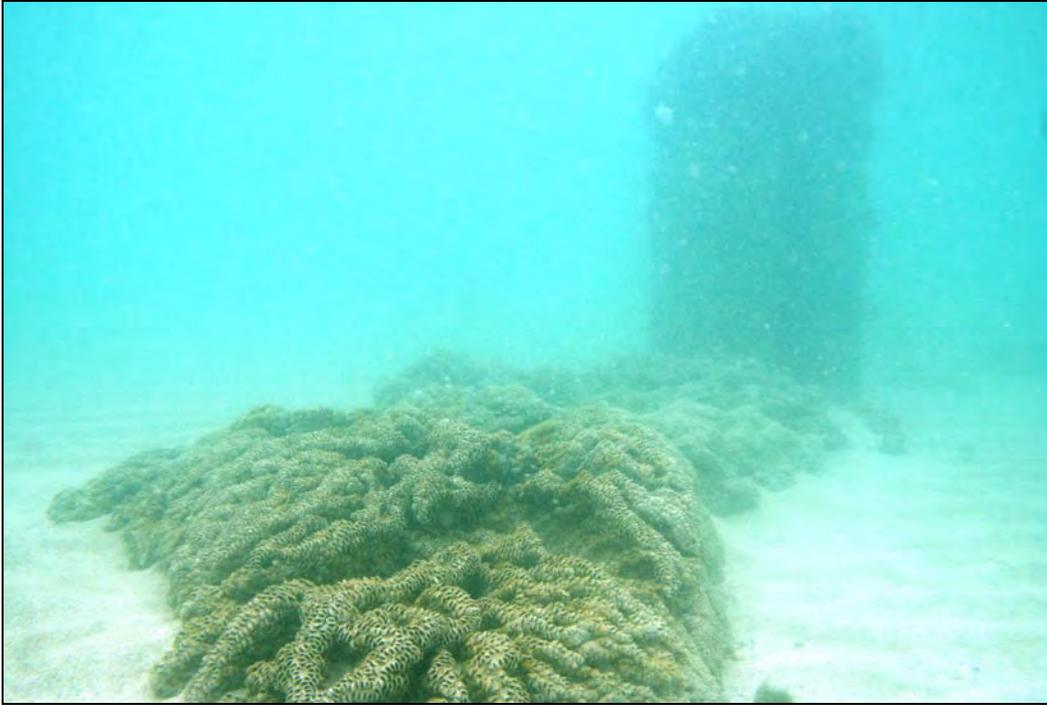
Figure 3. Worm reef (*Phragmatopoma caudata*) adjacent to structure at Groin C.
