SEAGRASS SURVEYS

Post-Construction Benthic Resources Surveys for Maintenance Dredging of the Intracoastal Waterway in the Vicinity of Bakers Haulover Inlet

Submitted by Miami-Dade County Department of Economic and Regulatory Resources –
Environmental Resources Management,
in accordance with Scope of work for FIND Agreement #ICW-DA-13-02 with Miami-Dade
County

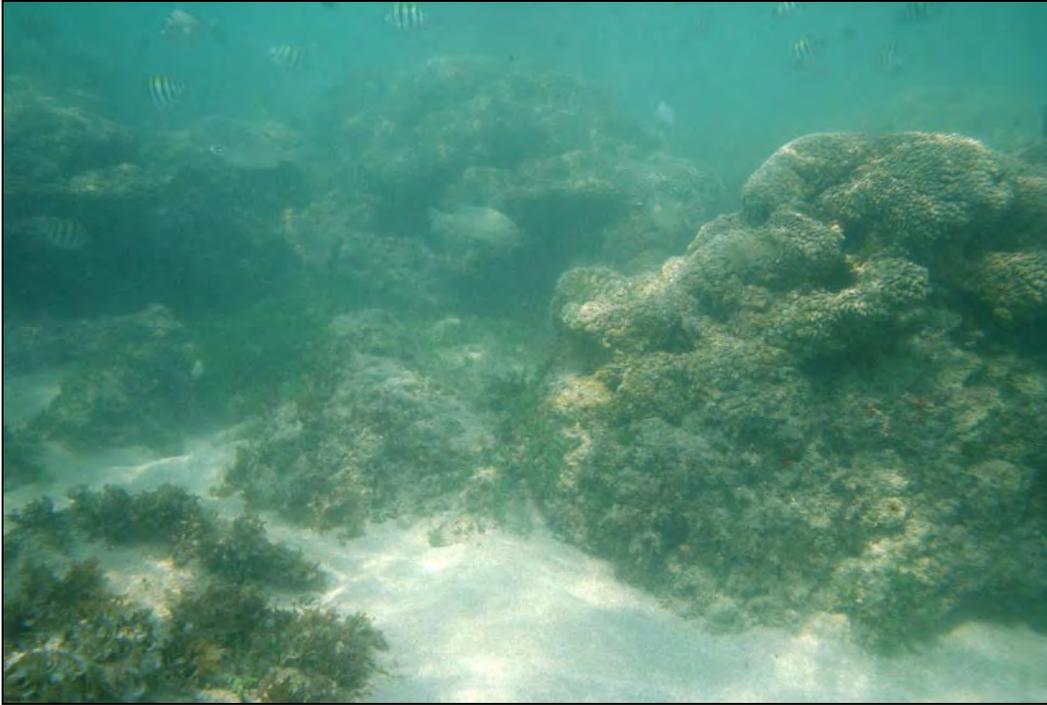
Figure 5. Worm reef (*Phragmatopoma caudata*) and algae along with numerous fish at Groin E.

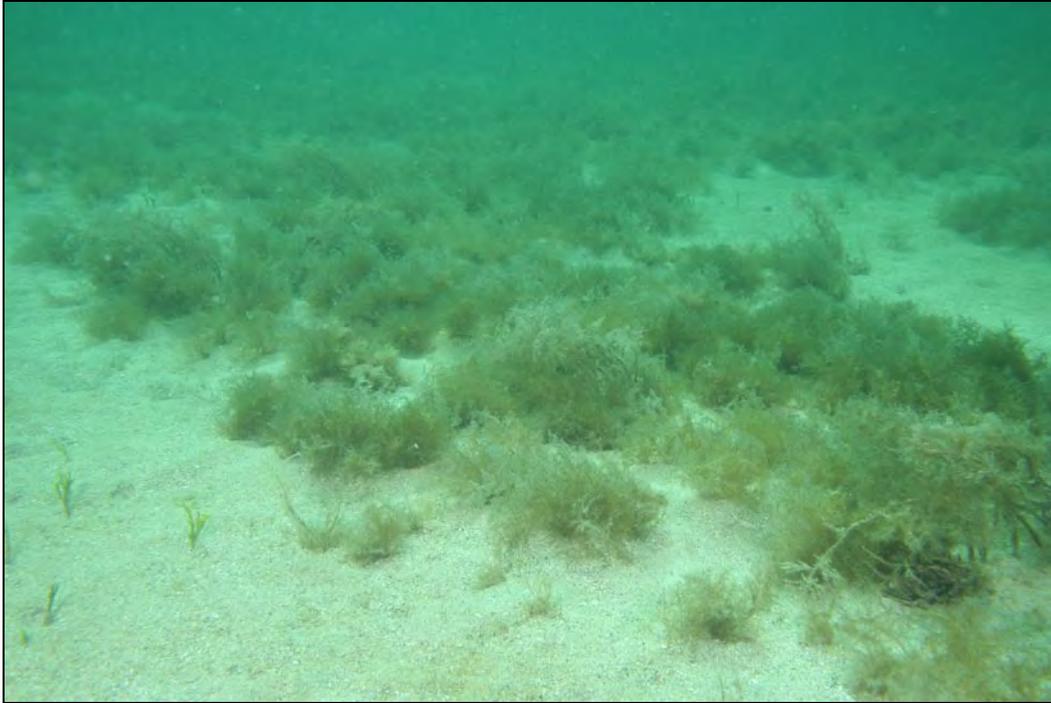
Figure 2. Significant habitat and drift red algae community on sand veneer at eastern end of the northern transect (MB-1) of Miami Beach segment

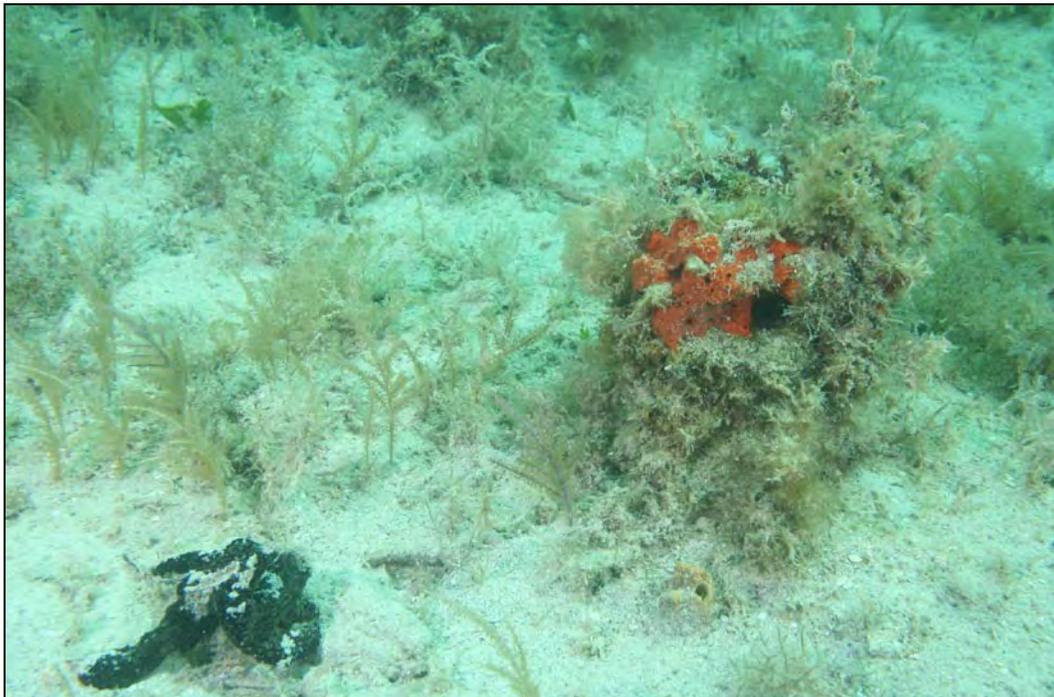
Figure 3. Sponges and juvenile soft coral (*Pseudopterogorgia* sp.) in the northern significant habitat area (off transect MB-1) of Miami Beach segment.

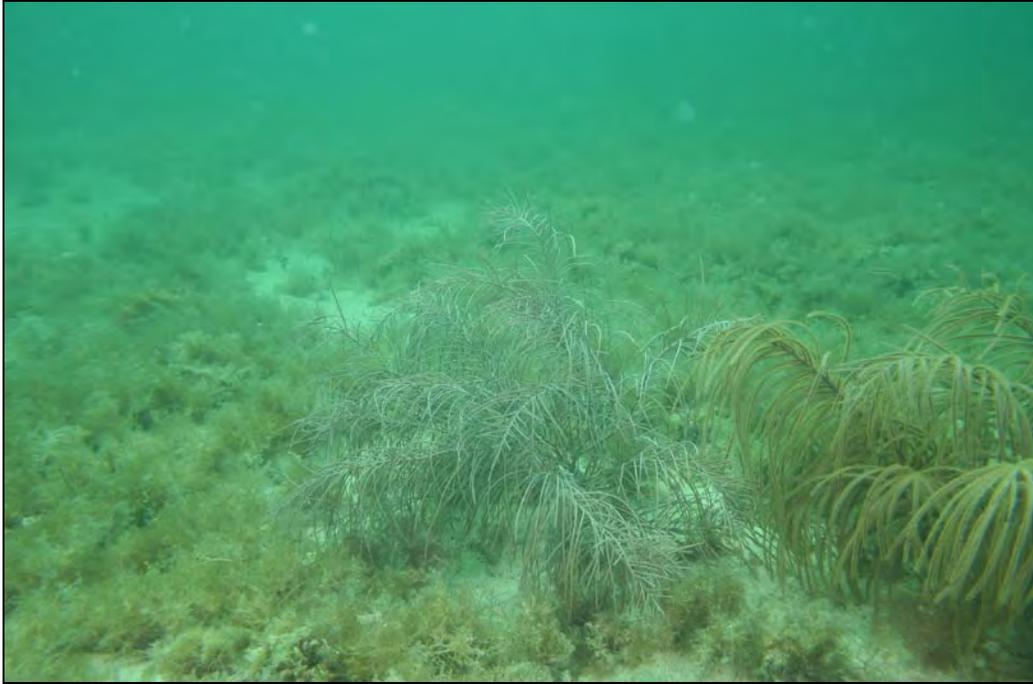
Figure 4. *Pseudopterogorgia* spp. among a drift red algae community in northern significant habitat area within the Miami Beach segment.

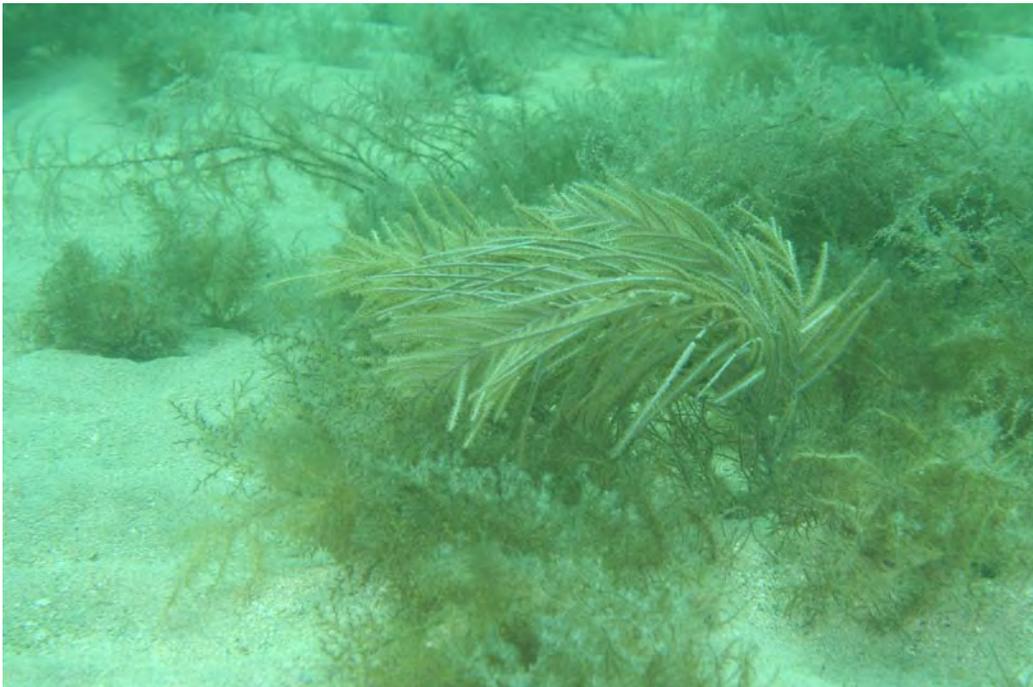
Figure 5. *Pseudopterogorgia* spp. among a drift red algae in southern significant habitat area within the Miami Beach Segment.

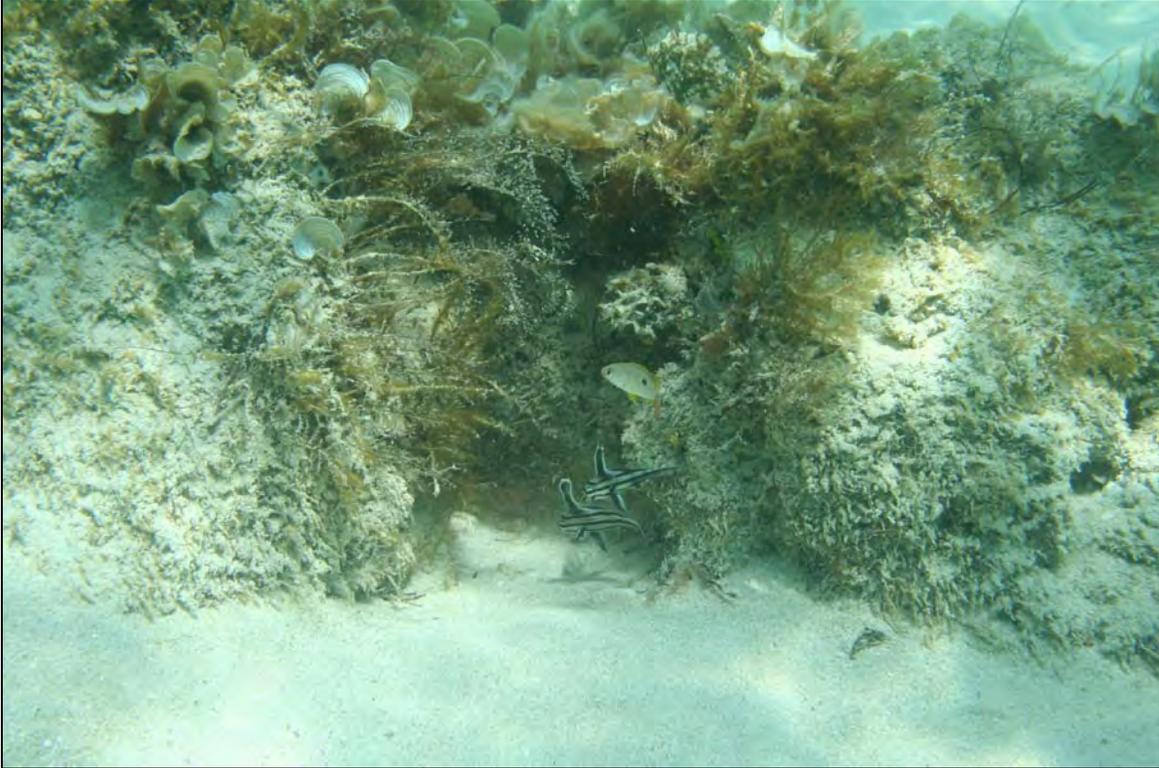
Figure 7. Juvenile *Equetus punctatus* and *Lutjanus synagris* among algae (*Padina* spp.) and hydroids on the exposed portions of the shore beach groin structures off the Bal Harbour Beach Segment.

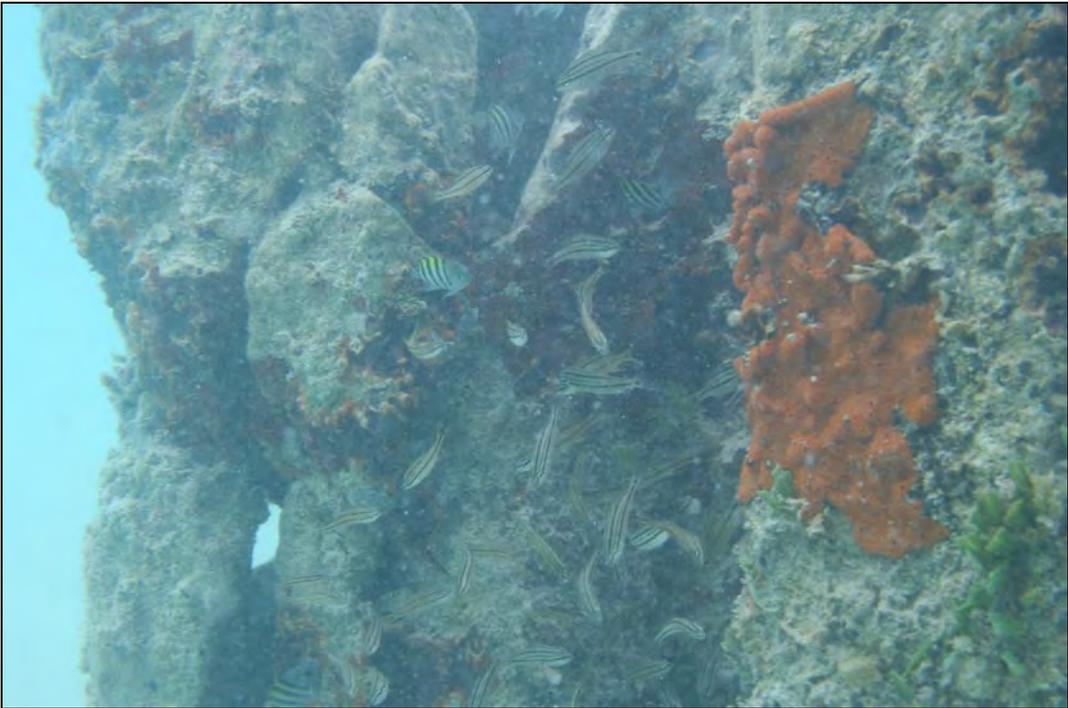
Figure 8. Juvenile grunts (*Haemulon* spp.) and *Abudefduf saxatilis* along with encrusting tunicates, sponges, and algae (*Caulerpa sertularioides*) on the groin structures off the Bal Harbour Beach Segment.

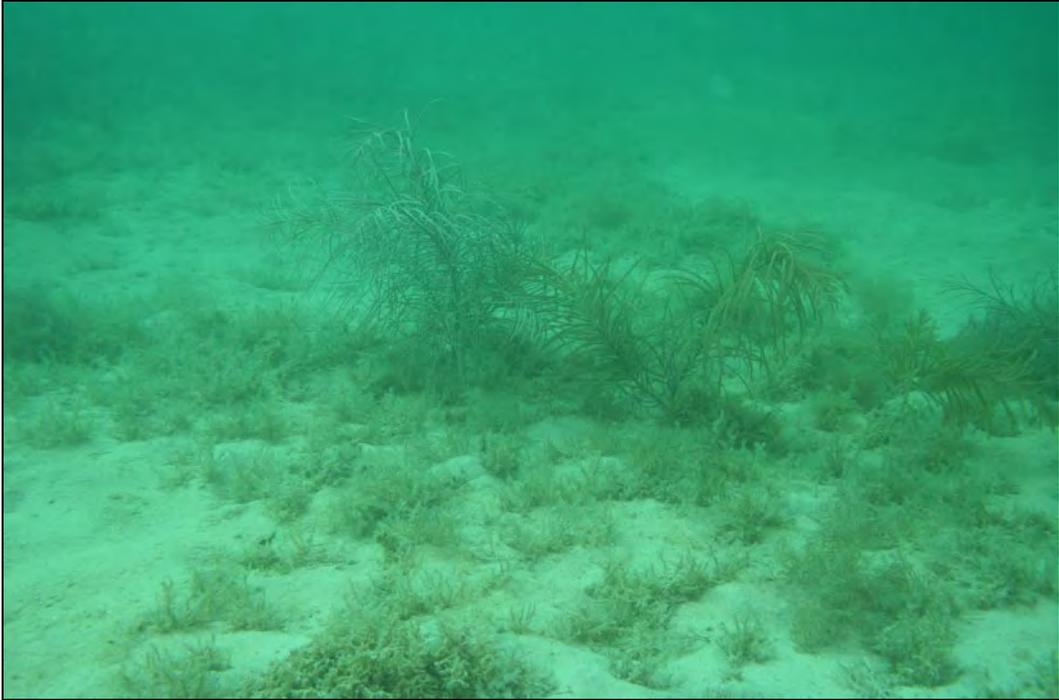
Figure 9. Attached and drift macroalgae and *Pseudopterogorgia* spp. on rubble and sand veneer in northern portion of significant habitat area within the Bal Harbour Beach segment.

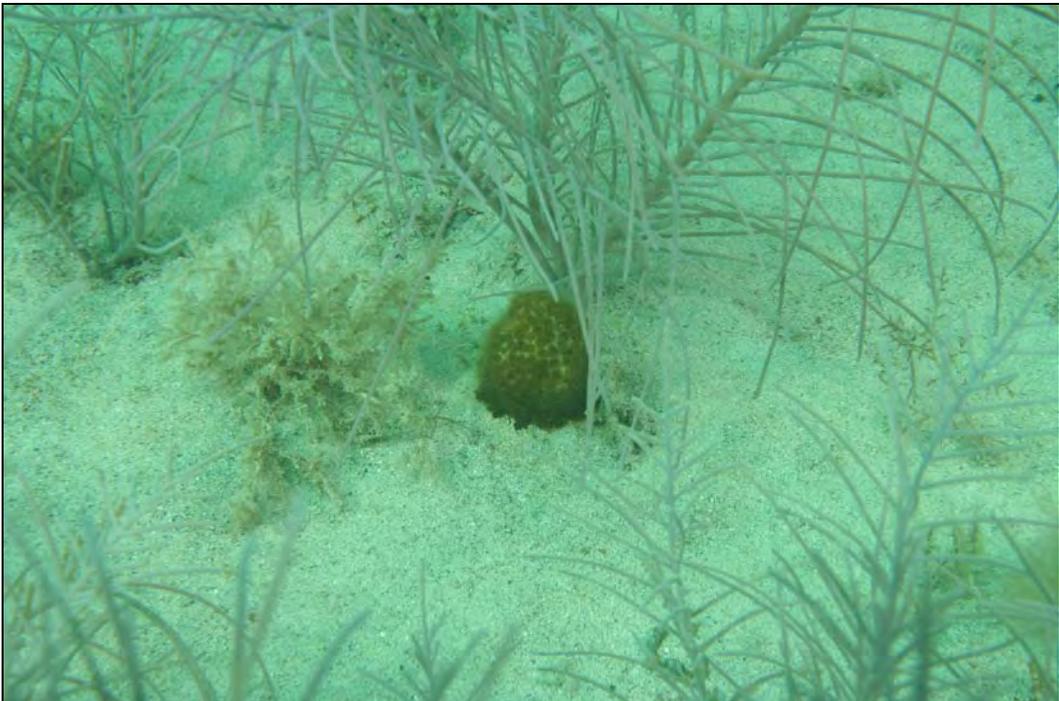
Figure 10. *Solenastrea bournoni* and *Pseudopterogorgia* spp. in significant habitat area within the Bal Harbour Beach segment.

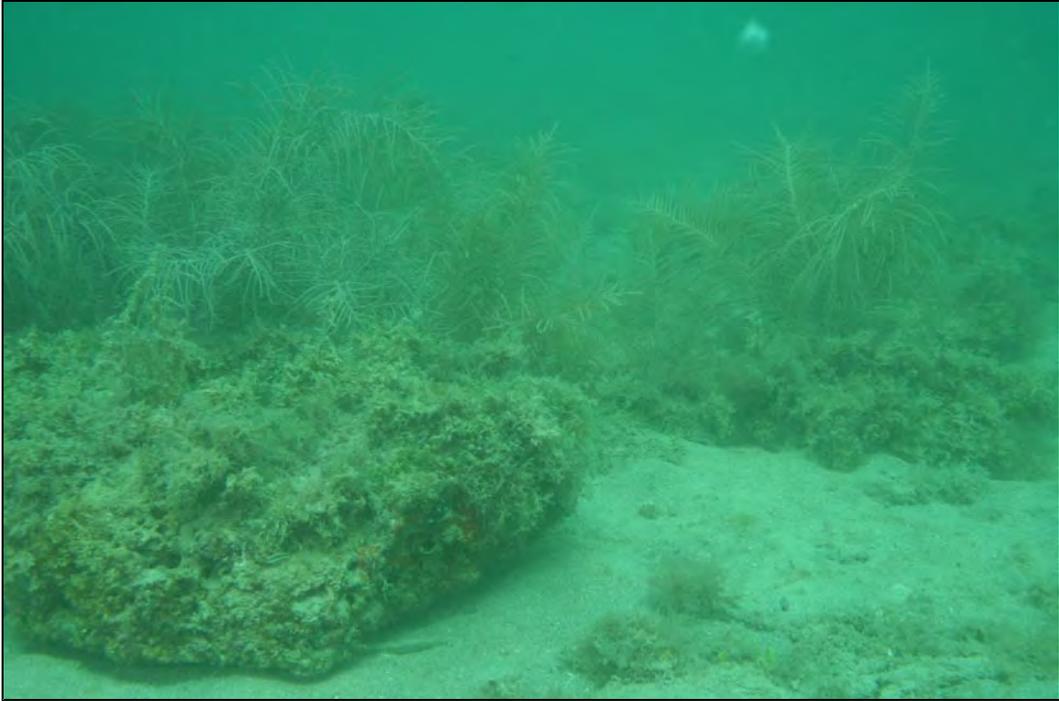
Figure 11. Exposed hardbottom with *Pseudopterogorgia* spp. in significant habitat area within the Bal Harbour Beach segment.

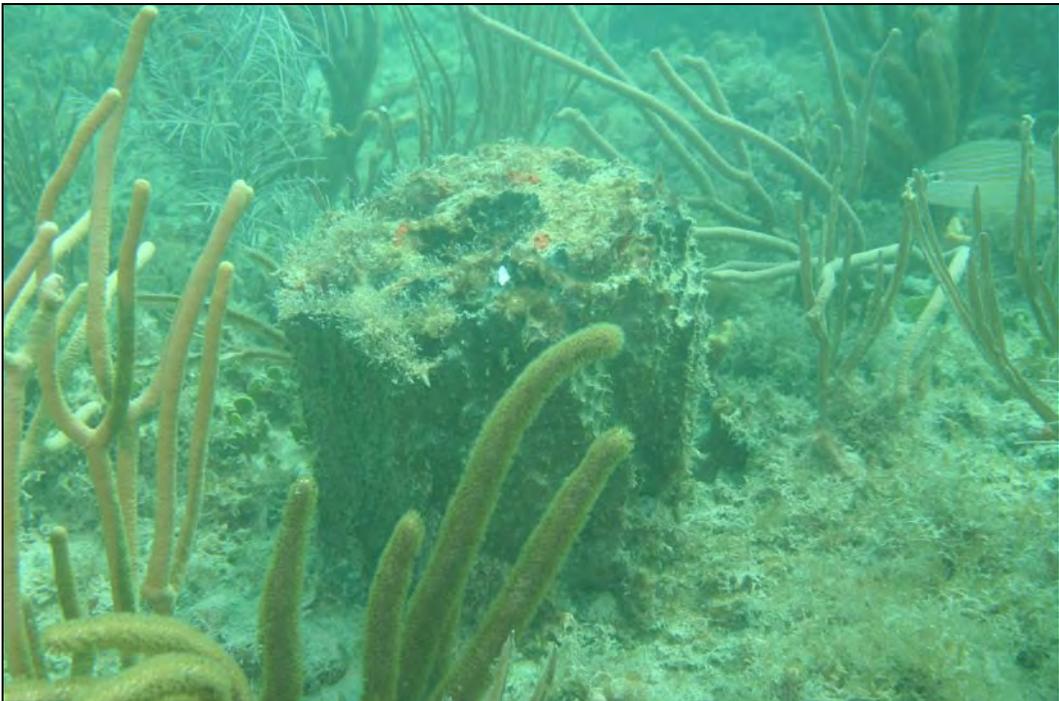
Figure 12. Hardbottom with soft corals and large barrel sponge, *Spheciospongia vesparium*, in significant habitat area within the Bal Harbour Beach segment.

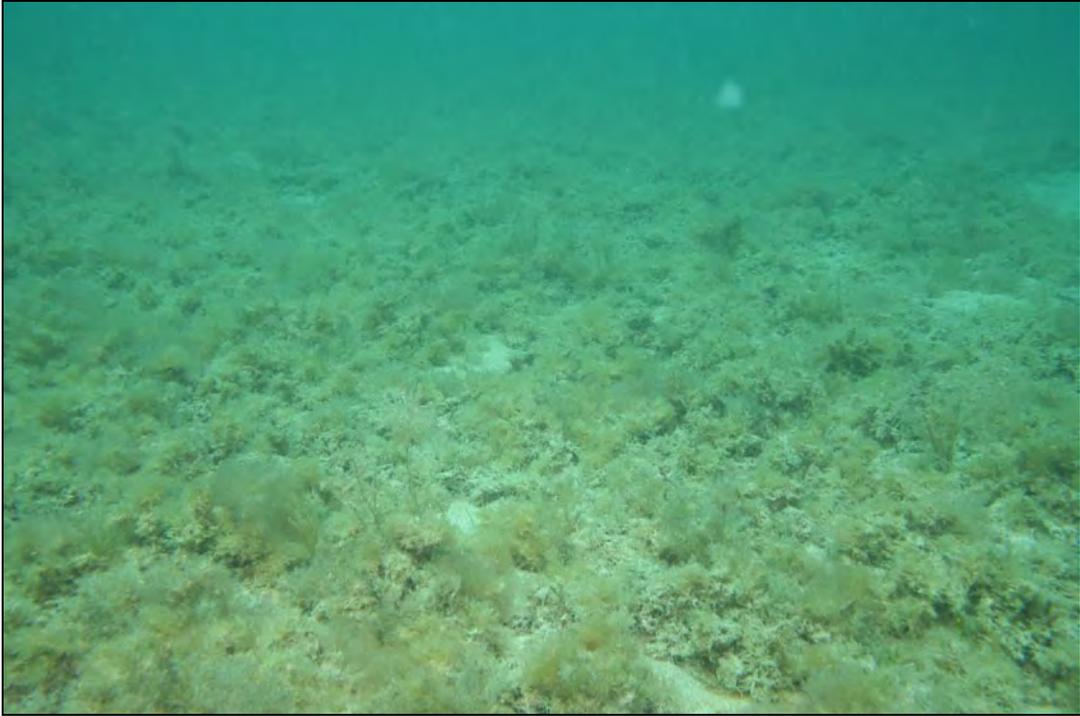
Figure 14. Abundant drift red algae dominated area of the Sunny Isles Beach Segment.

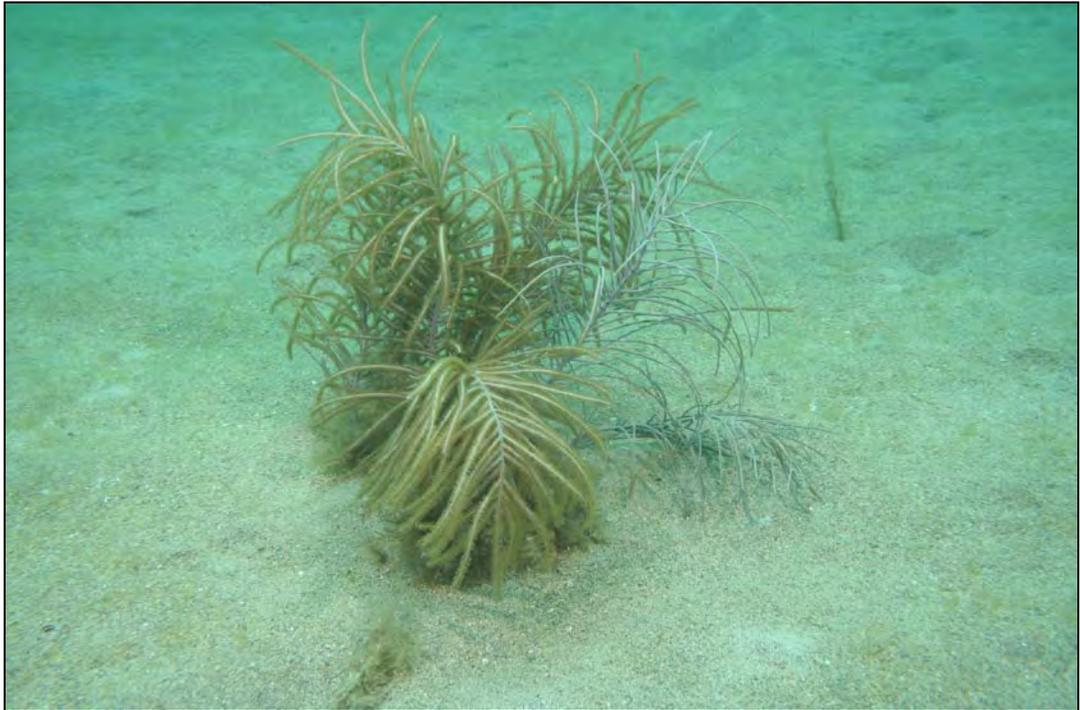
Figure 15. *Pseudopterogorgia* sp. surrounded by sand within the Sunny Isles Beach segment.

The abundance of sponges, soft coral and hard corals ranged greatly from a solitary soft coral (*Pseudopterogorgia* sp.) surrounded by sand to a few soft corals surrounded by the drift red algae community to denser areas with several soft corals, sponges, and hard corals. Figures 15 through 17 illustrate some of the variation in the components of the significant habitat in this area. Worm rock (*Phragmatopoma caudata*) was also occasionally observed in this area (Figure 19 and 20). Benthic and fish species identified during the surveys for the Sunny Isles Segment and their relative abundance are listed in Tables 4 and 5 respectively. More extensive exposed hardbottom (with 1-2' relief) and dense benthic assemblages were observed farther to the east approximately 1500' offshore at the eastern transect edges.

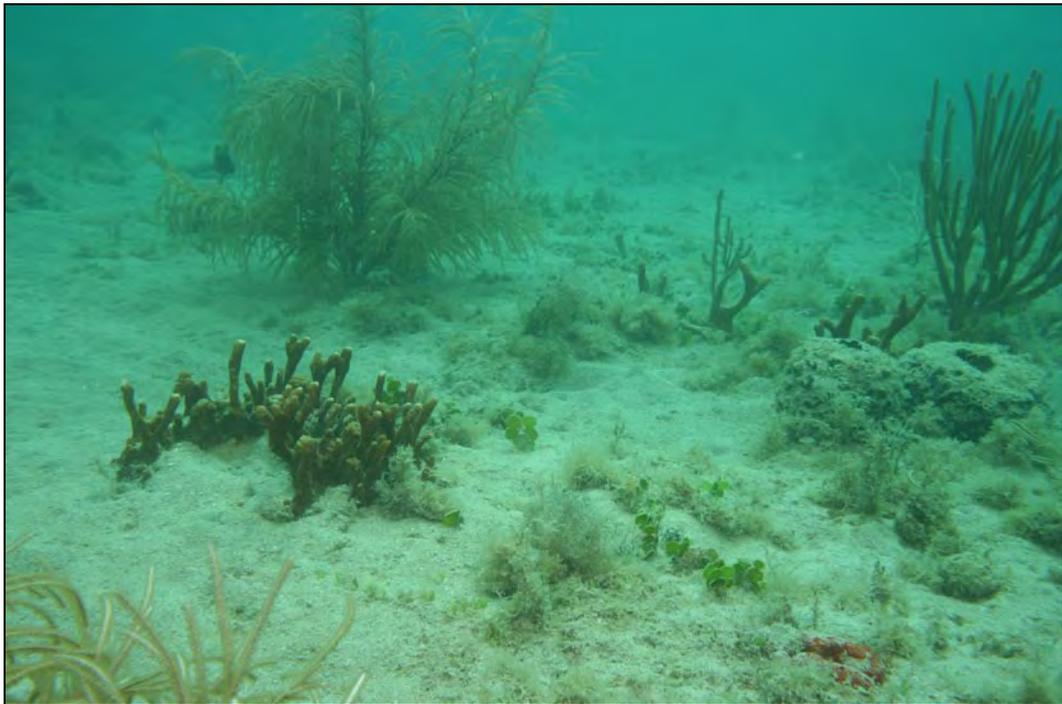
Figure 17. Soft coral (*Pseudopterogorgia* spp. and *Plexaurella* spp.), sponges (*Anthosigmella varians* and *Spheciospongia vesparium*), and algae within the Sunny Isles Beach Segment.

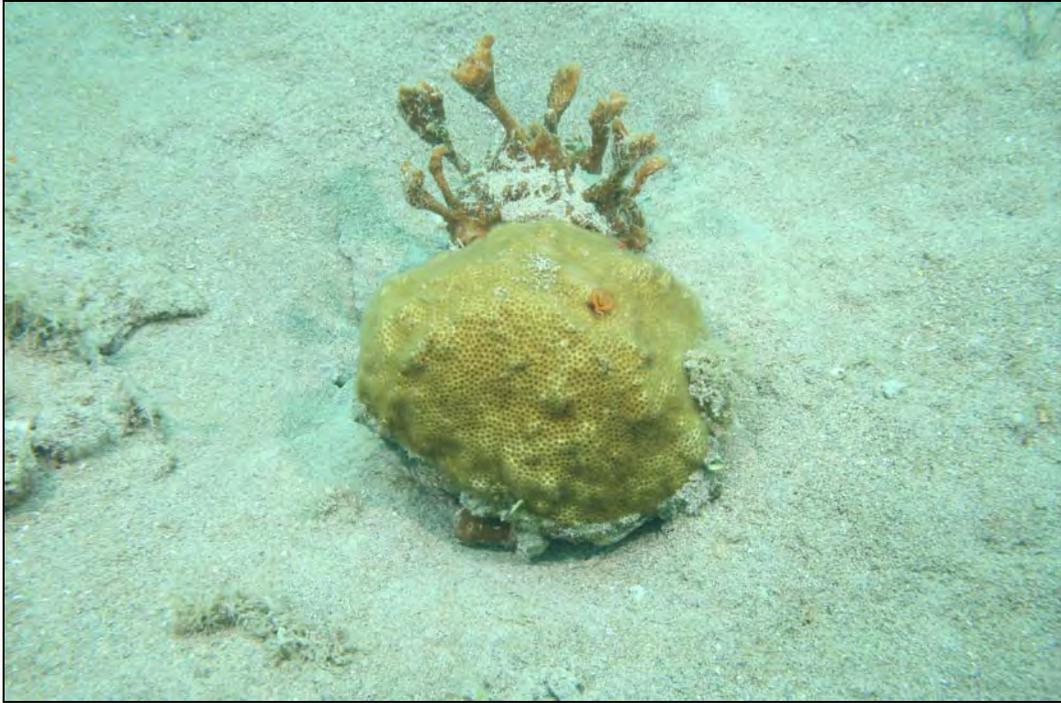
Figure 18. Hard coral, *Solenastrea bournoni*, and sponge, *Anthosigmella varians*, within the Sunny Isles Beach Segment.

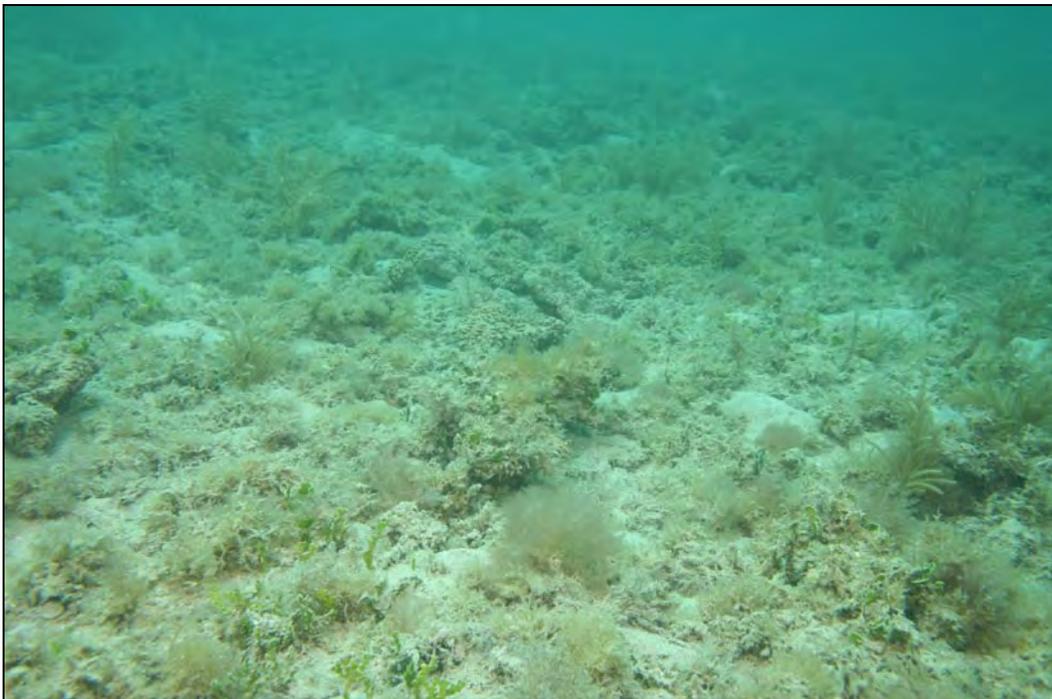
Figure 19. Significant habitat area with soft corals (*Pseudopterogorgia* sp.) and worm rock (*Phragmatopoma caudata*) within the Sunny Isles Segment.

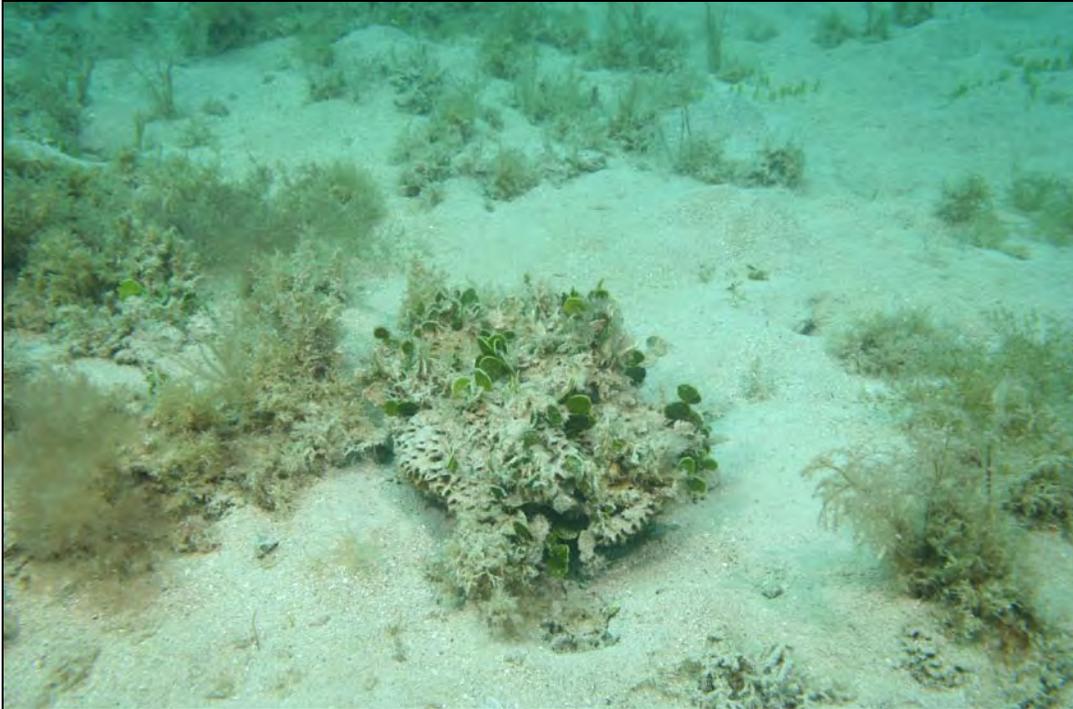
Figure 20. Worm rock (*Phragmatopoma caudata*) and algae within the Sunny Isles Segment.

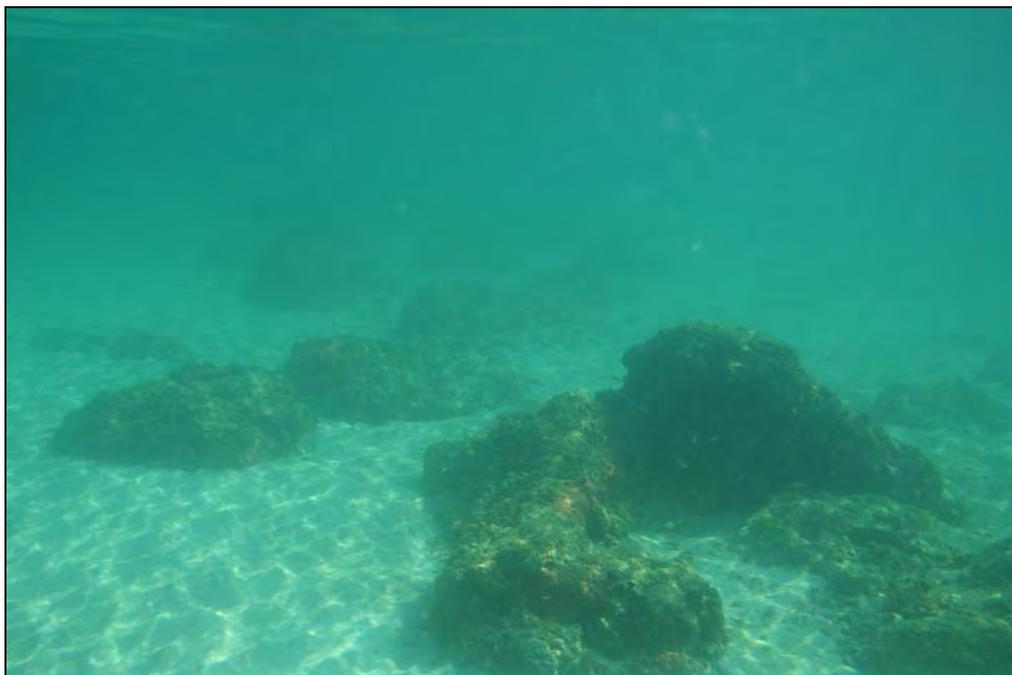
Figure 21. Northern breakwater structure with sponge growth (*Cliona* sp.) and juvenile grunts (*Haemulon* spp.) sheltered by boulders.

In addition to the natural habitat described above, two submerged breakwater structures are located approximately 400' from shore between R-7 and R-8 (transects SI-1 to SI-3) as shown in Figure 13. The breakwater structures off the Sunny Isles Segment were constructed from limerock boulders during the summer and fall of 2001 and now support benthic invertebrate, algal, and fish assemblages (Figures 21 and 22). Benthic and fish species observed on the boulders are included in Tables 4 and 5 respectively.

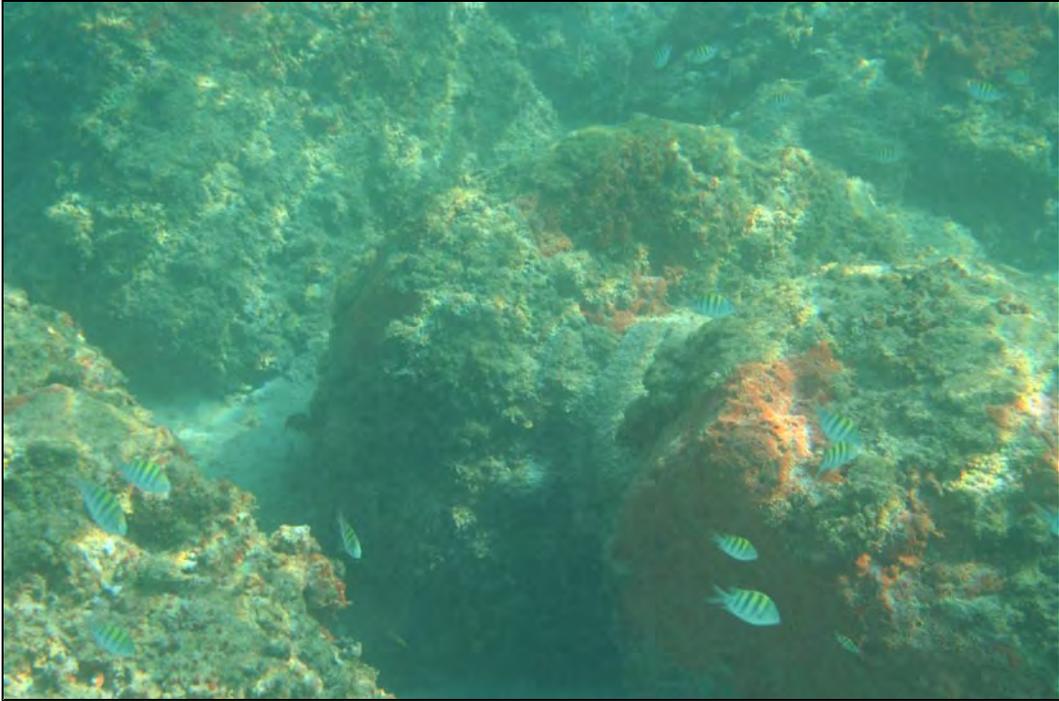
Figure 22. Southern breakwater structure with sponge growth (*Cliona* sp.) and Sergeant Majors (*Abudefduf saxatilis*).
