**PRELIMINARY
ASSESSMENT**

FORT PICKENS

**Pensacola, Escambia County, Florida
Project Number – I04FL006301**

**FINAL – 26 September 2007
Volume 1 of 4**

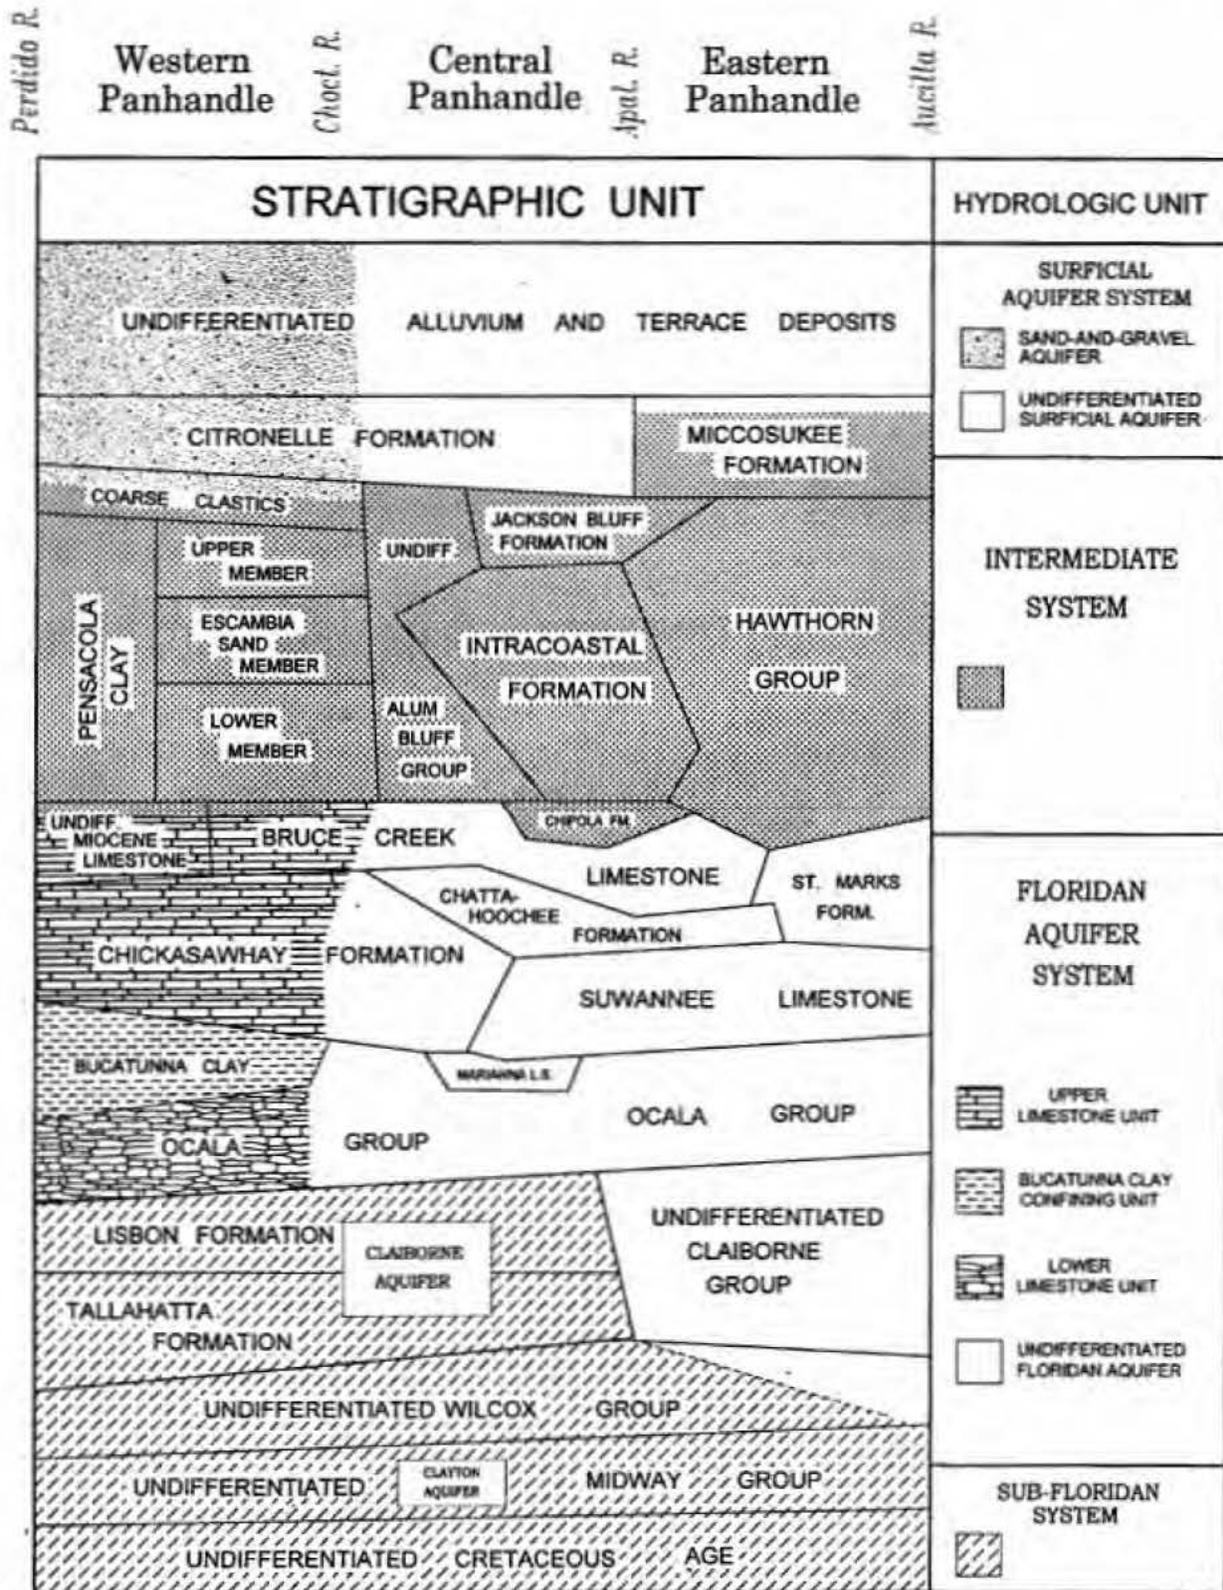
Figure 3-1. Correlation of Hydrogeologic Systems to Stratigraphy in the Panhandle Region

systems are: the Surficial Aquifer System (which includes the Sand and Gravel Aquifer); the Intermediate System; the Floridan Aquifer System (FAS); and the Sub-Floridan System. The Intermediate and Sub-Floridan systems function as groups of sediments that retard the vertical movement of groundwater. The Intermediate System limits the exchange of water between the Surficial Aquifer System and the FAS. The Sub-Floridan System forms the base of the FAS groundwater flow regime. The correlation of hydrogeologic systems to stratigraphy in the Panhandle Region of Florida is depicted in **Figure 3-1** below.²³⁷

NOTE: LITHOSTRATIGRAPHIC UNITS ARE NOT NECESSARILY SHOWN IN CORRECT CHRONOSTRATIGRAPHIC POSITION.

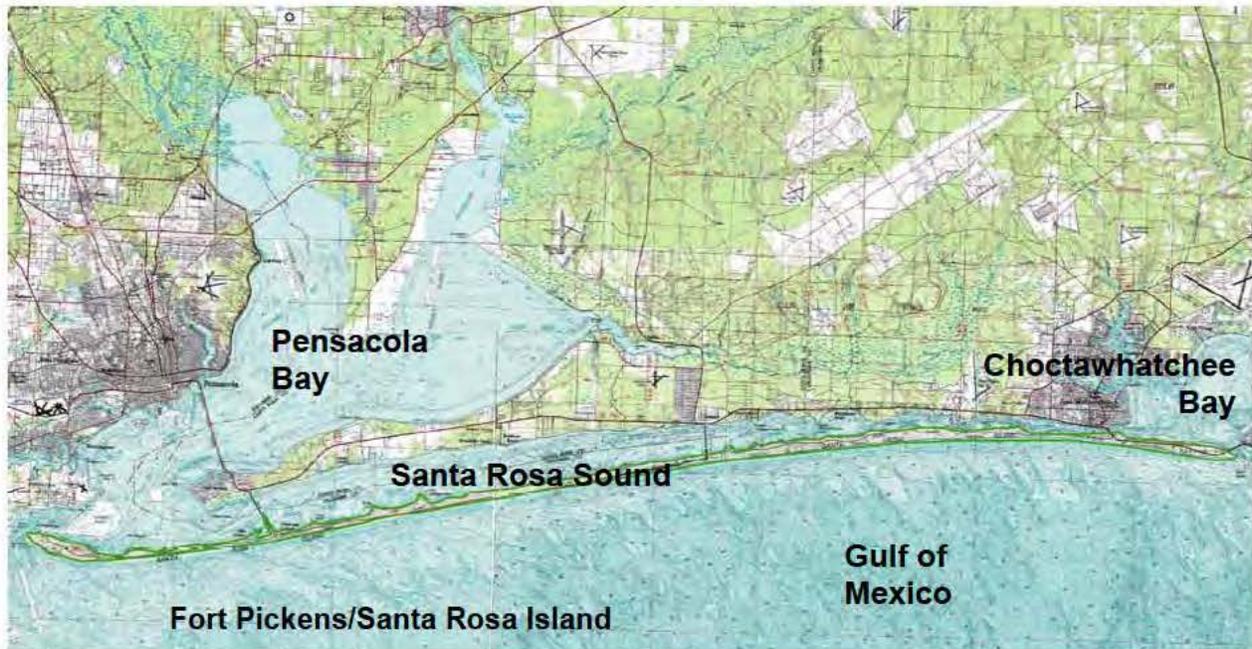
Figure 3-2. Fort Pickens Military Reservation Hydrological Setting

United States Geological Survey (USGS) topographic mapping in conjunction with Environmental Systems Research Institute, Inc (ESRI) software was used for the analysis of FUDS property drainage patterns.²⁵⁸ Elevations cited herein are referenced to the National Geodetic Vertical Datum of 1929. The Fort Pickens Military Reservation is located on the western end of Santa Rosa Island, Escambia County, with the Gulf of Mexico to the south and Pensacola Bay to the north as shown in **Figure 3-2** below.

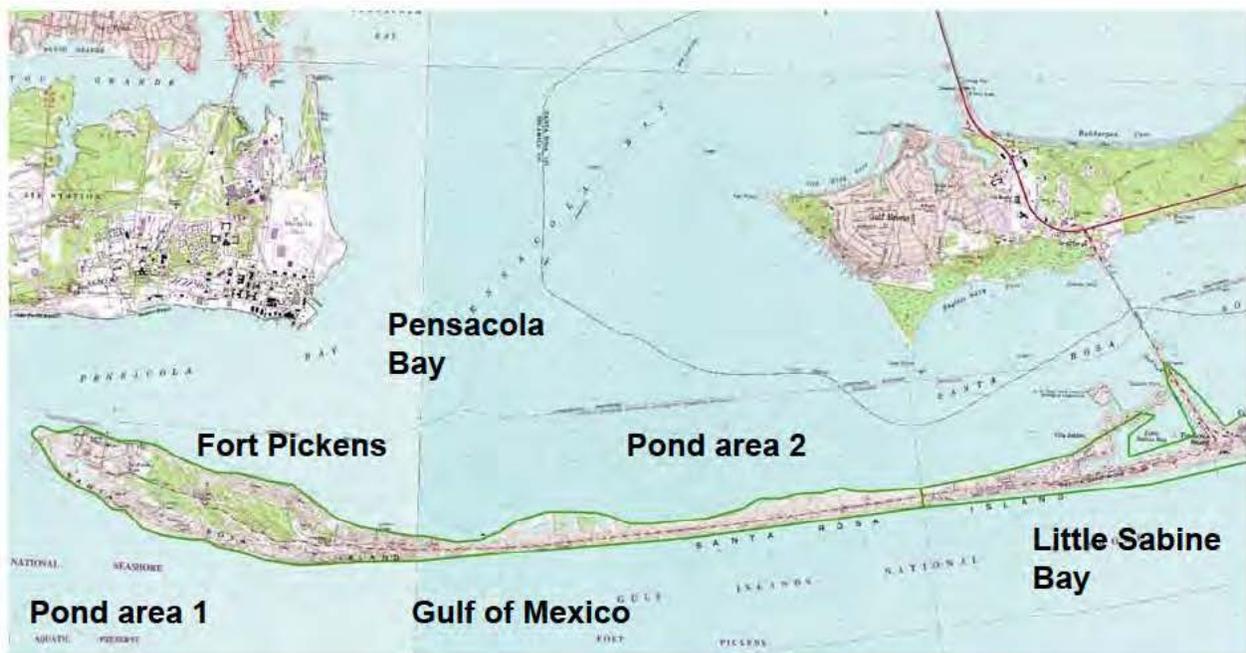
Figure 3-3. Fort Pickens to Little Sabine Bay, Santa Rosa Island

Man-made drainage works associated with the roads and other development on the Reservation most likely redirect and channel runoff. The higher elevation portions of the western end of Santa Rosa Island, from Little Sabine Bay to the western edge, are located on the Gulf side of the island as depicted in **Figure 3-3** below.

Topographic mapping indicates two pond areas on the western end of this site on the bay side of the island and several marshes (see **Figure 3-3** above). Aerial photography shown in **Figure 3-4** below indicates a filled area in Little Sabine Bay, while topographic mapping does not (see **Figure 3-3** above).

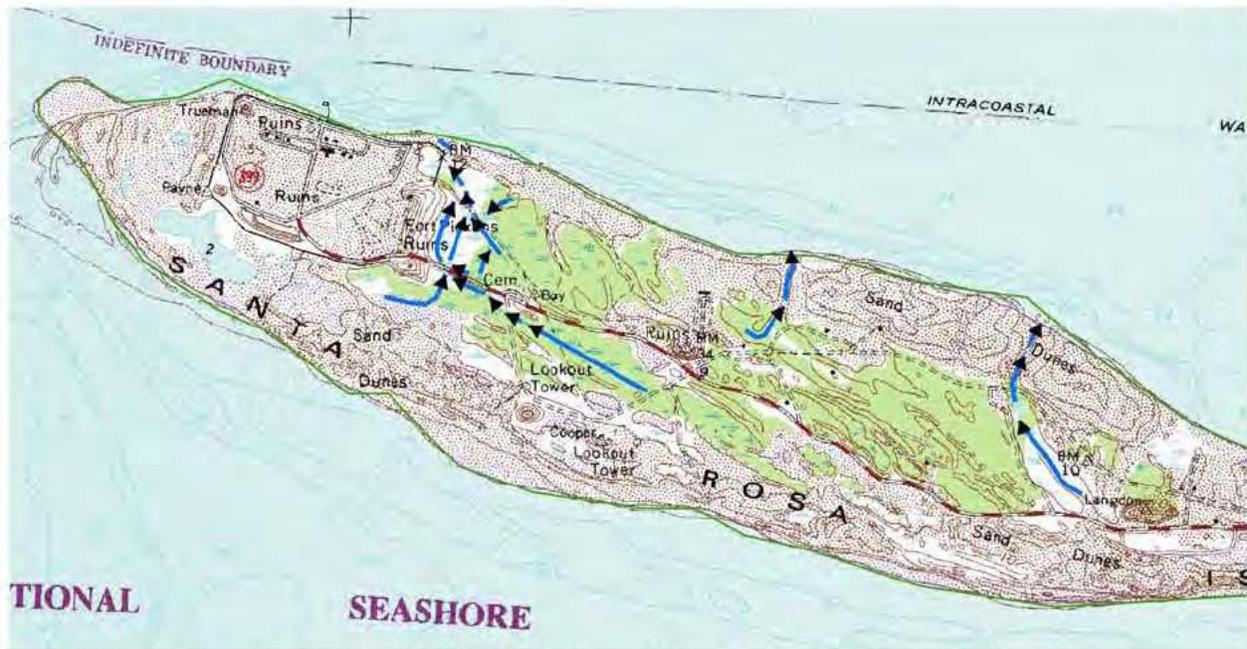
Figure 3-5. Fort Pickens Military Reservation Drainage Pathways

Because the FUDS property is very large and, thus, has a long perimeter, it is difficult to account for all possible paths taken by runoff. Thus, runoff from some peripheral portions of the Fort Pickens Military Reservation may flow into streams other than those shown in **Figure 3-5** below.

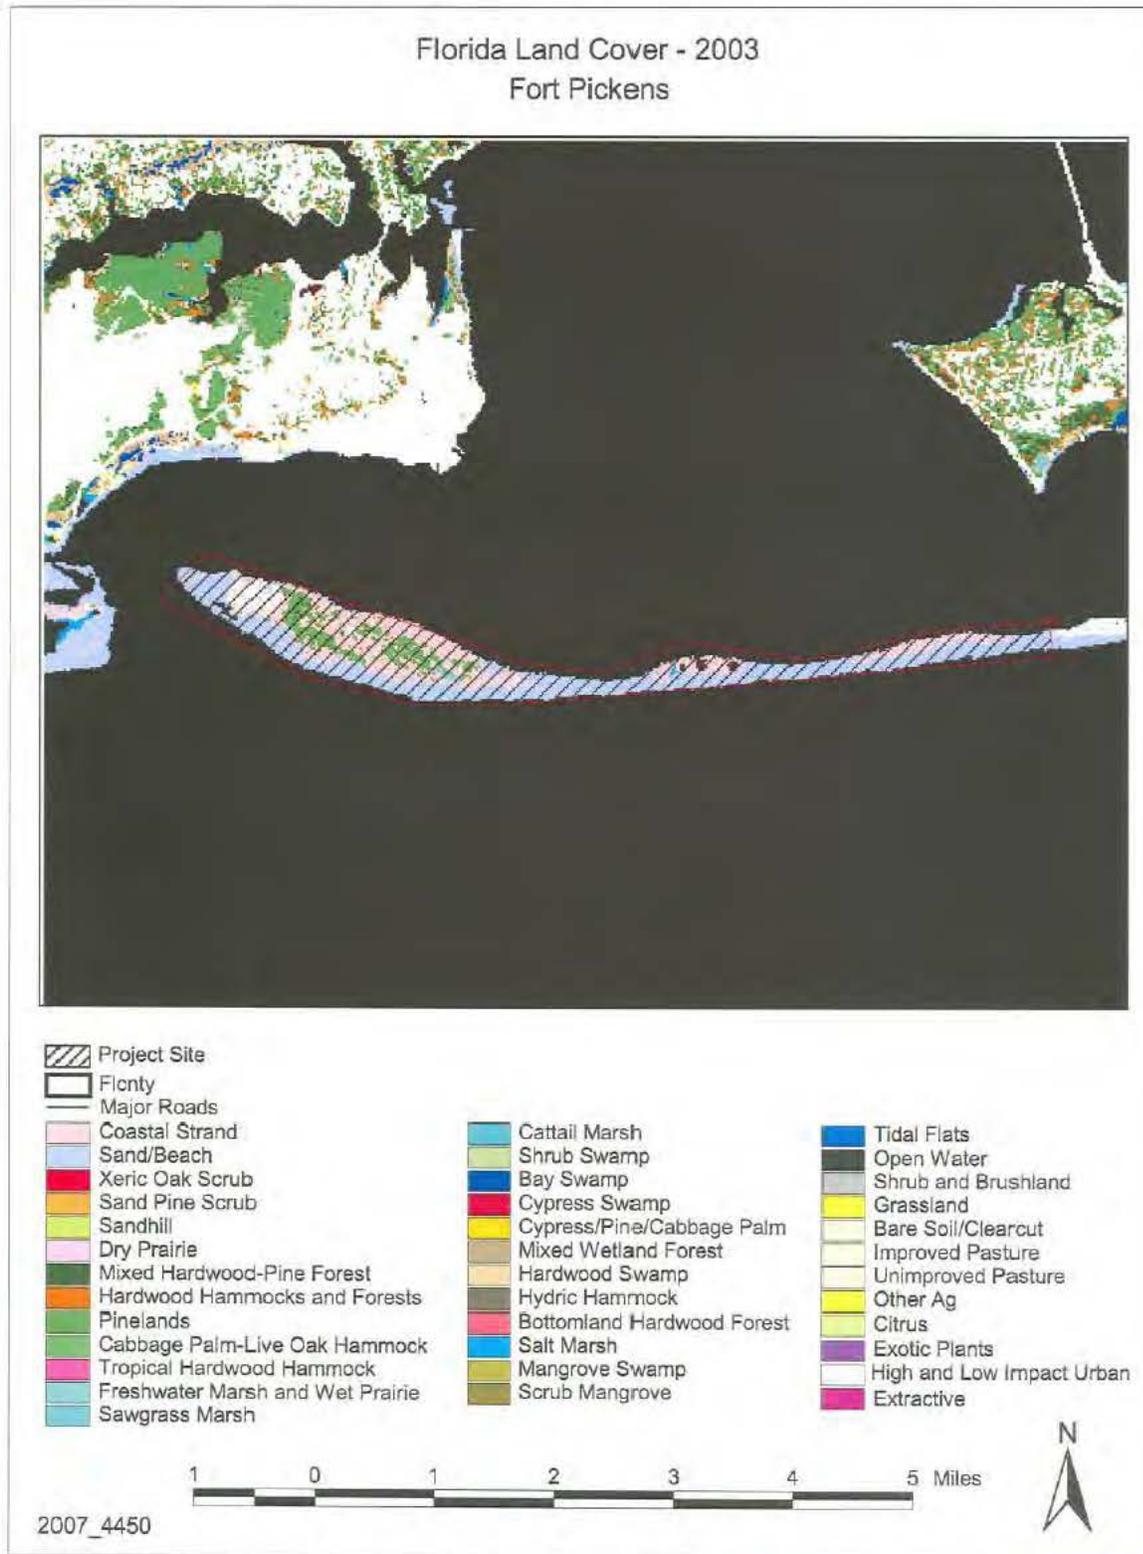
The various land cover types associated with the FUDS property are depicted in **Figure 3-7** below.²⁷⁰

Figure 3-7. Land Cover Types at the Fort Pickens Military Reservation

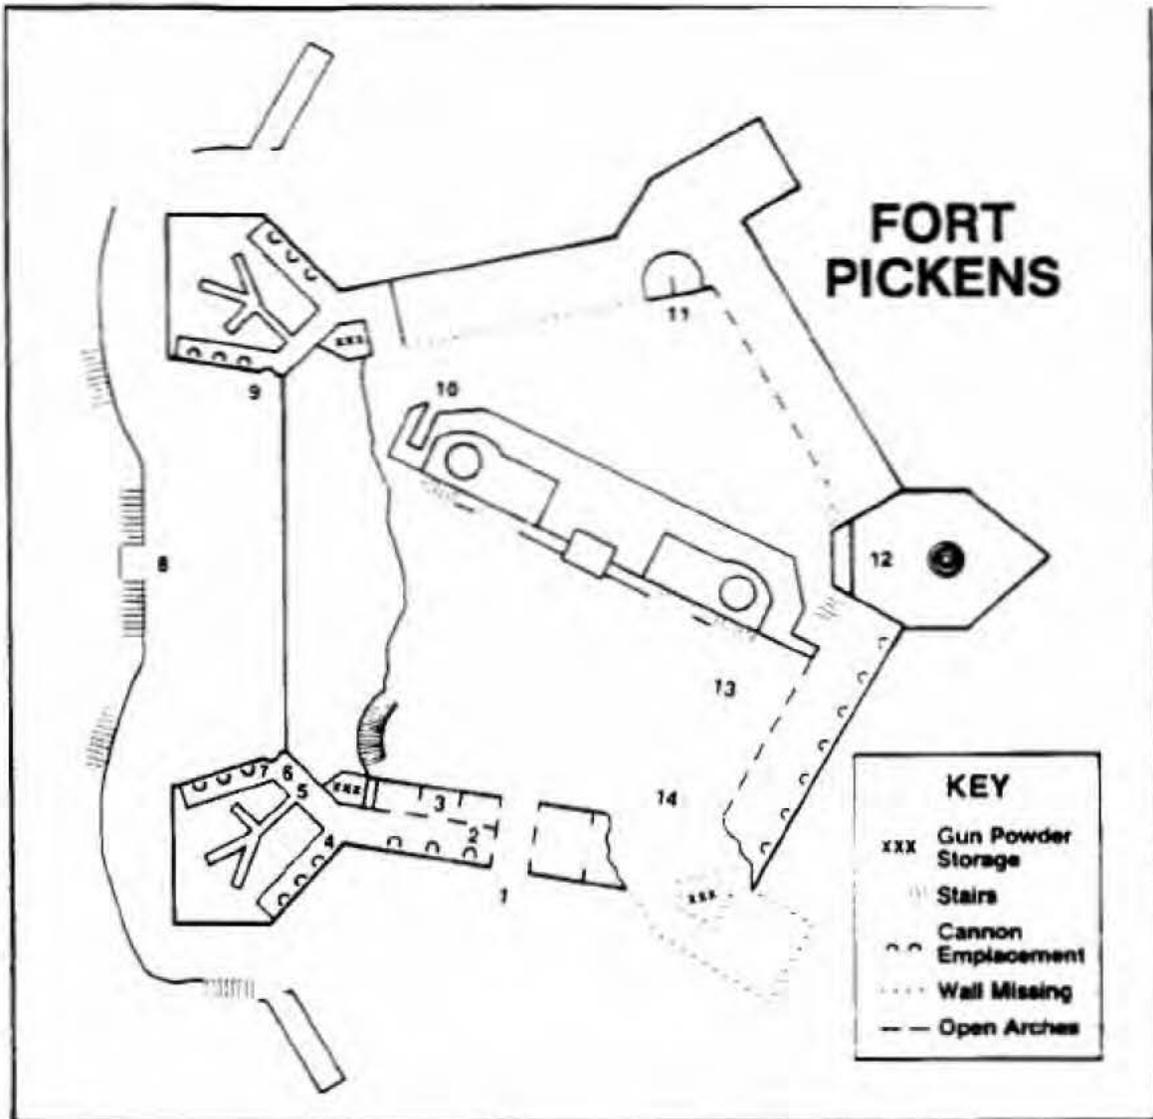
Figure 4-1. Basic Layout for Fort Pickens, Florida

Each of the numbered features in **Figure 4-1** above is described in the following text. In the Casemate Embrasure (1), heavy oak doors once secured the main entrance into the Fort. The Casemate (2) held a variety of interior cannon emplacements. Chimneys over the embrasure (gun port) vented smoke from the room during firing. The plaster lined Quarters (3) were intended to house officers. The fireplaces held marble mantels and the floors, doors and window sashes were wood. Enlisted men camped outside in the fort's center or in the casemate alongside the cannon. The Apache prisoner Geronimo and his renegade followers were housed in these rooms from 1886-1888. In 1894, two casemates were converted into concrete Battery Storage Rooms (4) (vaults) for electric batteries. The batteries controlled torpedo mines, via a network of cables, placed in the harbor for defense. Dampness forced the relocation of the operation to buildings outside the fort. Three Mine Chambers (6) were designed to hold about 3,000 pounds of black powder. Opposite the chambers, two vent windows led to the gunpowder magazine.

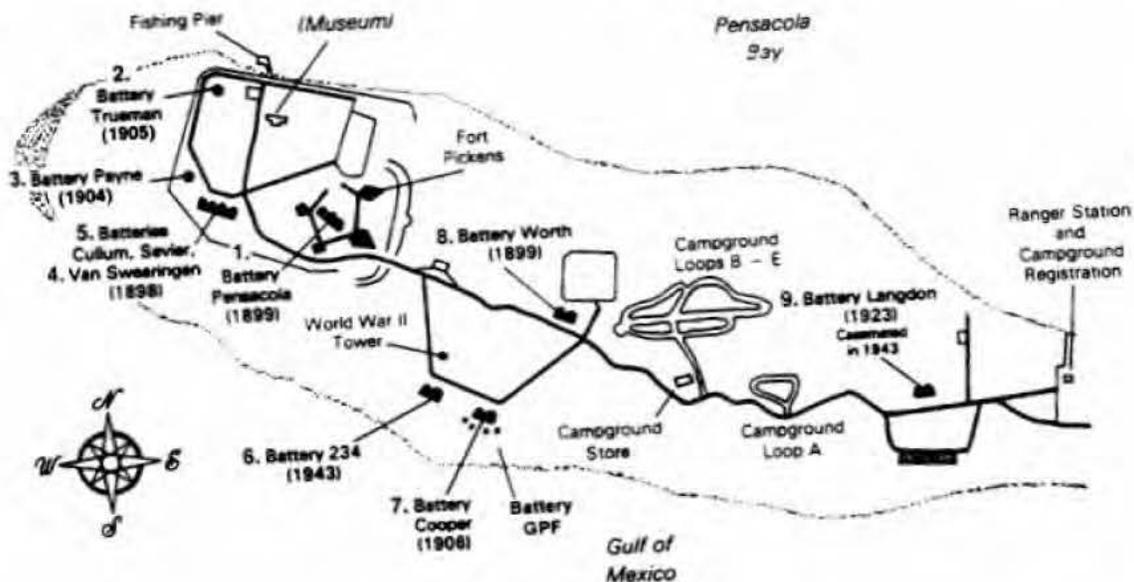
Figure 4-2. Layout of Batteries Surrounding Fort Pickens

As stated above, there were nine concrete batteries on Santa Rosa Island. In chronological order of completion they were: Batteries Cullum and Sevier, Battery Pensacola, Battery Worth, Battery Van Swearingen, Battery Payne, Battery Trueman, Battery Cooper, Battery Langdon, and Battery No. 234.^{454, 455} The locations of these batteries in relation to Fort Pickens are illustrated in **Figure 4-2** below and described in the following paragraphs.⁴⁵⁶

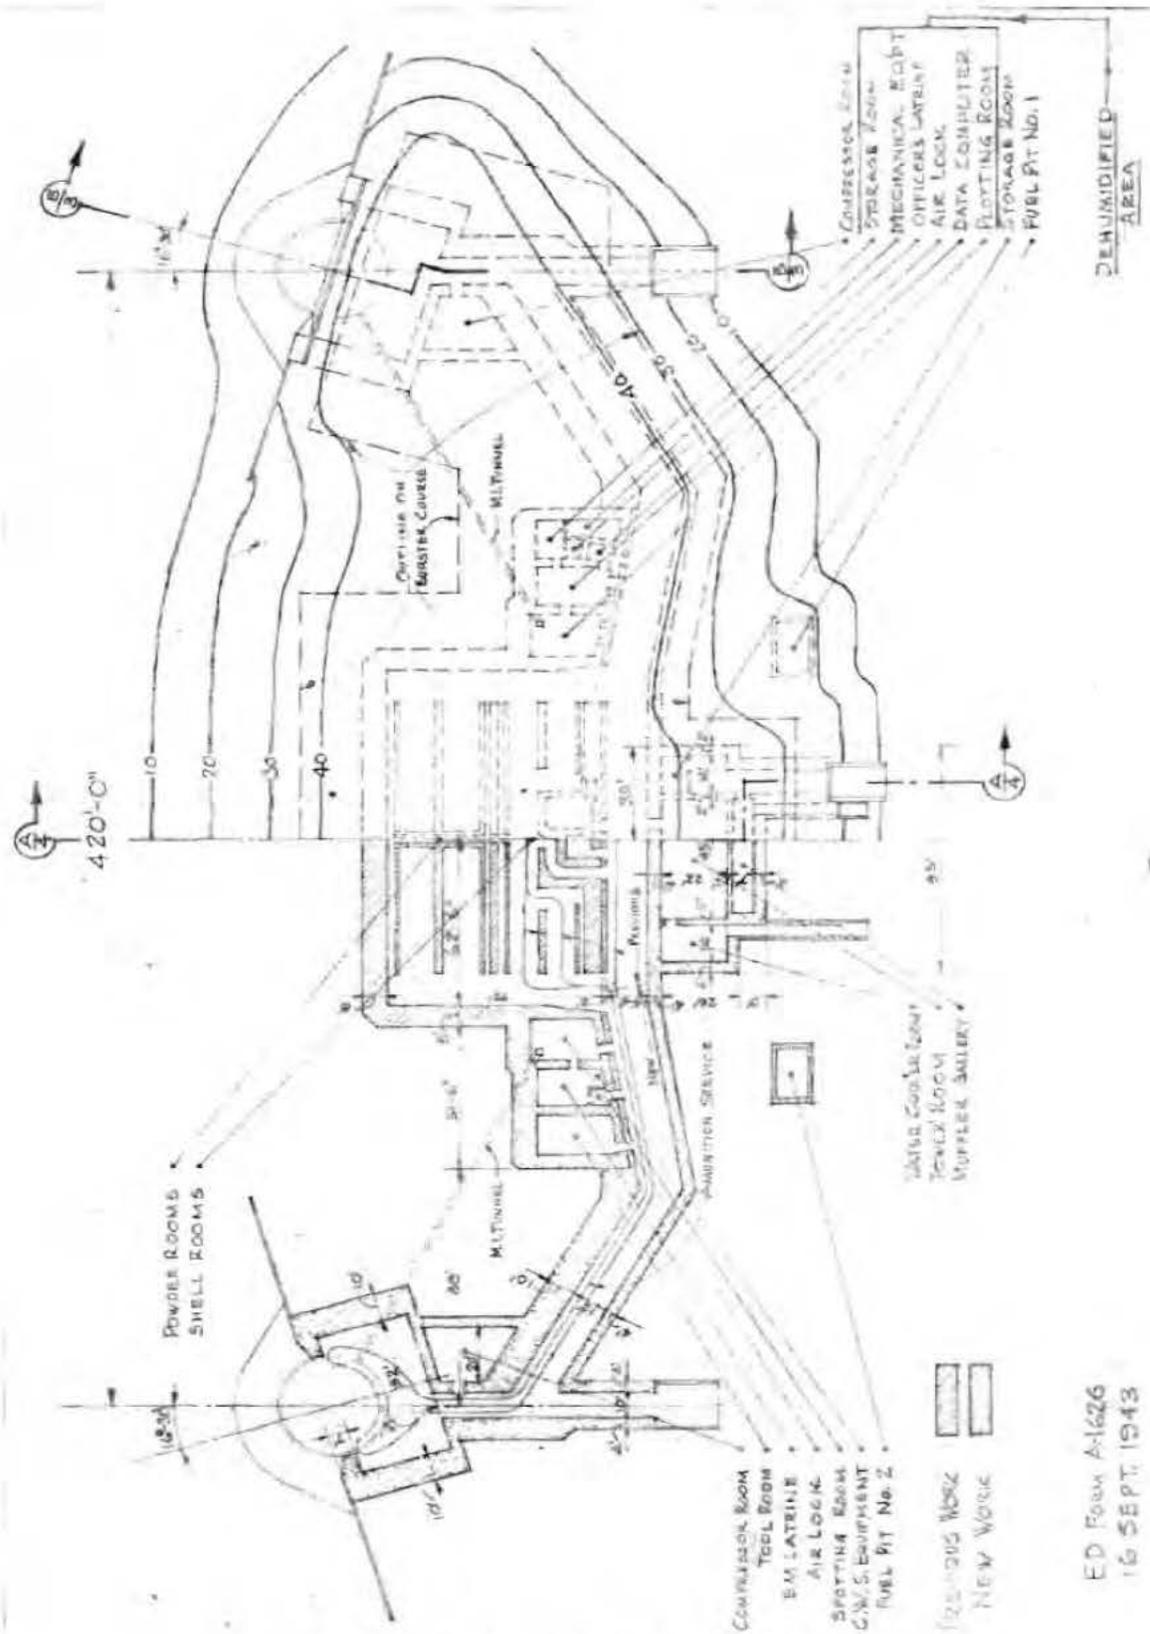
Figure 4-10. Layout of Battery Langdon

Major structural changes were made to Battery Langdon during 1942-43. Massive concrete casemates, with walls 10 feet thick and 17 feet of overhead masonry, were added to protect the guns and crews. Construction of the casemates reduced each gun's field of fire from 360 to 145 degrees. Each emplacement was connected with the magazines in the traverse by reinforced concrete corridors with more than eight feet of masonry, 20 feet of sand fill, and a two-foot burster course of concrete overhead. A new power room in the rear of the traverse was built. The power room was protected by five-foot concrete walls with five feet of concrete and more than six feet of sand fill overhead. This structure was divided by concrete interior walls into a power room, storeroom, water cooler room, muffler gallery, corridor, and two exhaust tunnels. On either side was a fuel storage tank positioned in a pit.⁵⁷⁹ In 1945, four 40-mm and four caliber .50 machine guns were installed at Battery Langdon.⁵⁸⁰ In May 1947, the War Department declared the Pensacola Harbor Defenses surplus to the nation's needs and ordered them deactivated.^{581, 582} During June and July 1947, the two 12-inch guns and Barbette carriages at Battery Langdon were completely demilitarized, removed, mutilated, and sold for scrap.^{583, 584}
