Proposal Name: Proposal for authorization to correct navigation safety deficiencies in the Bayport Ship Channel and Houston Ship Channel

DEFICIENCY CORRECTION EVALUATION REPORT AND FINDING OF NO SIGNIFICANT IMPACT WITH ENVIRONMENTAL ASSESSMENT

Houston Ship Channel Project Deficiency Report (Flare at the Intersection of the Houston Ship Channel and Bayport Ship Channel) Houston-Galveston Navigation Channels, Texas

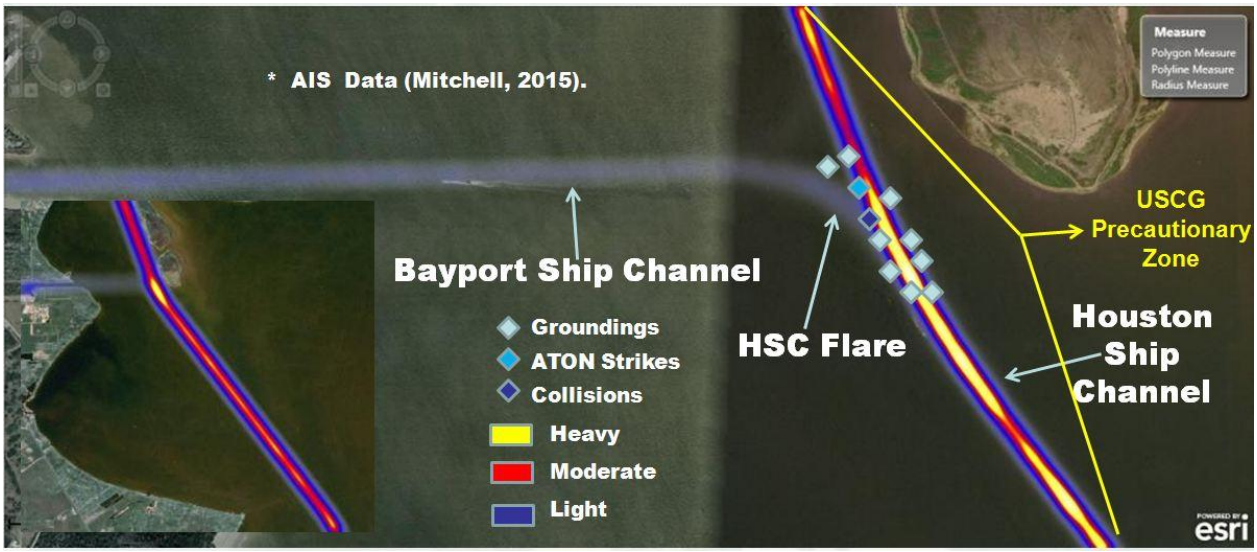
Figure 3-2: Figure of AIS Data Highlighting Known Groundings and Collisions

The ship simulation conducted for the WRDA 1996 project (ERDC 1994 Report) detailed concerns regarding the meeting/passing of the design vessels. The design vessels used in the 1995 LRR ranged in length from 921 feet to 990 feet, having beam widths of between 140 feet and 156 feet, with a loaded drafting 44 feet.
